**PRODUCT CAMPAIGN BULLETIN**

**APPLICABILITY:** 2017-18MY Impreza  
2018MY Crosstrek

**NUMBER:** WUP-01R

**SUBJECT:** PCV Valve- Design Change

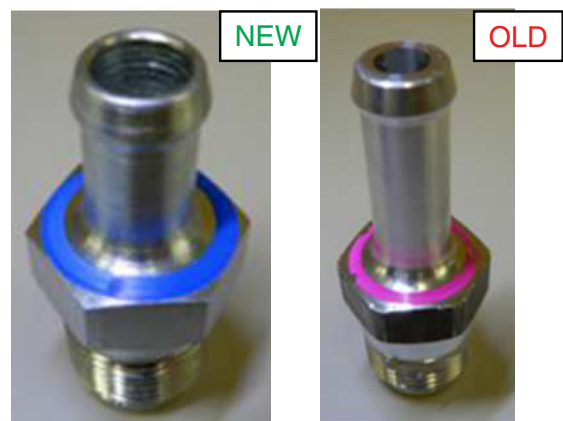
A new parts kit, **p.n. X1181AA000** consisting of a new steel PCV valve and hose **is now available**. The NEW -style PCV Valve is made of steel and has a **BLUE** ring above the hex portion as shown. The old -style is made of aluminum and has a **PINK** ring above the hex portion.

A photo of the new hose is also shown.

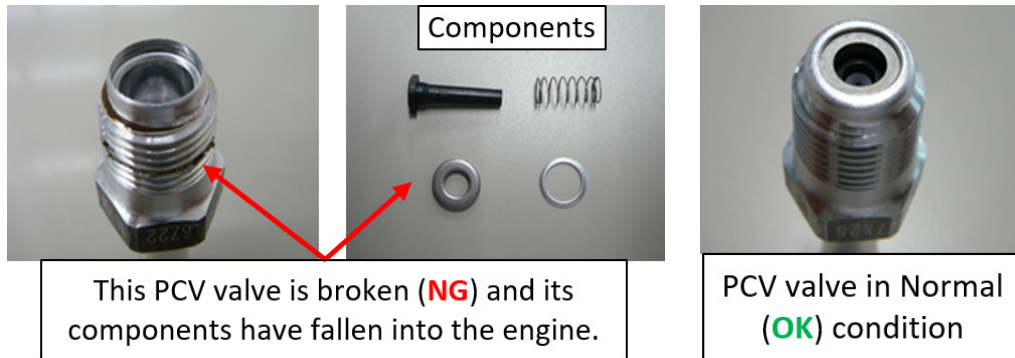
**Step 2:** Remove the **PINK** PCV valve and inspect it for breakage. Use the photos below for reference.

- If the PCV valve is **BROKEN (NG)**, proceed to **Step 3** and remove the engine following the procedure in the applicable Service Manual.
- If the PCV valve is **OK (NOT broken)**, replace it with the new **BLUE** valve and hose from the kit to complete the procedure following the applicable Service Manual.

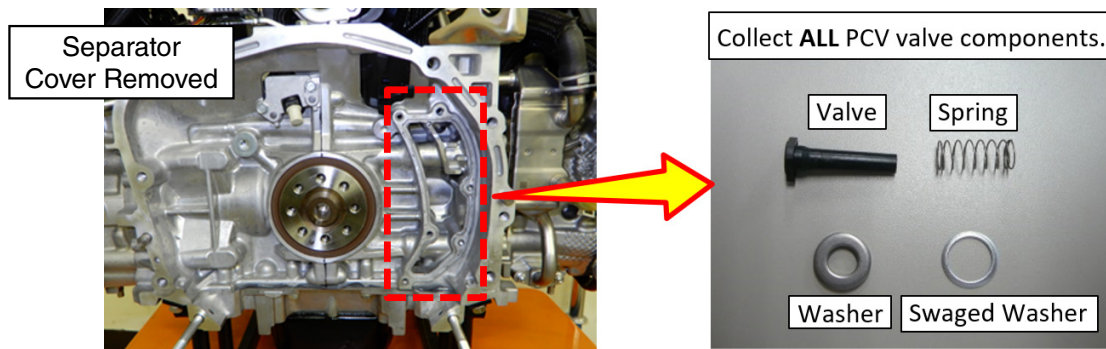
**Step 3:** (If necessary), following the applicable Service Manual procedures, remove the engine to collect the PCV valve component parts that may have fallen into the engine. Remove the oil separator cover and collect the PCV valve components (4 small parts) as shown in the photos below. If all the PCV valve components cannot be collected after removing the oil separator cover, proceed with removing the engine oil pan to collect any remaining components.

- If all the broken PCV valve components cannot be found and collected, replace the short block assembly along with a new PCV valve and hose (kit) following the applicable Service Manual procedures.
- If all the broken PCV valve components are found and collected, install a **new** separator cover, PCV valve and hose (kit) then reassemble the vehicle following the applicable Service Manual procedures to complete the procedure.

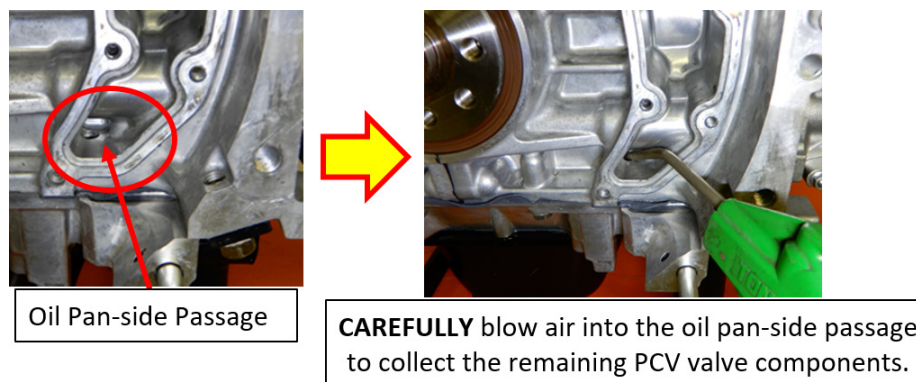
**TIP:** If any PCV valve components remain in the oil pan-side passage, **CAREFULLY** apply compressed air to the oil pan-side passage as shown below.

- Always wear safety glasses.
- Never reuse the oil separator cover as it is a one-time use item. Replace it with p.n. **11831AA260**.
