PRODUCT CAMPAIGN BULLETIN

APPLICABILITY: 2017-18MY Impreza
2018MY Crosstrek

NUMBER: WUP-01R

SUBJECT: PCV Valve- Design Change

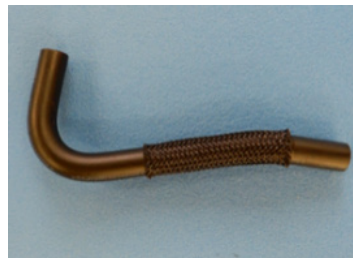
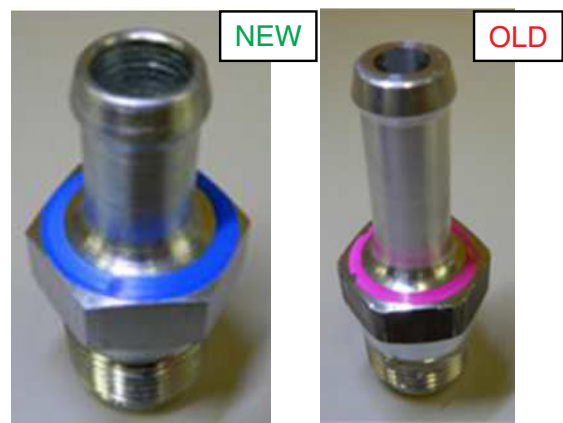
A new parts kit, **p.n. X1181AA000** consisting of a new steel PCV valve and hose will be available soon. The NEW -style PCV Valve is made of steel and has a **BLUE** ring above the hex portion as shown. The old -style is made of aluminum and has a **PINK** ring above the hex portion.

A photo of the new hose is also shown.

NOTE: The new **p.n. X1181AA000** PCV valve kit is expected to be available in early November.
