Mercedes-Benz

Campaign No. 2020020017, March 2020

SUBJECT: **Models Various**
Model Year 2018-2019
Implausible Seat Belt Detection

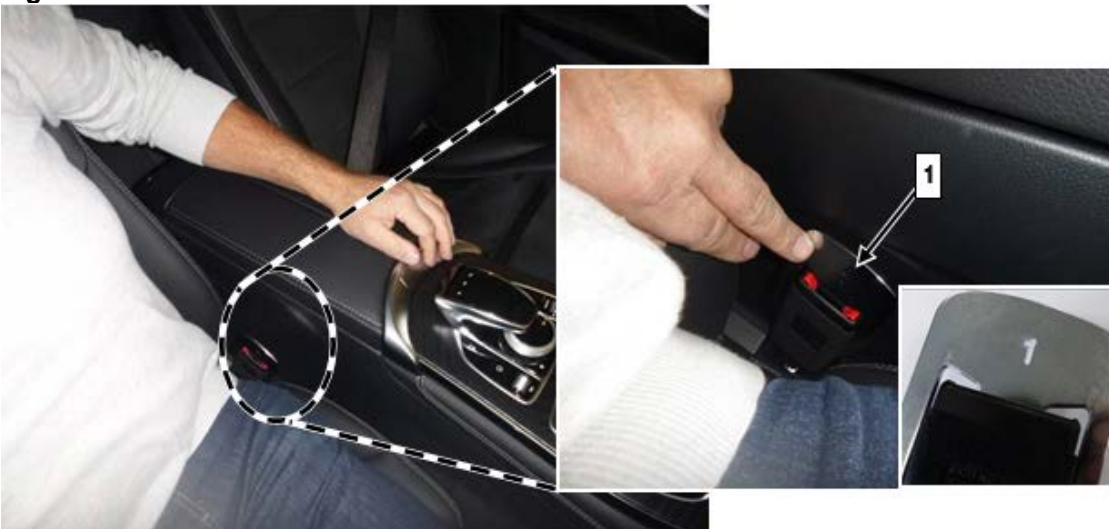
Figure 4

6. Insert test seat belt tongues (**beginning with test seat belt tongue 1**) into the front passenger side seat belt buckle in accordance with the specification of the test sequence (**1, figure 4**).

i **ATTENTION: Pay attention to the insertion direction of the test seat belt tongue.** The number of the test seat belt tongue must face the sitting surface of the vehicle occupant (figure 4), and the seat belt tongue must be inserted so that it is straight (not misaligned).
