SIB 65 23 19

RECALL 19V-851: DRIVER'S FRONT AIR BAG (NADI) INFLATORThis Service Information Bulletin (Revision 16) replaces SI B65 23 19 **dated December 2022**.**What's New** (Specific text highlighted):

E-Series	Model Description	Production Date
E46	3 Series Sedan	July 2, 1998 – January 5, 1999

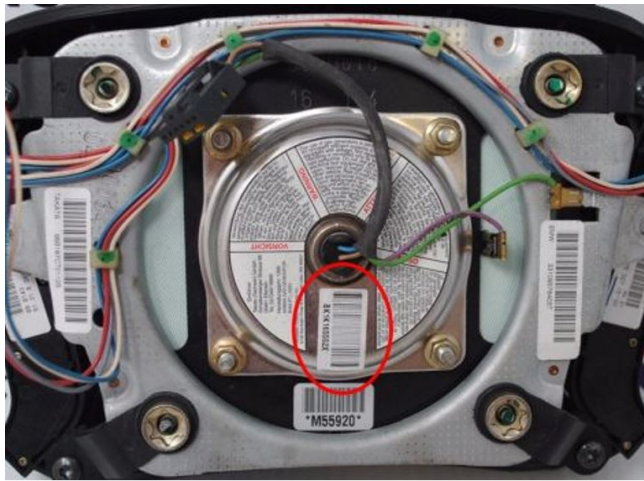
Once the air bag is removed and the wiring is disconnected, turn the air bag over to read the parts label(s) on the gas generator on the back.

Basic Driver's air bag, showing the location of the parts label.

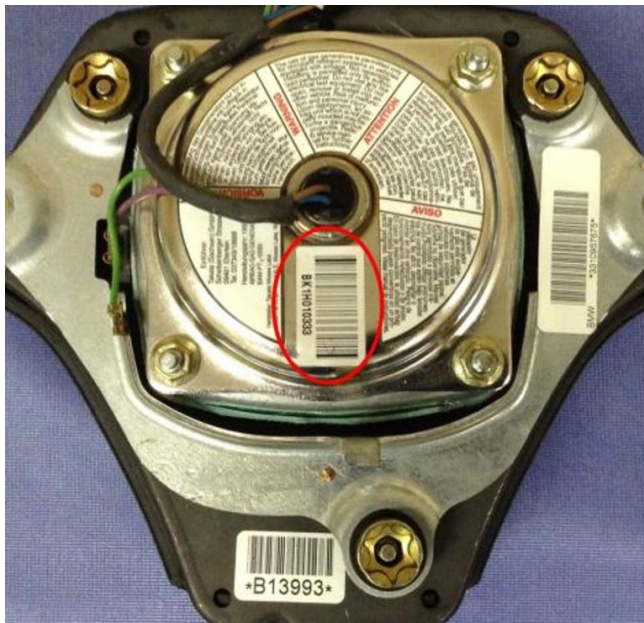
Sport Driver's air bag, showing the location of the parts label.

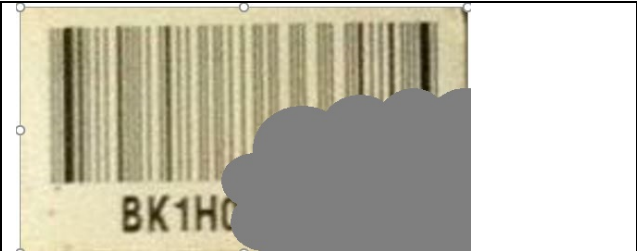
Gas generator serial number decoding:

- Digits 1-2 = Type of gas generator
- Digit 3 = Production Line
- Digit 4 = Production year
- Digit 5-11* = Serial #

***NOTE:** The serial number can have 10 or 11 characters. Only the first 10 characters counted from
Copyright ©2023 BMW of North America, Inc.

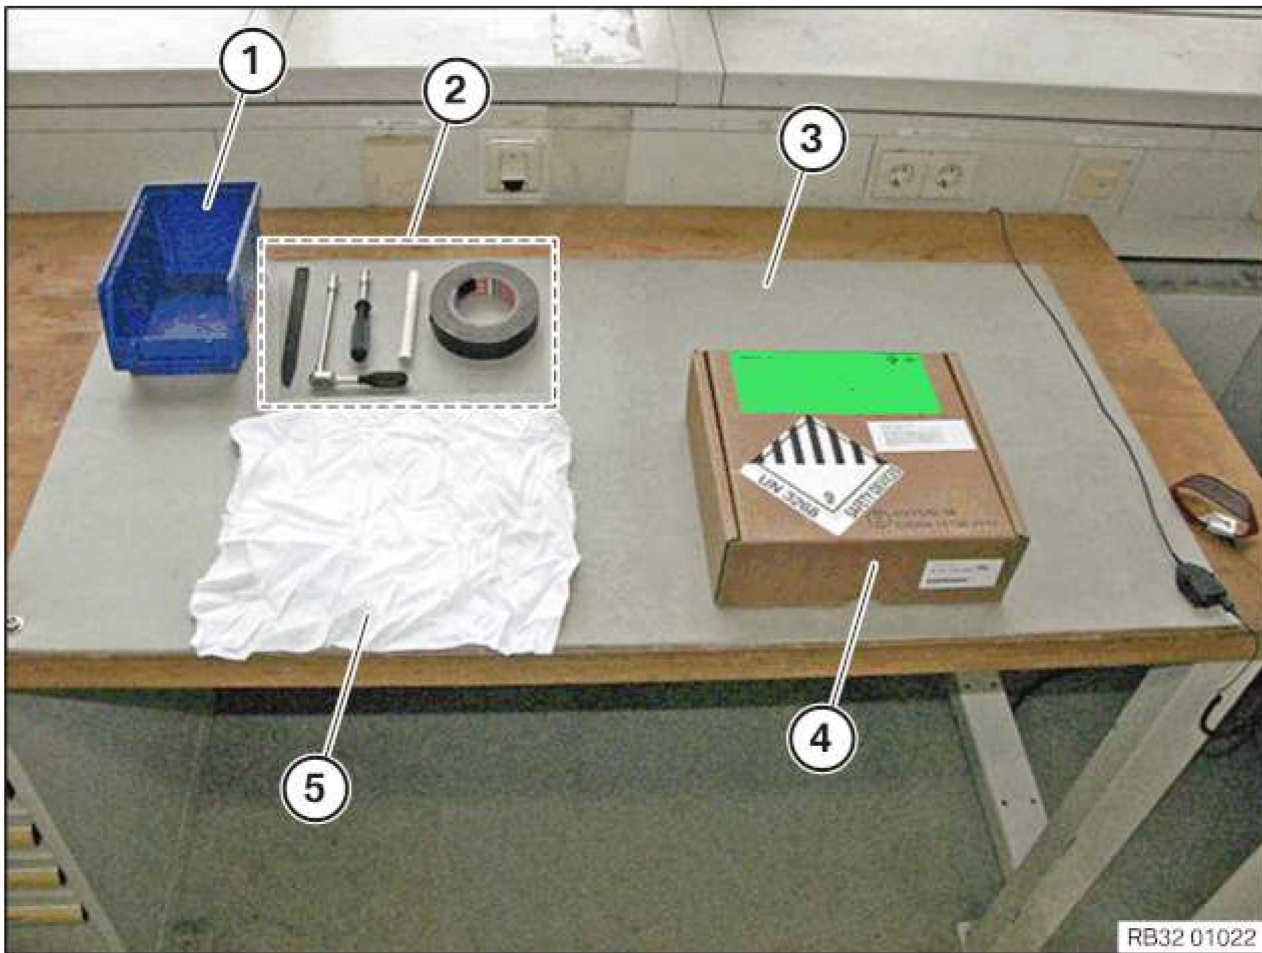
Workplace for replacement of the gas generator (E46)

- 1 Collection container for disposal of the nuts
- 2 Tools required for the exchange
- 3 Antistatic mat
- 4 New, packaged gas generator
- 5 Scratch-resistant cotton underlay

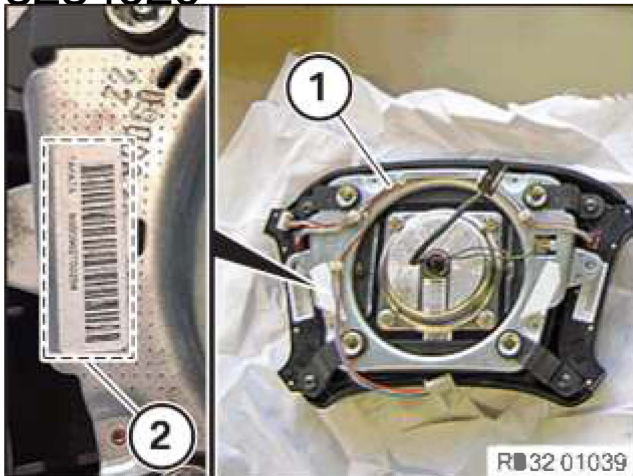
- Place the airbag unit (1) turned around as shown.
- Note the serial number (2) of the airbag unit (1) on the work order.

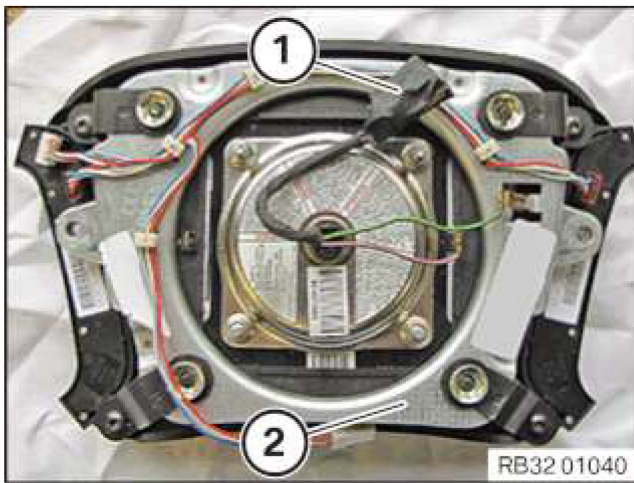
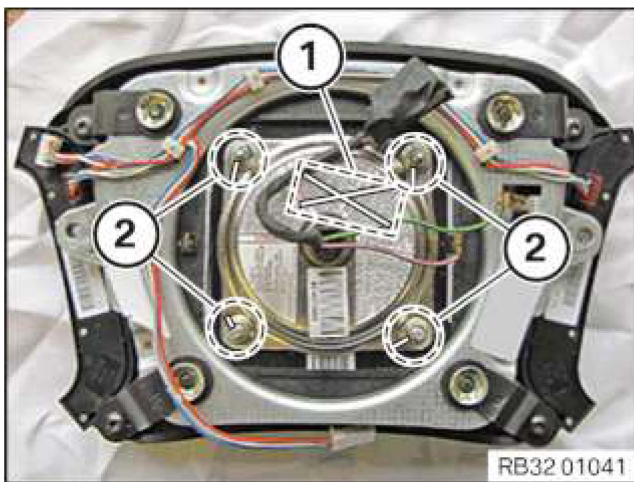
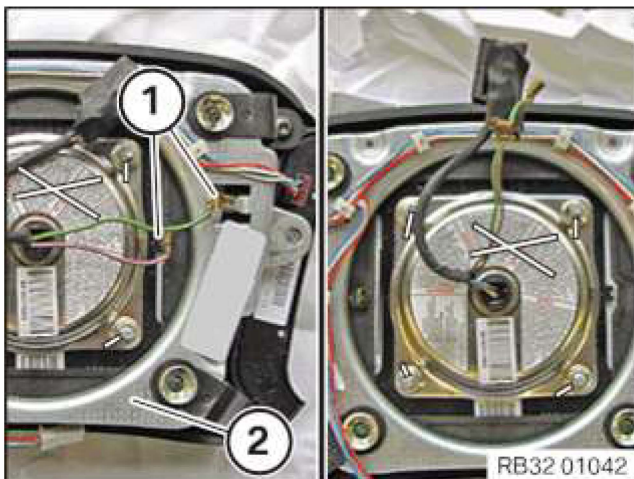
- Glue the connector (1) from the previous gas generator of the airbag unit (2) with the adhesive tape so that the contacts cannot be touched.

- Mark a cross (1) with the felt pen to avoid a mix-up with the new gas generator.
 - Mark all the four nuts (2) with the felt pen to avoid a mix-up with the new nuts.
-
- Release both the connectors (1) on the airbag unit (2).
-
- **Auxiliary person:** Hold the airbag unit (1).
 - Unscrew all the nuts (2) in any order and dispose of immediately in the collection container provided (3).
 - Do not reuse the nuts (2).

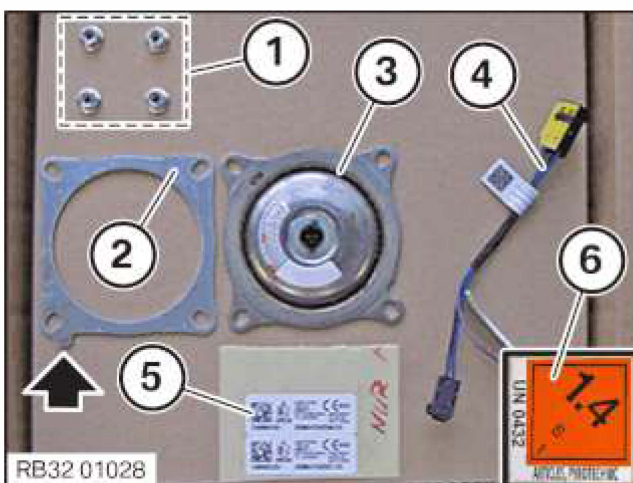
- Unpack the new nuts (1), reinforcement plate (2), new gas generator (3), cable (4) and sticker (5) and place it as shown.
- Make sure that the groove (arrow) of the reinforcement plate (2) is positioned correctly.
- USA only:
Dispose of the hazard sticker (6).

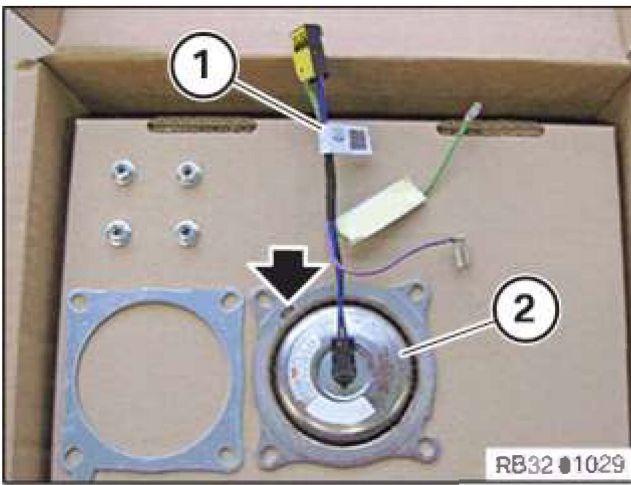
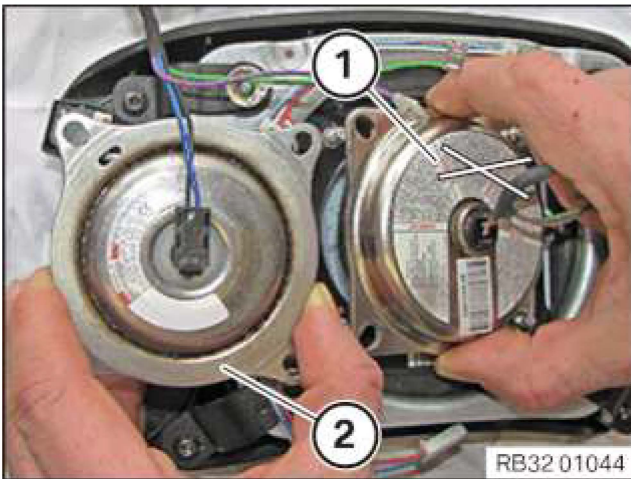
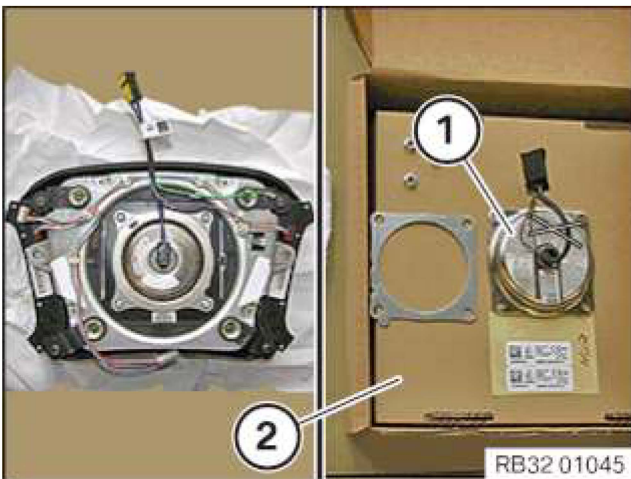
- Clip in the cable (1) as shown in the new gas generator (2).

The cable (1) and the groove (arrow) of the new gas generator (2) point upwards.

The connector is encoded against incorrect assembly.

- Remove the previous gas generator (1) and subsequently directly place the new gas generator (2).

The cable and the groove of the new gas generator (2) point upwards.

- Insert the previous gas generator (1) in the packaging (2).

- Position the reinforcement plate (1) over the new gas generator (2).
- Make sure that the groove (arrow) of the reinforcement plate (1) is positioned correctly.

The groove (arrow) points downwards to the left.

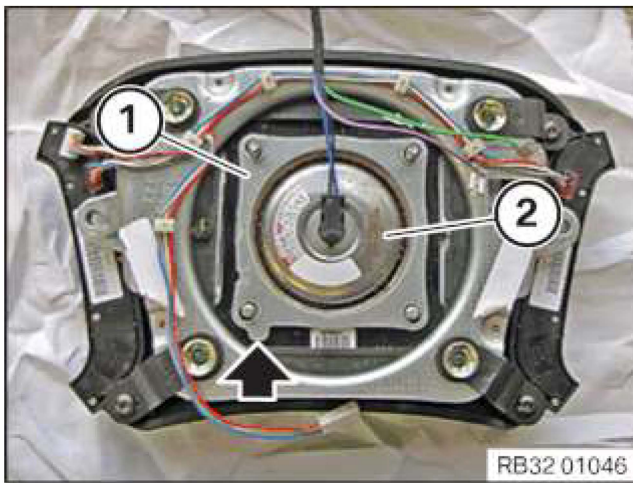
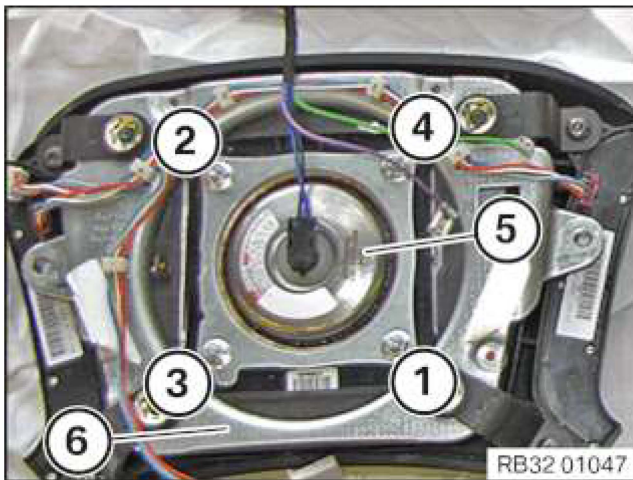
- **Auxiliary person:**

Hold the airbag unit (6).

Check whether the nuts have been tightened correctly by the executing person.

The noise must be audible while retorquing.

- **Executing person:**

Lightly screw on the new gas generator (5) with the new nuts in the screwing sequence (1) to (4).

Tighten the nuts in the screwing sequence (1) to (4).

Retorque the nuts in screwing sequence (1) to (4).

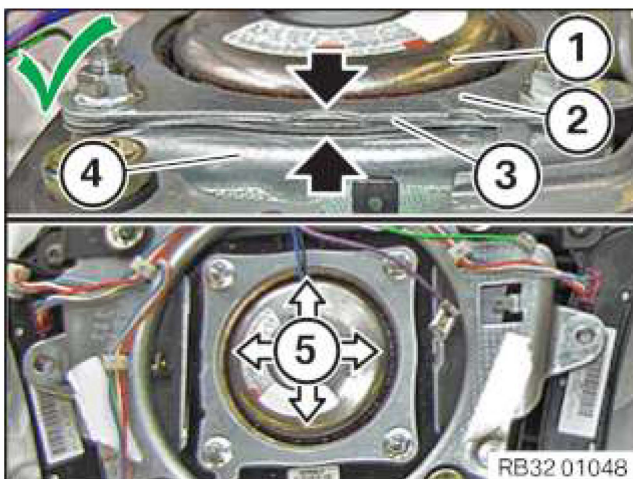
- **Executing person:**

Visually inspect the gap (3) between the new gas generator (1), reinforcement plate (2) and airbag unit (4) on all four sides (5).

- **If the gap (3) is not OK:**

Release the screw connection and tighten again as described in the previous step. If the gap is still not OK, then cancel the repair. Install the new airbag unit in this case.

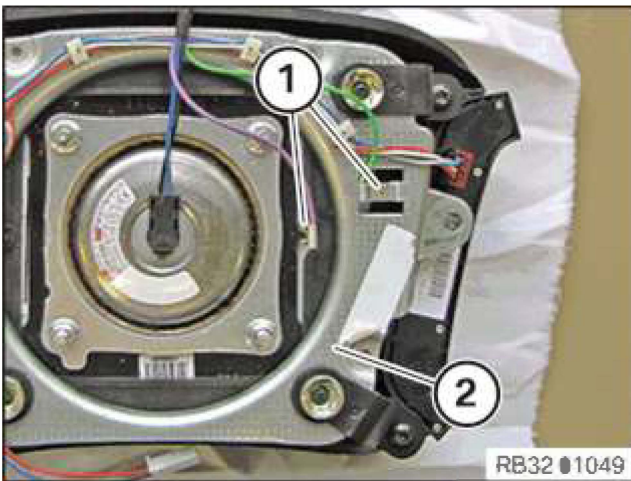
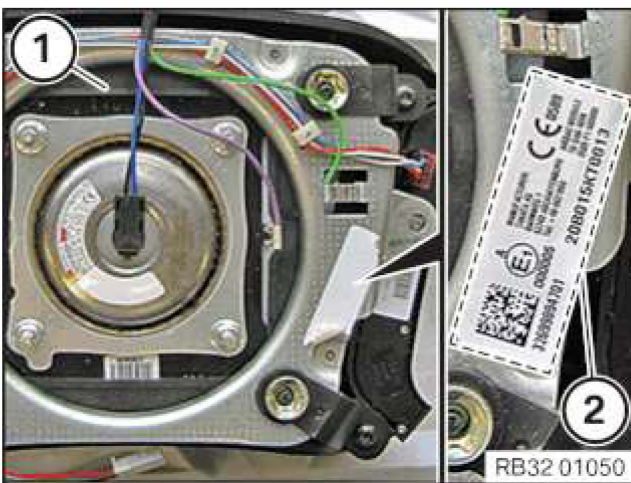
- Connect both the connectors (1) with the airbag unit (2).

- Glue on the first sticker on the airbag unit (1) with the new number on the position (2).
- Glue on the second sticker on the work order.

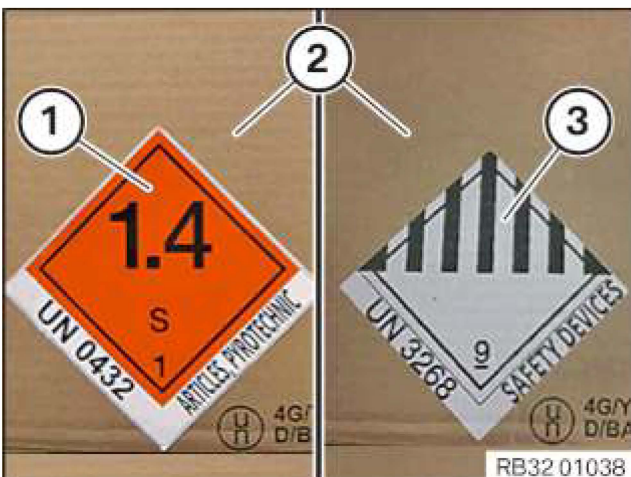
- All except USA:

Affix the hazard sticker (1) externally on the packaging (2).

- USA:

Do not affix any hazard sticker (3) externally on the packaging (2).

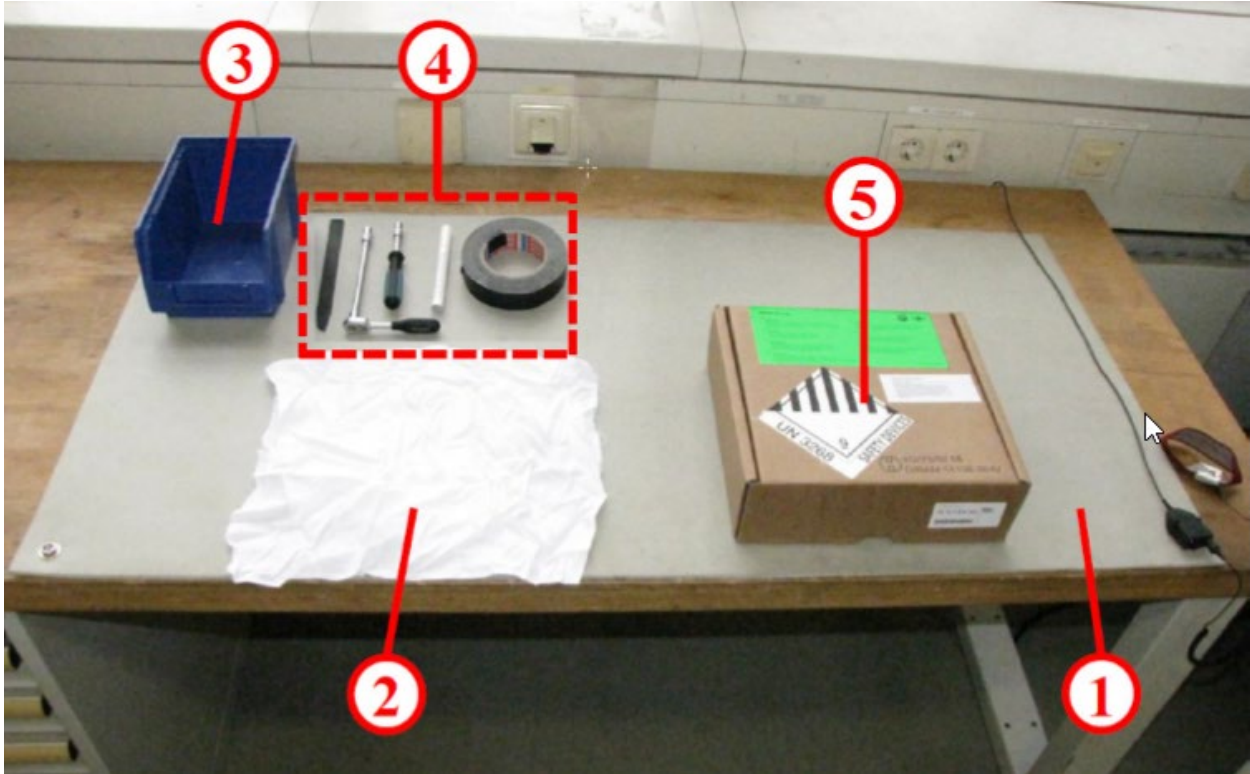
The workbench should be prepared with the following items:

- Anti-Static mat (1) which must be grounded (See SWS 2 06 04 (128))
- A soft blanket or material (2) to prevent damaging the air bag cover
- A container (3) for disposal of the original Generator nuts
- A packaged new part (5)

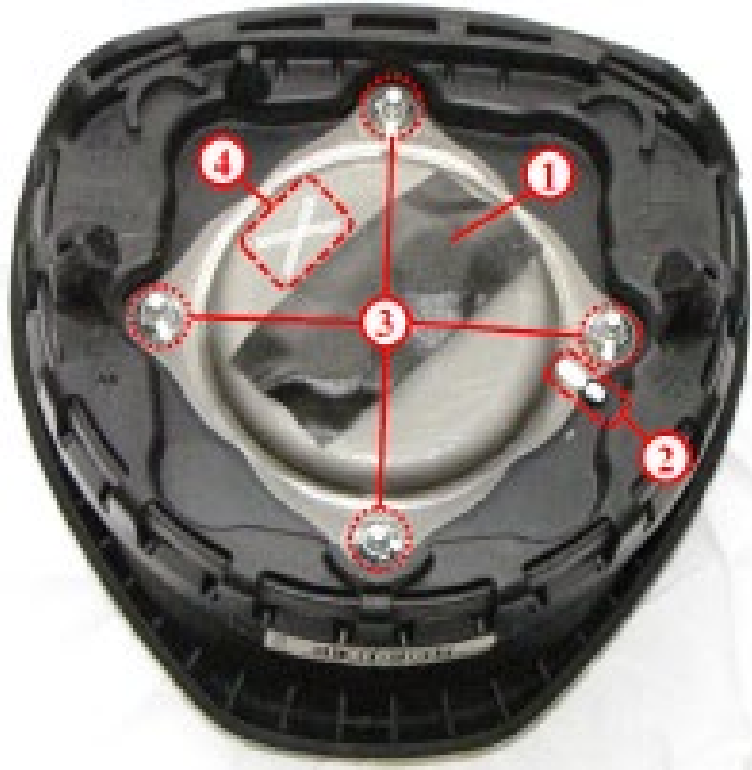
- Place air bag unit face down on the soft work surface
- Write serial number of the original Air Bag unit on the work order
- Primary mechanic must place ground strap on their wrist

NOTE: – Picture above is an example and may not exactly match your Generator / air bag.

- Cover the connections on the old Generator with duct tape (1) so the contacts cannot be touched.
- Mark orientation (2) of the Generator in the Air Bag with the felt tip marker.

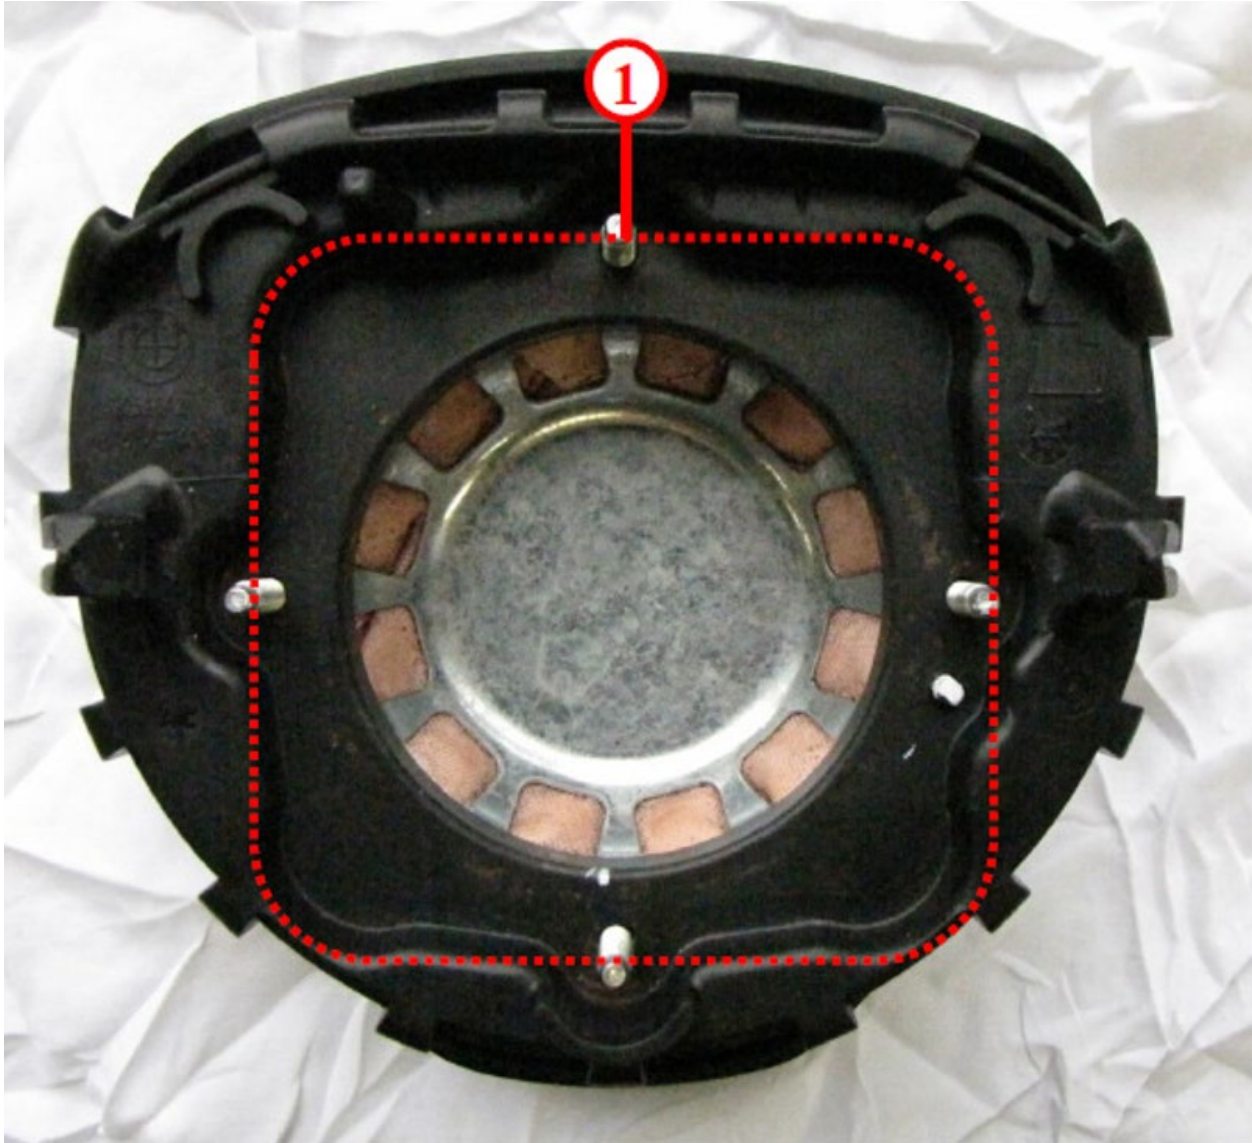
NOTE: – Picture above is an example and may not exactly match your air bag

ATTENTION: In the area (1) above there must be no foreign objects!

There may be a small amount of surface rust on the metal within the air bag. This is normal.

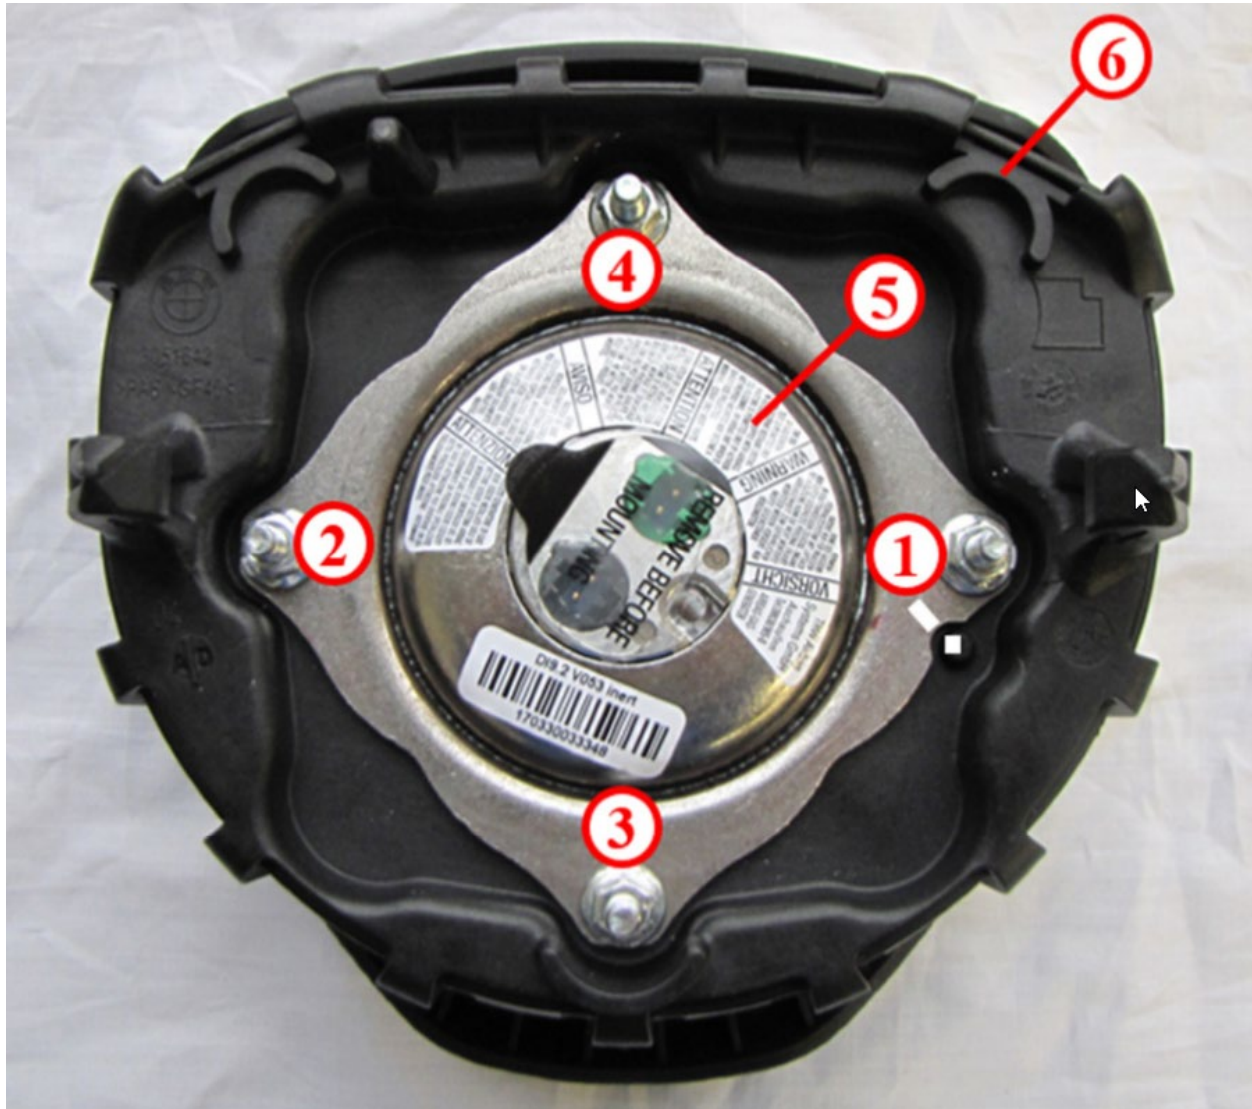
NOTE: – Picture above is an example and may not exactly match your Generator / air bag.

2nd Technician should hold air bag steady for 1st Technician.

Install the four new nuts (1,2,3,4) onto the studs and lightly tighten the nuts in the sequence shown (1,2,3,4).

Torque nuts in sequence (1,2,3,4,) to 5 Nm

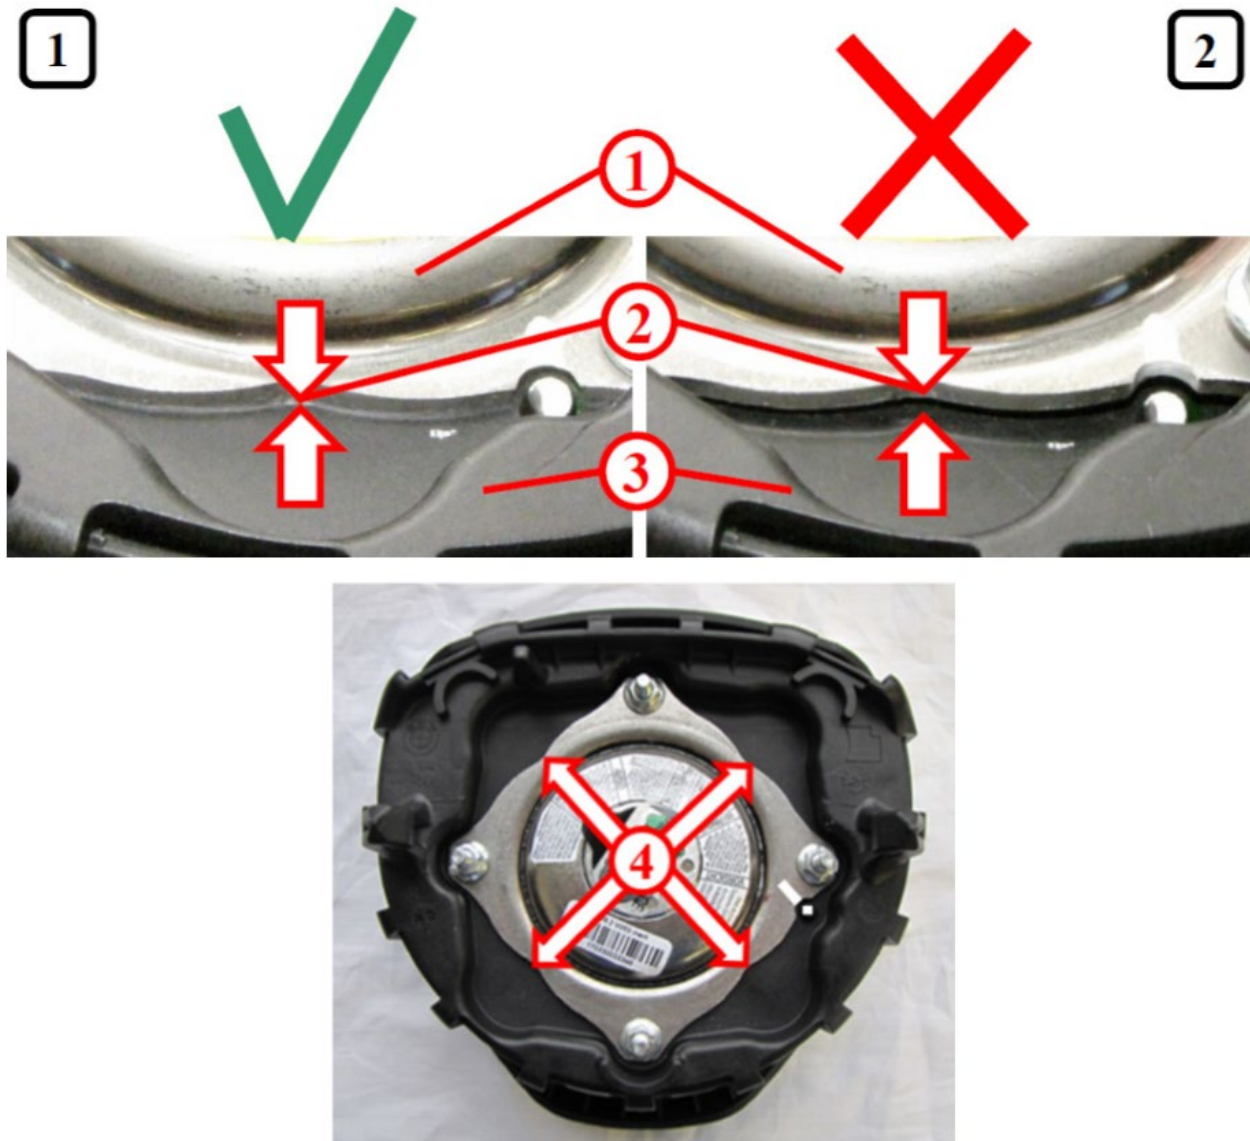
Perform a visual inspection of the gap (2) between the Generator (1) and the Air Bag (3) on all four sides of the Generator (4).

Picture (1) shows a correctly installed Generator

Picture (2) shows an improperly installed Generator with an excessive gap (2).

ATTENTION: If the gap cannot be closed up then cancel this procedure and replace the entire Air Bag assembly.
