SIB 65 23 19

#### RECALL 19V-851: DRIVER'S FRONT AIR BAG (NADI) INFLATOR

This Service Information Bulletin (Revision 10) replaces SI B65 23 19 dated October 2020.

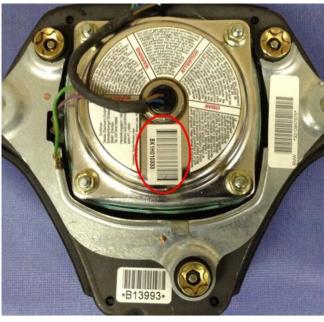
Once the air bag is removed and the wiring is disconnected, turn the air bag over to read the parts label(s) on the gas generator on the back.

**Basic Driver's air bag,** showing the location of the parts label.
