SIB 65 24 19

RECALL 19V-852: DRIVER'S FRONT AIR BAG (NADI) INFLATOR

This Service Information Bulletin (Revision 12) replaces SI B65 24 19 **dated April 2021**.

E-Series	Model Description	Production Date
E46	3 Series Sedan, Coupe	March 17, 1998 – March 3, 2000

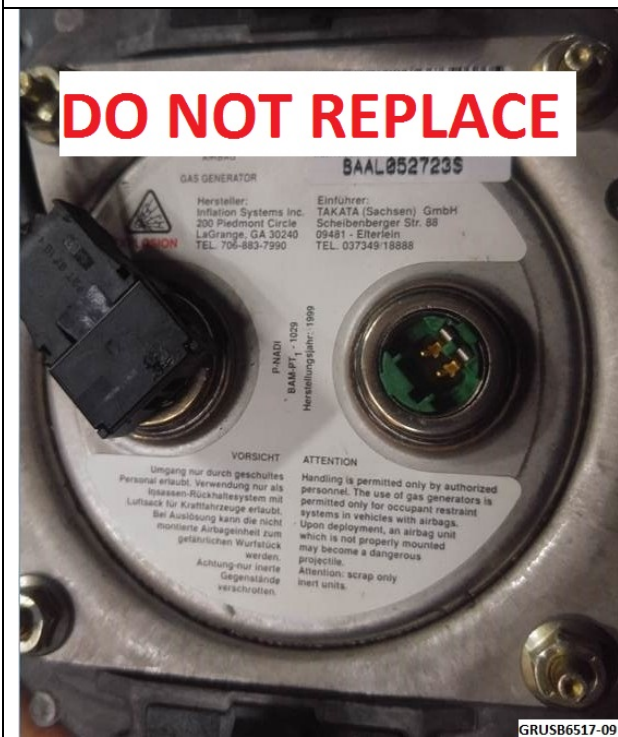
Some vehicles may have air bag control unit MRS III which was introduced in some models starting September 1999 and supports a dual stage gas generator.

Standard steering wheel gas generator pictured. Takata air bags with different chemical compositions (white label) are not affected by this recall and DO NOT need to be replaced. **Reinstall the driver's air bag.**

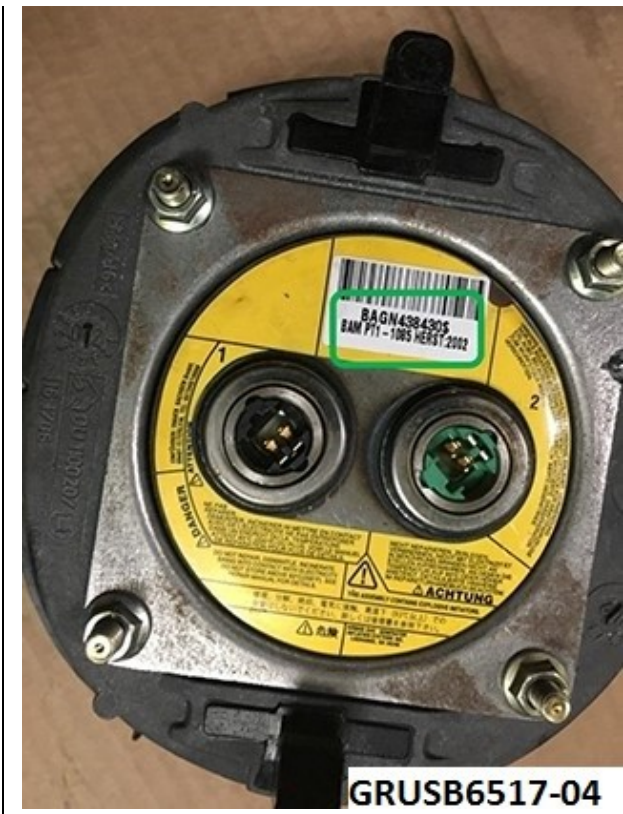
Some vehicles may have air bag control unit MRS III which was introduced in some models starting September 1999 and supports a dual stage gas generator

Sport steering wheel gas generator pictured.

These gas generators must be replaced. See SI [B65 02 17](#) for parts information.

Submit an INFO ONLY TSARA case to document this repair.
