2020-05-28

SIB 65 24 19

RECALL 19V-852: DRIVER'S FRONT AIR BAG (NADI) INFLATOR

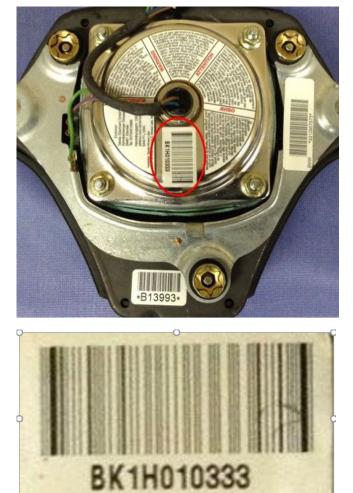
Once the air bag is removed and the wiring is disconnected, turn the air bag over to read the parts label(s) on the back.

Basic Driver's air bag, showing the location of the parts label.

Sport Driver's air bag, showing the location of the parts label.

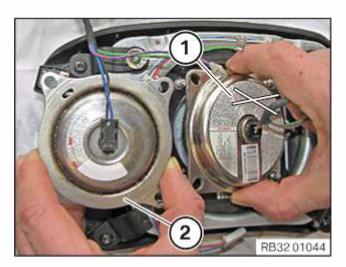
- 1
 - Remove the previous gas generator (1) and subsequently directly place the new gas generator (2).

The cable and the groove of the new gas generator (2) point upwards.
