SIB 65 24 19

RECALL 19V-852: DRIVER'S FRONT AIR BAG (NADI) INFLATOR

2021-02-16

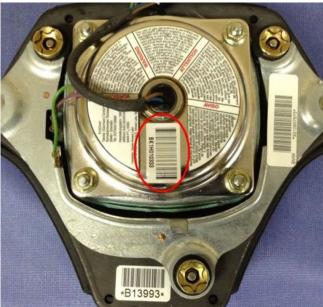
Basic Driver's air bag, showing the location of the parts label.

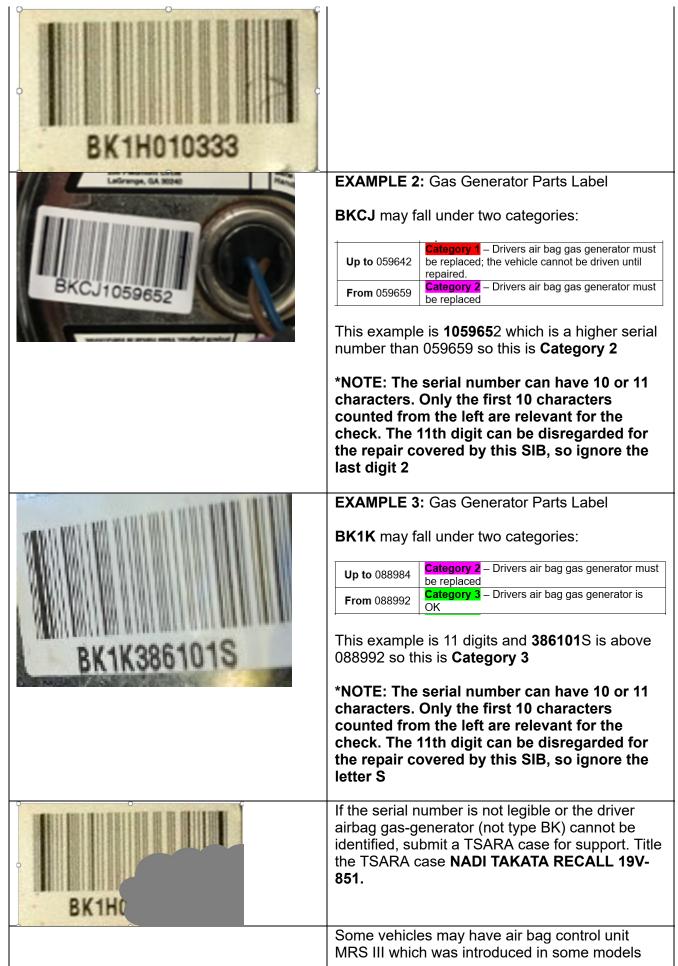
Sport Driver's air bag, showing the location of the parts label.

Gas generator serial number decoding:
Digits 1-2 = Type of gas generator Digit 3 = Production Line Digit 4 = Production year Digit 5-11* = Serial #
*NOTE: The serial number can have 10 or 11 characters. Only the first 10 characters counted from the left are relevant for the check. The 11th digit can be disregarded for the repair covered by this SIB
EXAMPLE 1: Gas Generator Parts Label
All BK1H are Category 2

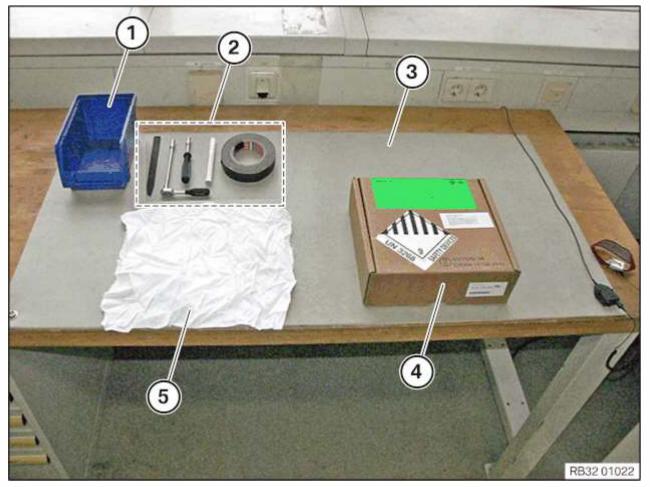
Workplace for replacement of the gas generator (E46)

- 1 Collection container for disposal of the nuts
- 2 Tools required for the exchange
- 3 Antistatic mat
- 4 New, packaged gas generator
- 5 Scratch-resistant cotton underlay

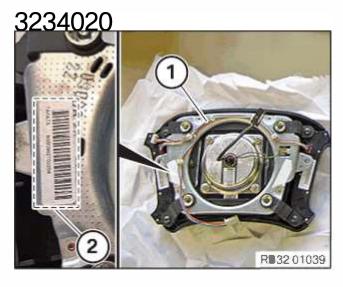
- Place the airbag unit (1) turned around as shown.
- Note the serial number (2) of the airbag unit (1) on the work order.

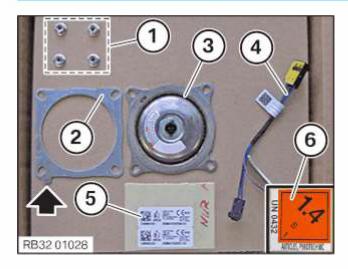
- Unpack the new nuts (1), reinforcement plate (2), new gas generator (3), cable (4) and sticker (5) and place it as shown.
- Make sure that the groove (arrow) of the reinforcement plate (2) is positioned correctly.
- USA only:

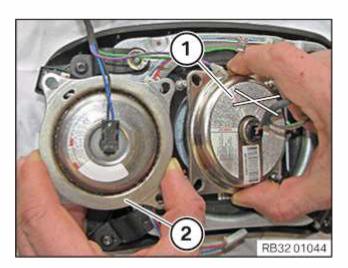
- - Remove the previous gas generator (1) and subsequently directly place the new gas generator (2).

The cable and the groove of the new gas generator (2) point upwards.
