3 65 24 19 2021-10-04

RECALL 19V-852: DRIVER'S FRONT AIR BAG (NADI) INFLATOR

This Service Information Bulletin (Revision 13) [AM1] [CSC2] replaces SI B65 24 19 dated June 2021.

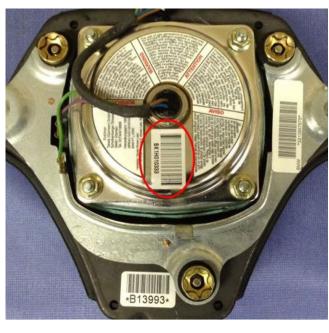
Basic Driver's air bag, showing the location of the parts label.

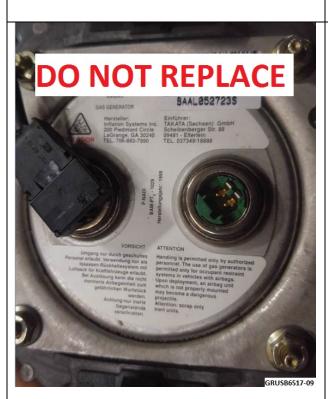
Situation 2: Some vehicles may have air bag control unit MRS III which was introduced in some models starting September 1999 and supports a dual stage gas generator.

Standard steering wheel gas generator pictured.

<u>Takata air bags with different chemical</u> <u>compositions (white label) are not affected by this</u> <u>recall and **DO NOT** need to be replaced.</u>

Reinstall the driver's air bag.

Submit an INFO ONLY TSARA case with a picture of the gas generator serial number to document this repair.

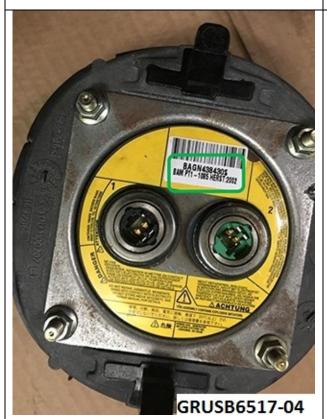
Situation 3: Some vehicles may have air bag control unit MRS III which was introduced in some models starting September 1999 and supports a dual stage gas generator.

This later production date **Sport steering wheel** gas generator (pictured) was retrofitted into the vehicle and is not covered under warranty replacement.

These gas generators must be replaced

Submit an INFO ONLY TSARA case with a picture of the gas generator serial number to document this repair.
