SIB 65 24 19

### RECALL 19V-852: DRIVER'S FRONT AIR BAG (NADI) INFLATOR

This Service Information Bulletin (Revision 10) replaces SI B65 24 19 dated February 2021.

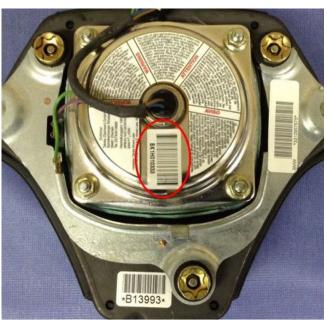
**Basic Driver's air bag**, showing the location of the parts label.

Once the air bag is removed and the wiring is disconnected, turn the air bag over to read the parts label(s) on the gas generator on the back.

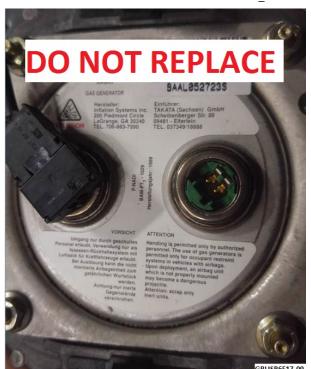
Some vehicles may have air bag control unit MRS III which was introduced in some models

starting September 1999 and supports a dual stage gas generator.

Standard steering wheel gas generator pictured.

<u>Takata air bags with different chemical</u>
<u>compositions (white label) are not affected by this recall and **DO NOT** need to be replaced. **Reinstall the driver's air bag.**This is **Category 3**.</u>

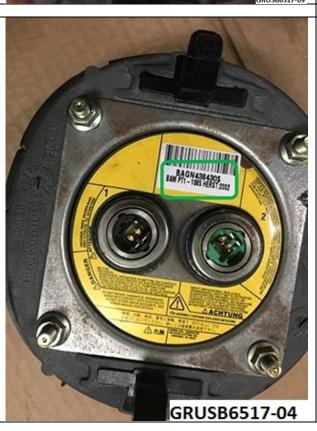
Some vehicles may have air bag control unit MRS III which was introduced in some models starting September 1999 and supports a dual stage gas generator

Sport steering wheel gas generator pictured.

These gas generators are **Category 2 and must** be replaced. See <u>SI B65 02 17</u> for parts information.

Submit an INFO ONLY TSARA case to document this repair.
