SIB 65 24 19

2023-05-17

RECALL 19V-852: DRIVER'S FRONT AIR BAG (NADI) INFLATORThis Service Information Bulletin (Revision 15) replaces SI B65 24 19 **dated December 2022**.**What's New** (Specific text highlighted):

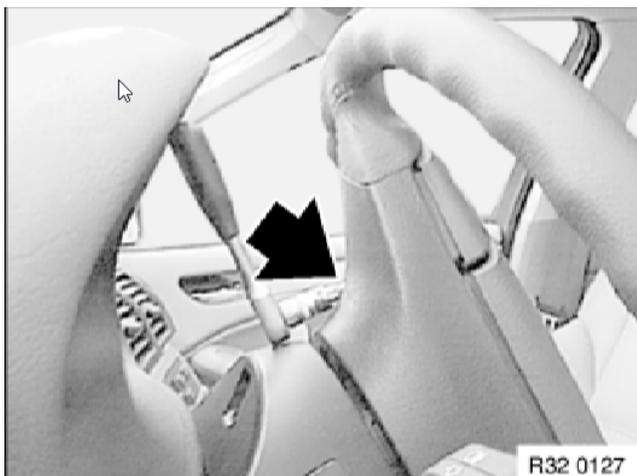
Remove **Basic Drivers air bag** as per

REP 32 34 020 "Removing and installing/replacing air bag unit"

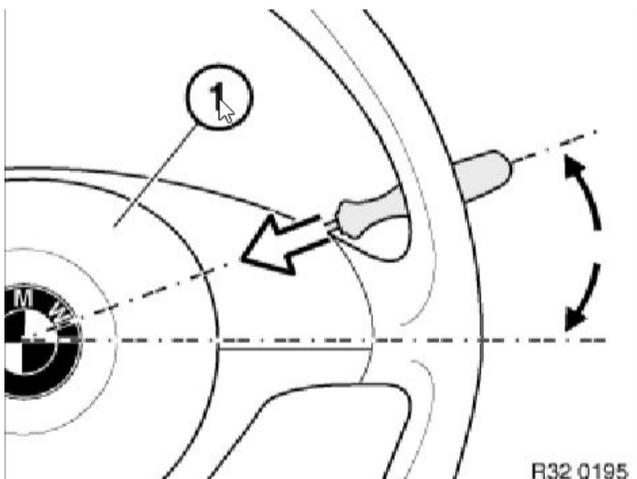
Remove **Sports Drivers air bag** as per

REP 32 34 020 "Removing and installing/replacing the air bag unit (sports steering wheel, inserted air bag unit)"

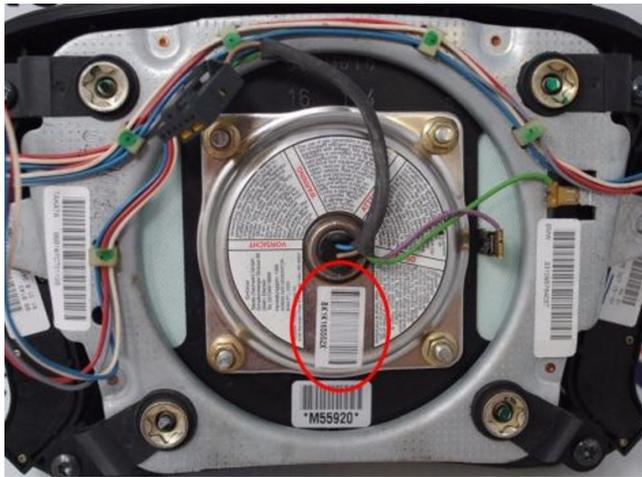
Once the air bag is removed and the wiring is disconnected, turn the air bag over to read the parts label(s) on the gas generator on the back.

Basic Driver's air bag, showing the location of the parts label.

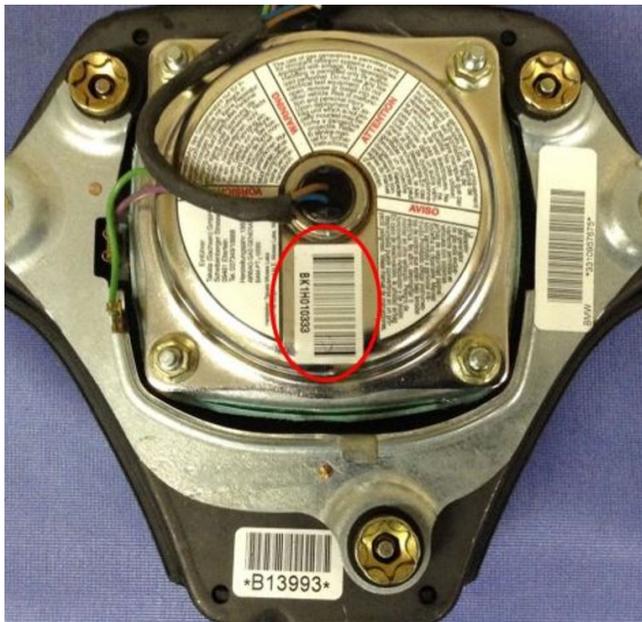
Sport Driver's air bag, showing the location of the parts label.

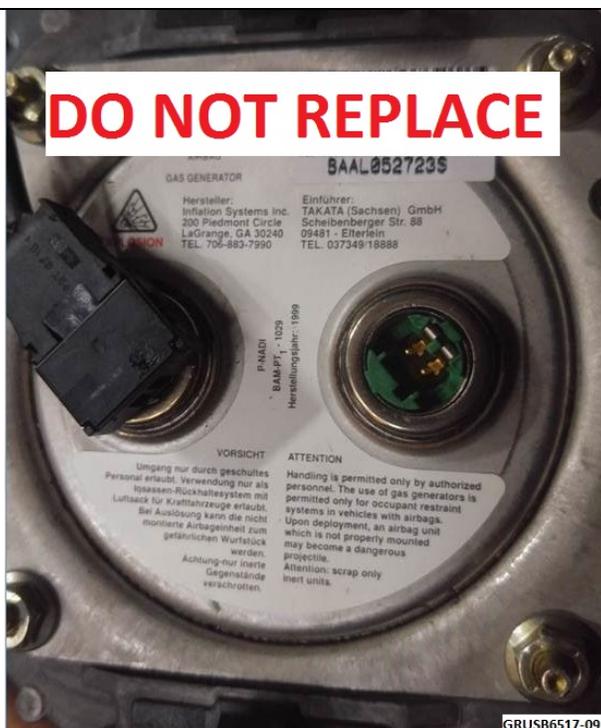
Situation 2: Some vehicles may have air bag control unit MRS III which was introduced in some models starting September 1999 and supports a dual stage gas generator.

Standard steering wheel gas generator pictured.

Takata air bags with different chemical compositions (DUAL STAGE IGNITOR with white label) are not affected by this recall and DO NOT need to be replaced.

Reinstall the driver's air bag.

Submit an INFO ONLY TSARA case with a picture of the gas generator serial number to document this repair.

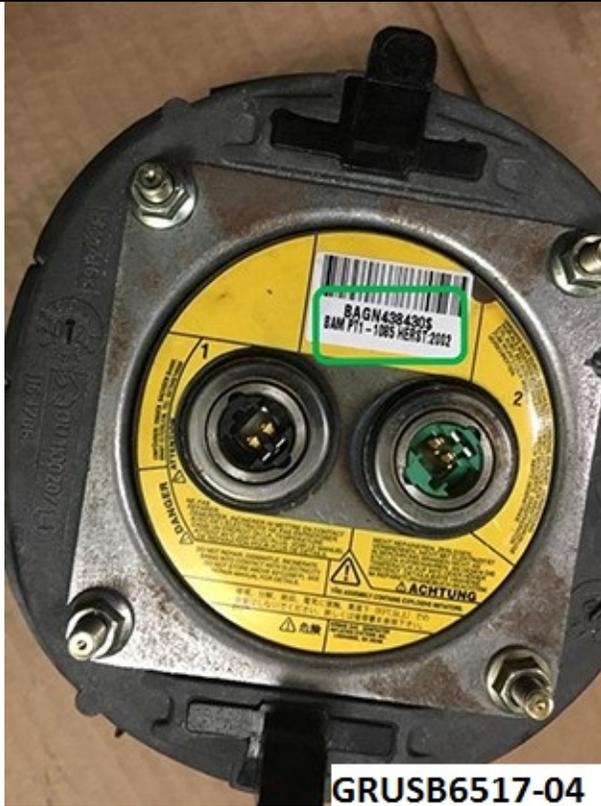
Situation 3: Some vehicles may have air bag control unit MRS III which was introduced in some models starting September 1999 and supports a dual stage gas generator.

This later production date **Sport steering wheel** gas generator (pictured) was retrofitted into the vehicle and is not covered under warranty replacement.

These gas generators must be replaced

Submit an INFO ONLY TSARA case with a picture of the gas generator serial number to document this repair.

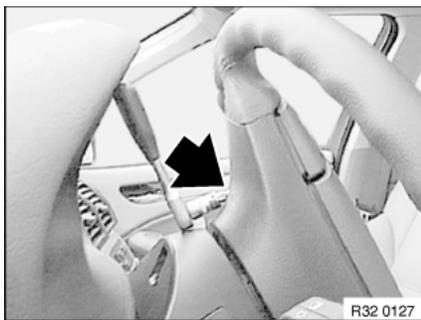
Release screws (Torx T30) on both sides.

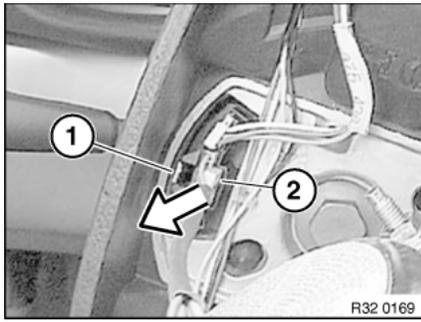
Press down lock (1) and disconnect plug (2).

Remove airbag unit.

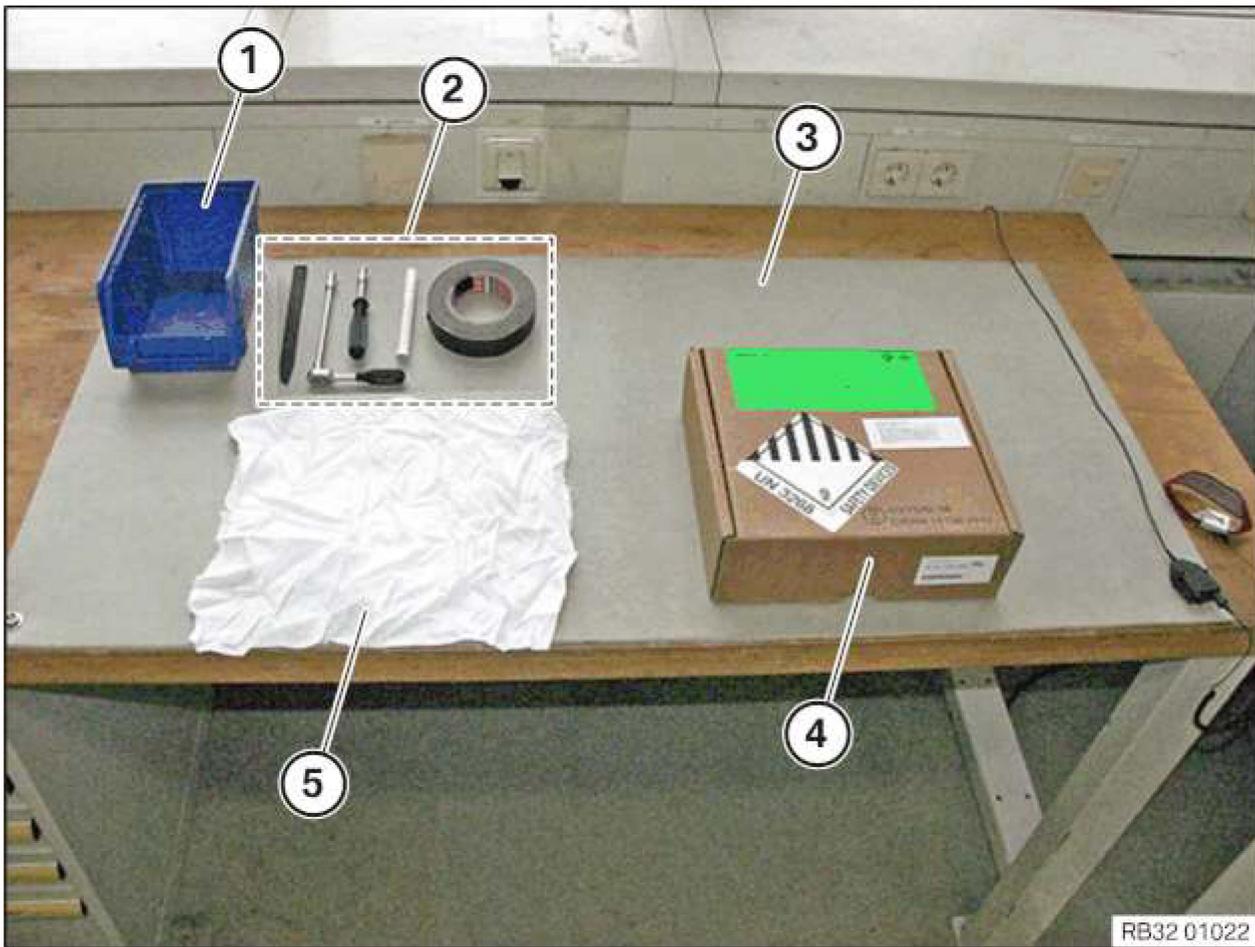
Workplace for replacement of the gas generator (E46)

- 1 Collection container for disposal of the nuts
- 2 Tools required for the exchange
- 3 Antistatic mat
- 4 New, packaged gas generator
- 5 Scratch-resistant cotton underlay

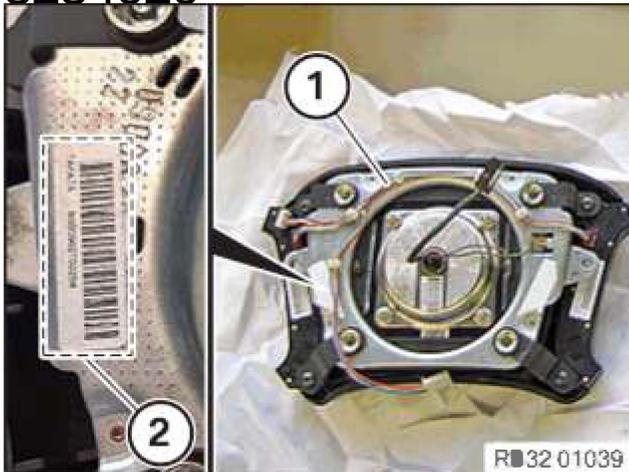
- Place the airbag unit (1) turned around as shown.
- Note the serial number (2) of the airbag unit (1) on the work order.

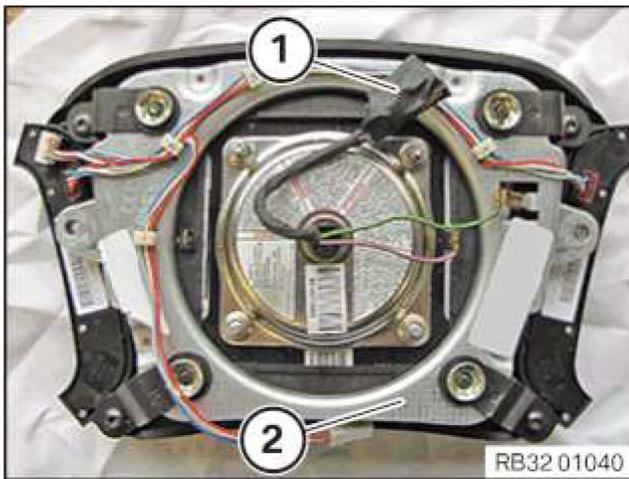
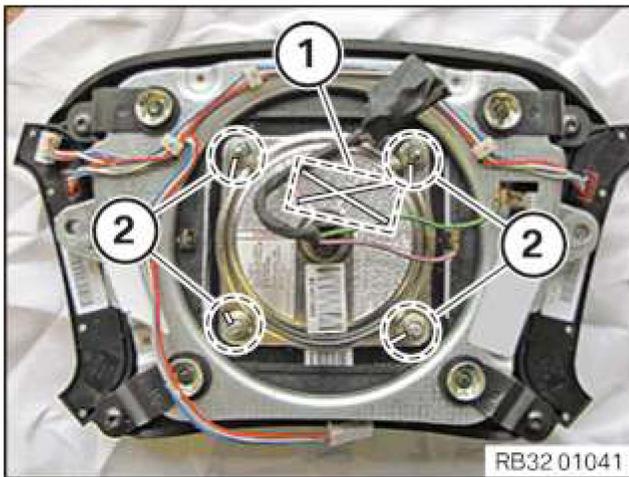
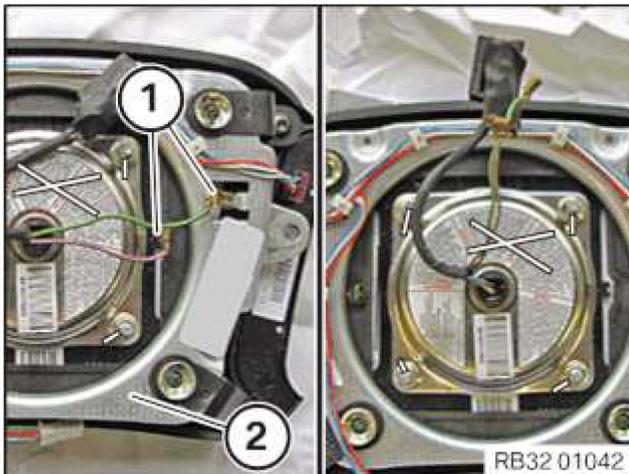
- Glue the connector (1) from the previous gas generator of the airbag unit (2) with the adhesive tape so that the contacts cannot be touched.

- Mark a cross (1) with the felt pen to avoid a mix-up with the new gas generator.
 - Mark all the four nuts (2) with the felt pen to avoid a mix-up with the new nuts.
-
- Release both the connectors (1) on the airbag unit (2).
-
- **Auxiliary person:** Hold the airbag unit (1).
 - Unscrew all the nuts (2) in any order and dispose of immediately in the collection container provided (3).
 - Do not reuse the nuts (2).

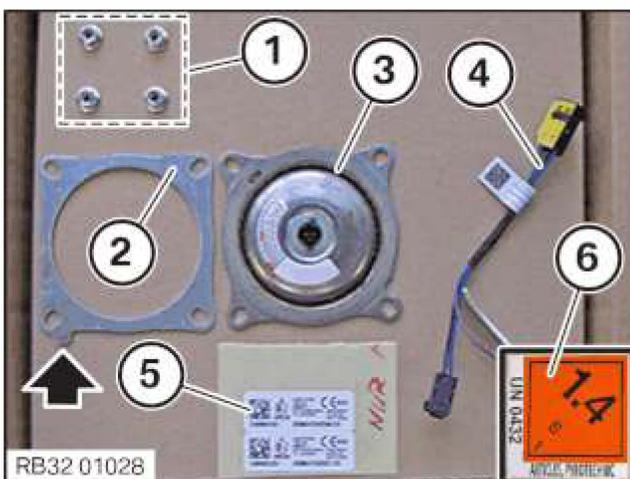
- Unpack the new nuts (1), reinforcement plate (2), new gas generator (3), cable (4) and sticker (5) and place it as shown.
- Make sure that the groove (arrow) of the reinforcement plate (2) is positioned correctly.
- USA only:
Dispose of the hazard sticker (6).

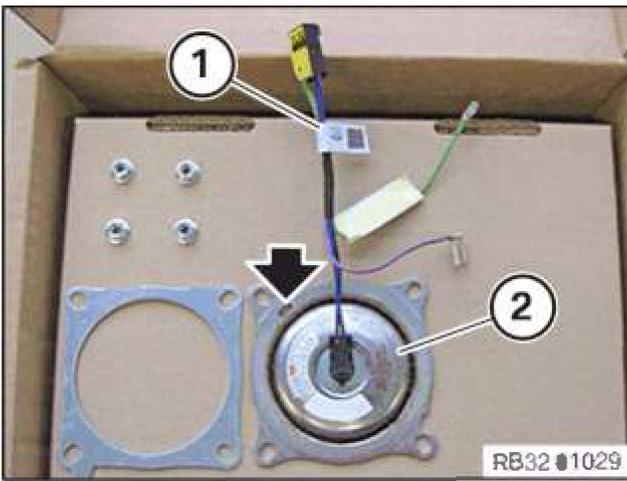
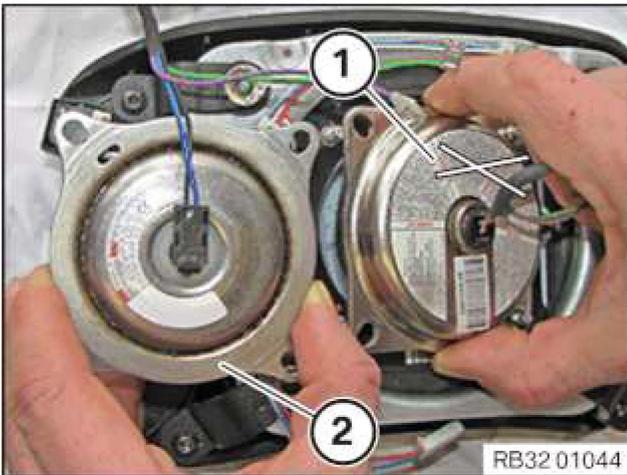
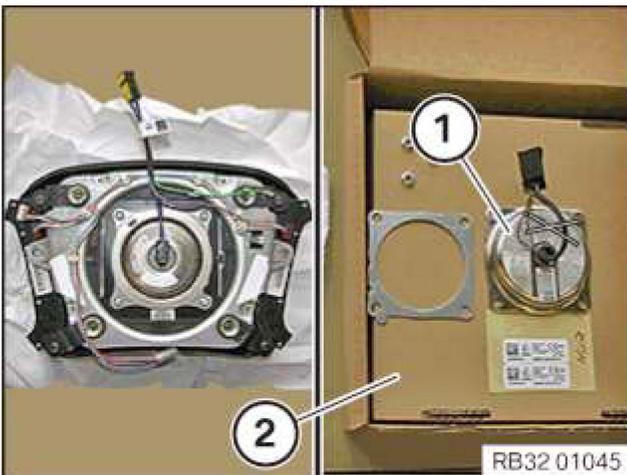
- Clip in the cable (1) as shown in the new gas generator (2).

The cable (1) and the groove (arrow) of the new gas generator (2) point upwards.

The connector is encoded against incorrect assembly.

- Remove the previous gas generator (1) and subsequently directly place the new gas generator (2).

The cable and the groove of the new gas generator (2) point upwards.

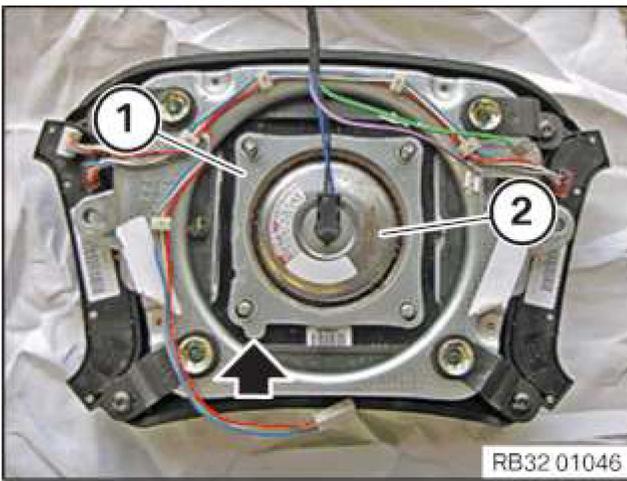
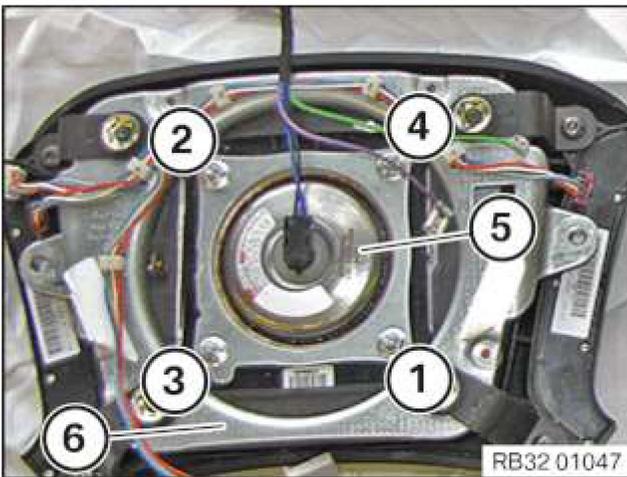
- Position the reinforcement plate (1) over the new gas generator (2).
- Make sure that the groove (arrow) of the reinforcement plate (1) is positioned correctly.

The groove (arrow) points downwards to the left.

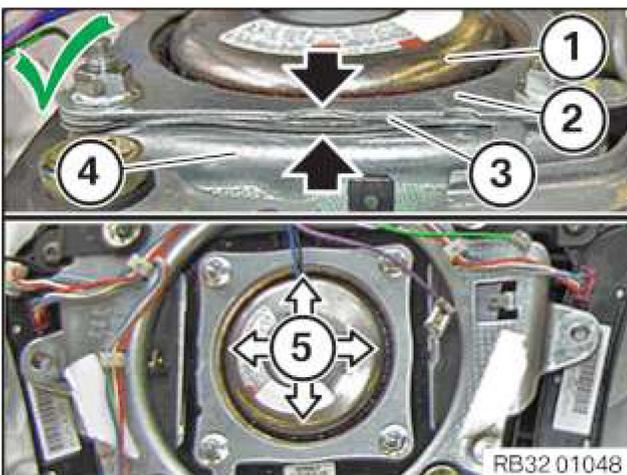
Nut
Renew nut.

Tightening torque
5Nm

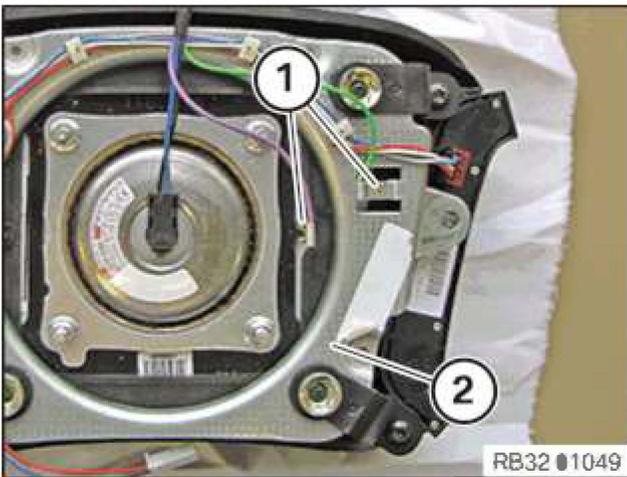
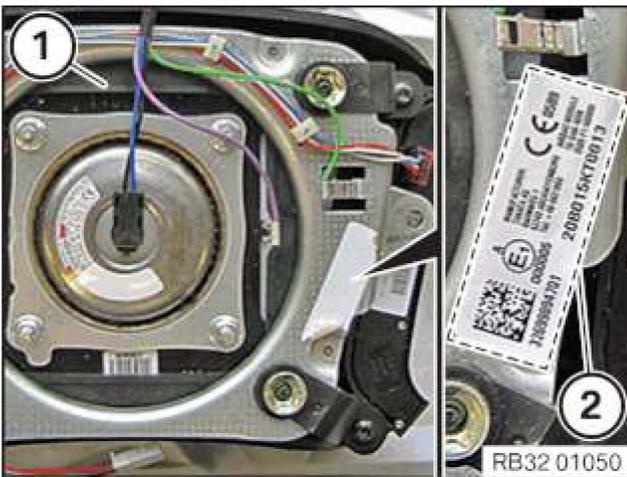
Visually inspect the gap (3) between the new gas generator (1), reinforcement plate (2) and airbag unit (4) on all four sides (5).

Release the screw connection and tighten again as described in the previous step. If the gap is still not OK, then cancel the repair. Install the new airbag unit in this case.

- Connect both the connectors (1) with the airbag unit (2).

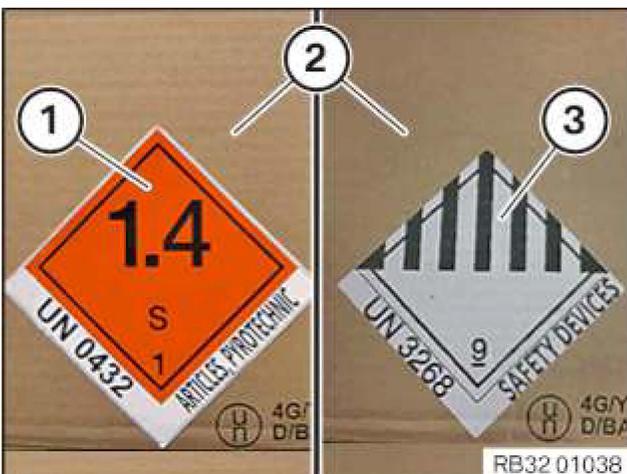
Affix the hazard sticker (1) externally on the packaging (2).

Do not affix any hazard sticker (3) externally on the packaging (2).

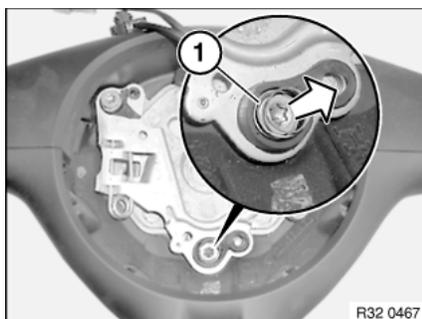
When installing a new airbag unit (see table below), the available ground spring (1) must be removed from the base plate of the steering wheel.

Omitting the ground spring (1) on new airbag units is not a safety hazard.

E46:	01/2002
E53:	02/2003
E39:	03/2002

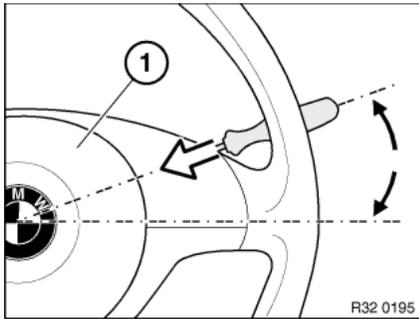
Insert a screwdriver through the opening on the rear side of the steering wheel and press on the lock. In the event of a spring resistance, press the lock up to the limit position and simultaneously pull away the airbag unit (1) from the steering wheel.

Repeat the process on the opposite side.

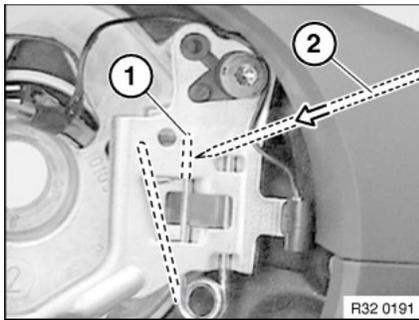
Use the screwdriver (2) to press on the lock (1).

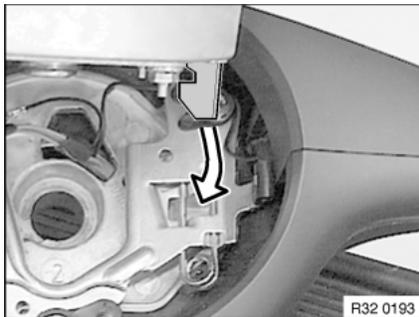
Make sure electrical leads are correctly positioned.

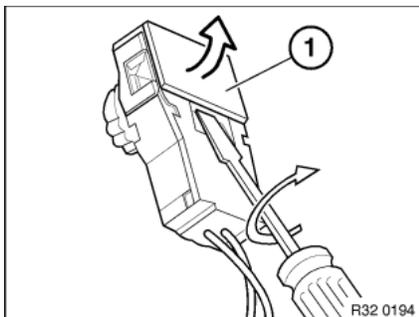
Unlocking the airbag plug connection:

Lever out the lock (1) with a screwdriver.

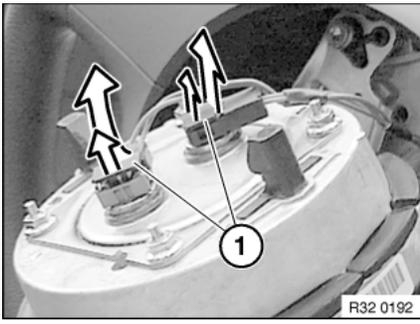
Connect plugs to connections of same colour on airbag unit.
