SIB 65 25 19

RECALL 19V-853: DRIVER'S FRONT AIR BAG (NADI) INFLATOR

This Service Information Bulletin (Revision 11) replaces SI B65 25 19 **dated February 2021**.

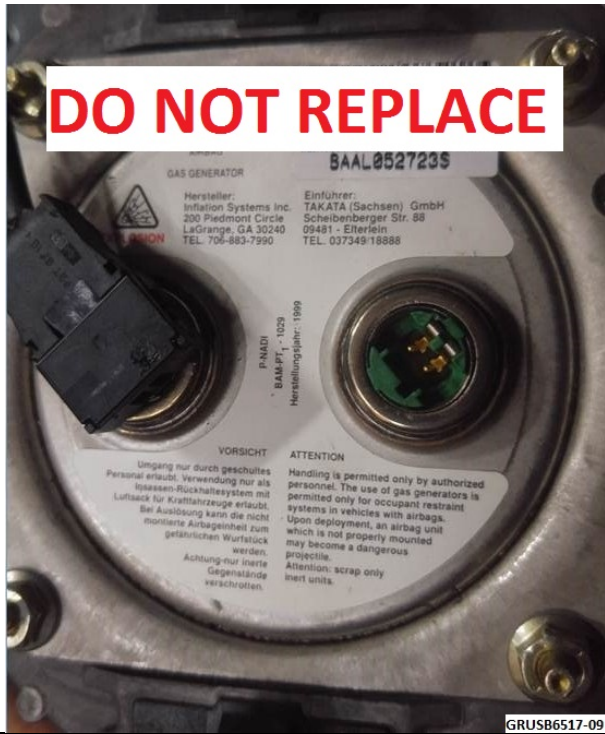
MRS III which was introduced in some models starting September 1999 and supports a dual stage gas generator.

Standard steering wheel gas generator pictured. Takata air bags with different chemical compositions (white label) are not affected by this recall and DO NOT need to be replaced.

This is **Category 3**.

Reinstall the driver's air bag.

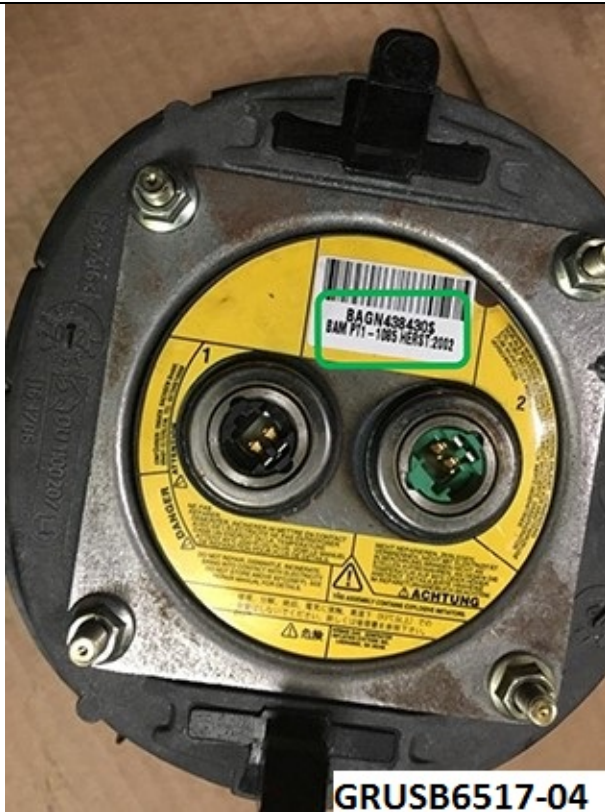
Some vehicles may have air bag control unit MRS III which was introduced in some models starting September 1999 and supports a dual stage gas generator

Sport steering wheel gas generator pictured.

These gas generators are **Category 2** and must be replaced. See [SI B65 02 17](#) for parts information.

Submit an INFO ONLY TSARA case to document this repair.
