## SIB 65 25 19

### RECALL 19V-853: DRIVER'S FRONT AIR BAG (NADI) INFLATOR

This Service Information Bulletin (Revision 9) replaces SI B65 25 19 **dated October 2020**.

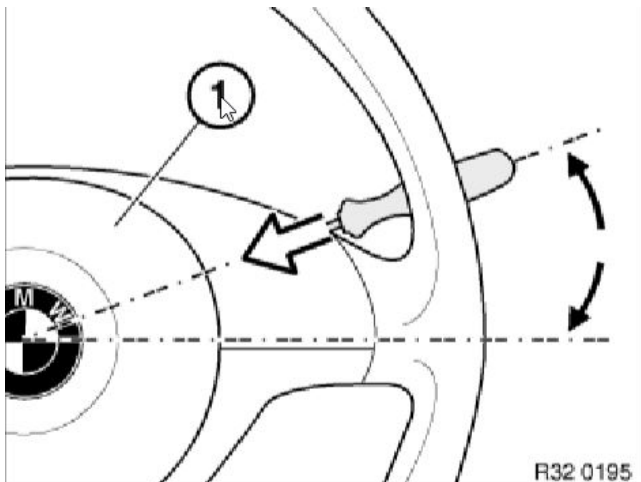
Remove **Sports Drivers air bag** as per

**REP 32 34 020** "Removing and installing/replacing the airbag unit (sports steering wheel, inserted airbag unit)"

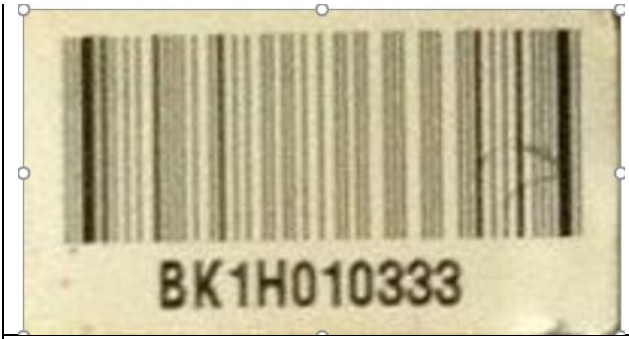
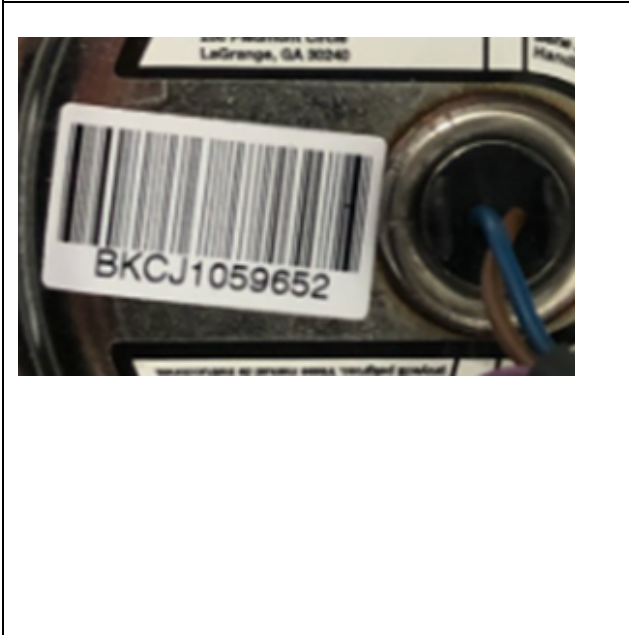
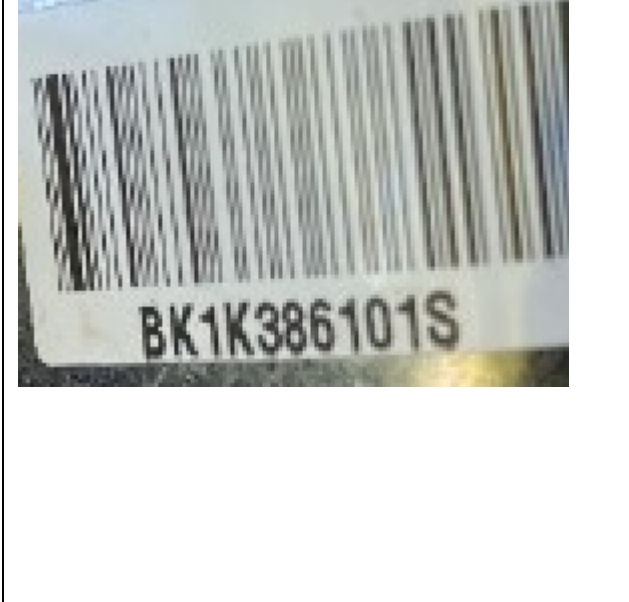
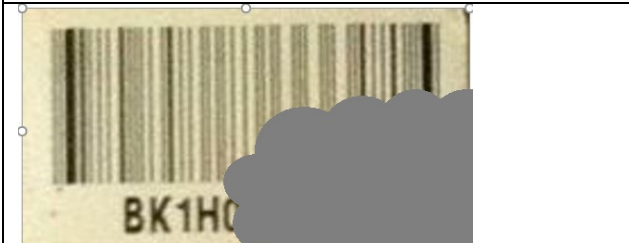
| | <p><b>Gas generator serial number decoding:</b></p> <p>Digits 1-2 = Type of gas generator<br/> Digit 3 = Production Line<br/> Digit 4 = Production year<br/> Digit 5-11* = Serial #</p> <p><b>*NOTE:</b> The serial number can have 10 or 11 characters. Only the first 10 characters counted from the left are relevant for the check. The 11th digit can be disregarded for the repair covered by this SIB</p> |
| | <p><b>EXAMPLE 1:</b> Gas Generator Parts Label</p> <p>All BK1H are <b>Category 2</b></p> |

**EXAMPLE 2: Gas Generator Parts Label**

**BKCJ** may fall under two categories:

This example is **1059652** which is a higher serial number than 059659 so this is **Category 2**

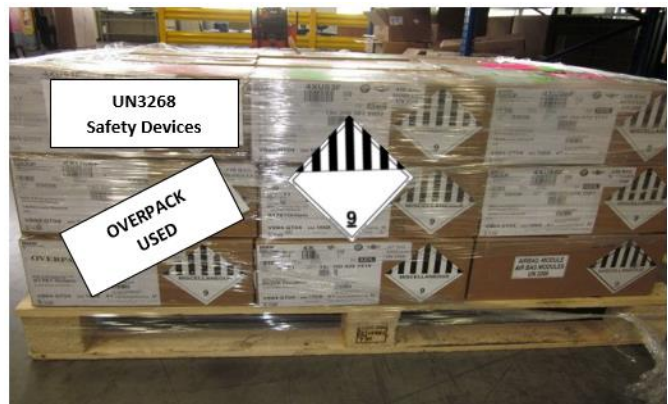
Securely attach the following labels on each side of the shrink-wrapped pallet.

- o Class 9 Label
- o UN3268 Safety Device \*
- o OVERPACK USED \*
