SIB 65 25 19

2021-06-07

RECALL 19V-853: DRIVER'S FRONT AIR BAG (NADI) INFLATOR

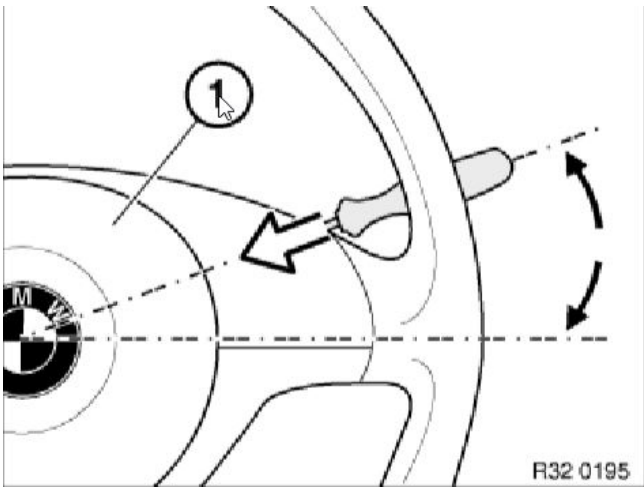
Basic Driver's air bag, showing the location of the parts label.

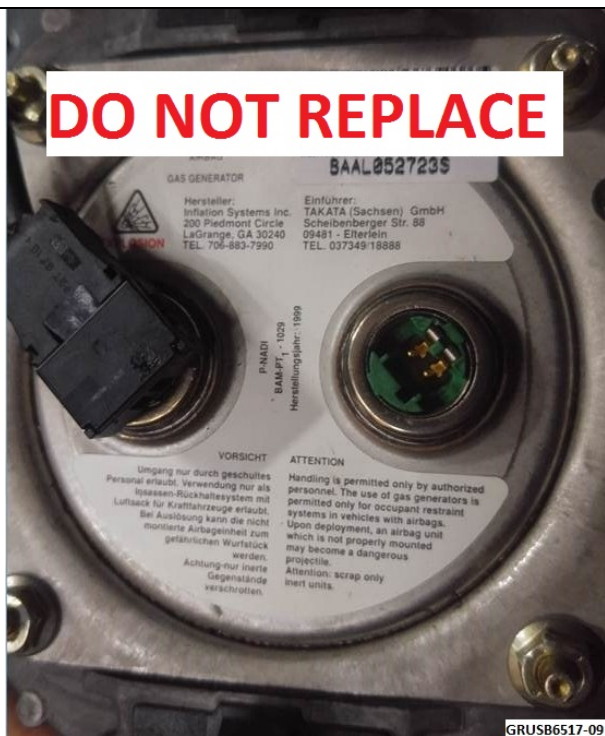
Some vehicles may have air bag control unit MRS III which was introduced in some models starting September 1999 and supports a dual stage gas generator.

Standard steering wheel gas generator pictured. Takata air bags with different chemical compositions (white label) are not affected by this recall and DO NOT need to be replaced. **Reinstall the driver's air bag.**

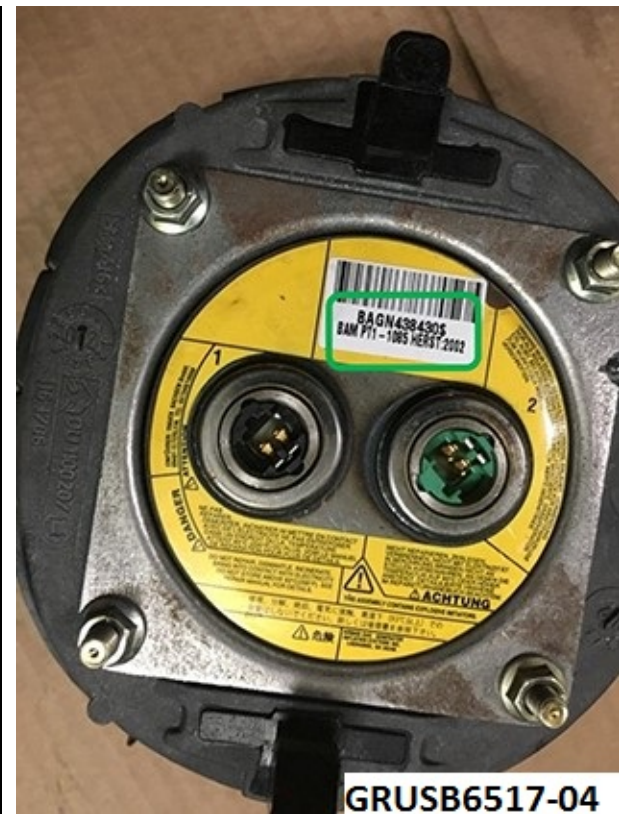
Some vehicles may have air bag control unit MRS III which was introduced in some models starting September 1999 and supports a dual stage gas generator

Sport steering wheel gas generator pictured.

These gas generators must be replaced. **See SI [B65 02 17](#)** for parts information.

Submit an INFO ONLY TSARA case to document this repair.
