SIB 65 25 19

RECALL 19V-853: DRIVER'S FRONT AIR BAG (NADI) INFLATOR

This Service Information Bulletin (Revision 5) replaces SI B65 25 19 **dated April 2020**.

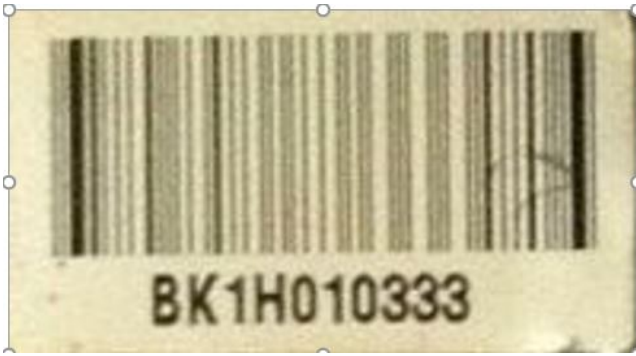
Parts label (sample):

Digits 1-2 = Type of gas generator
 Digit 3 = Production Line
 Digit 4 = Production year
 Digit 5-11 = Serial #

NOTE: The serial number can have 10 or 11 characters. Only the first 10 characters counted from the left are relevant for the check.

Refer to the table below to see which category this air bag falls into. Descriptions of each category are shown below the table.

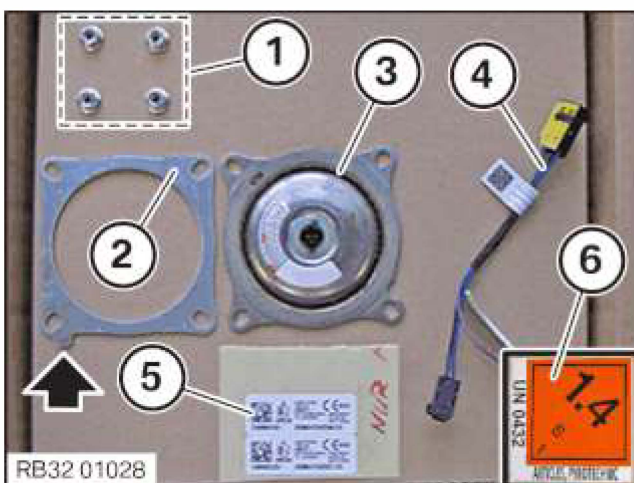
- Unpack the new nuts (1), reinforcement plate (2), new gas generator (3), cable (4) and sticker (5) and place it as shown.
- Make sure that the groove (arrow) of the reinforcement plate (2) is positioned correctly.
- USA only:
Dispose of the hazard sticker (6).
