SIB 65 25 19

## RECALL 19V-853: DRIVER'S FRONT AIR BAG (NADI) INFLATOR

This Service Information Bulletin (Revision 10) replaces SI B65 25 19 **dated October 2020**.

The single-stage Takata Non-Azide (NADI) Driver gas generator, also known as an air bag inflator, may have been produced with an insufficient seal that could allow moisture to enter the gas generator. The gas generator is a separately replaceable part of the air bag module.

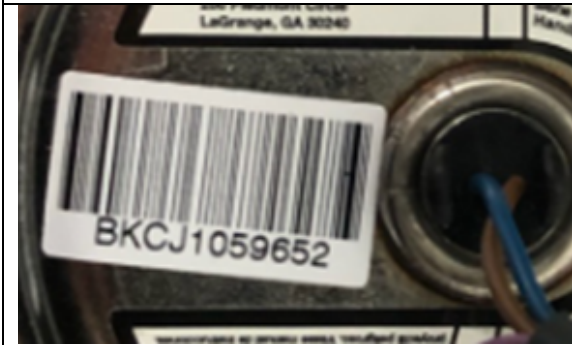
**EXAMPLE 2: Gas Generator Parts Label**

**BKCJ** may fall under two categories:

Up to 059642	<b>Category 1</b> – Drivers air bag gas generator must be replaced; the vehicle cannot be driven until repaired.
From 059659	<b>Category 2</b> – Drivers air bag gas generator must be replaced

This example is **1059652** which is a higher serial number than 059659 so this is **Category 2**

**\*NOTE: The serial number can have 10 or 11 characters. Only the first 10 characters counted from the left are relevant for the check. The 11th digit can be disregarded for the repair covered by this SIB, so ignore the last digit 2**

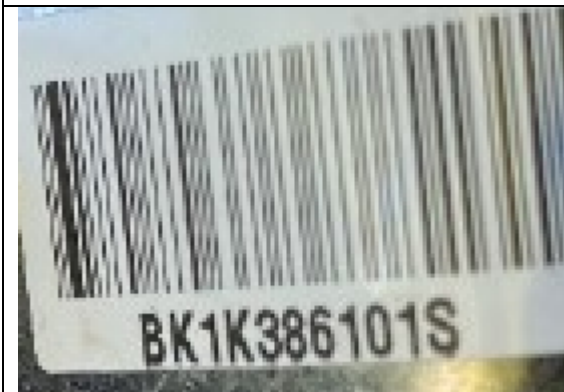
**EXAMPLE 3: Gas Generator Parts Label**

**BK1K** may fall under two categories:

Up to 088984	<b>Category 2</b> – Drivers air bag gas generator must be replaced
From 088992	<b>Category 3</b> – Drivers air bag gas generator is OK

This example is 11 digits and **386101S** is above 088992 so this is **Category 3**

**\*NOTE: The serial number can have 10 or 11 characters. Only the first 10 characters counted from the left are relevant for the check. The 11th digit can be disregarded for the repair covered by this SIB, so ignore the letter S**

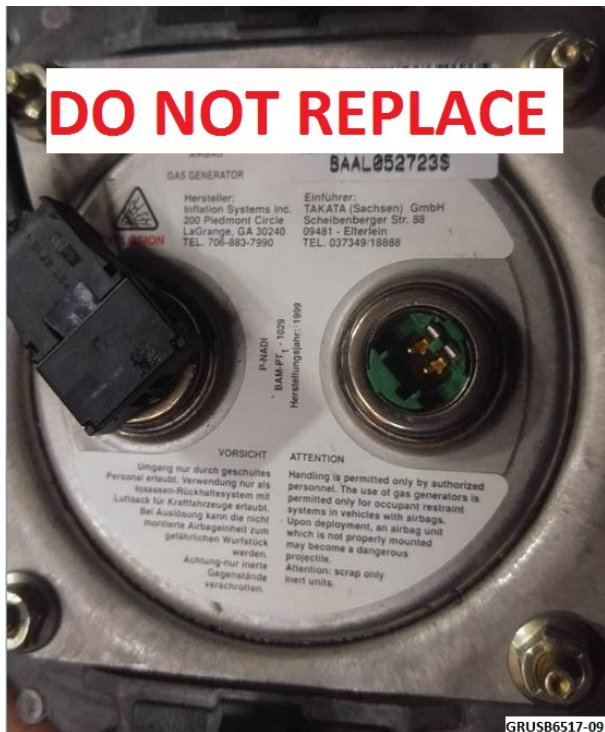
MRS III which was introduced in some models starting September 1999 and supports a dual stage gas generator.

Standard steering wheel gas generator pictured. Takata air bags with different chemical compositions (white label) are not affected by this recall and DO NOT need to be replaced. **Reinstall the driver's air bag.** This is **Category 3**.

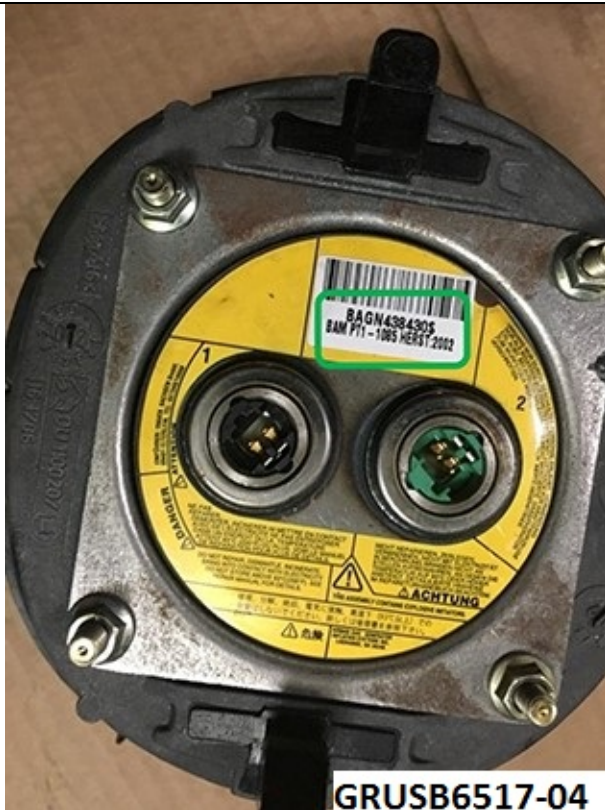
Some vehicles may have air bag control unit MRS III which was introduced in some models starting September 1999 and supports a dual stage gas generator

Sport steering wheel gas generator pictured.

These gas generators are **Category 2** and must be replaced. See [SI B65 02 17](#) for parts information.

**Submit an INFO ONLY TSARA case to document this repair.**
