SIB 65 25 19

2021-04-20

RECALL 19V-853: DRIVER'S FRONT AIR BAG (NADI) INFLATOR

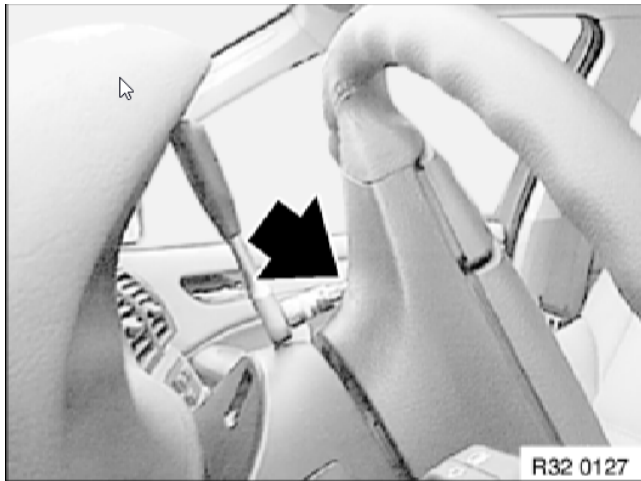
Follow all safety precautions when handling air bags.

Remove **Basic Drivers air bag** as per

REP 32 34 020 "Removing and installing/replacing air bag unit"

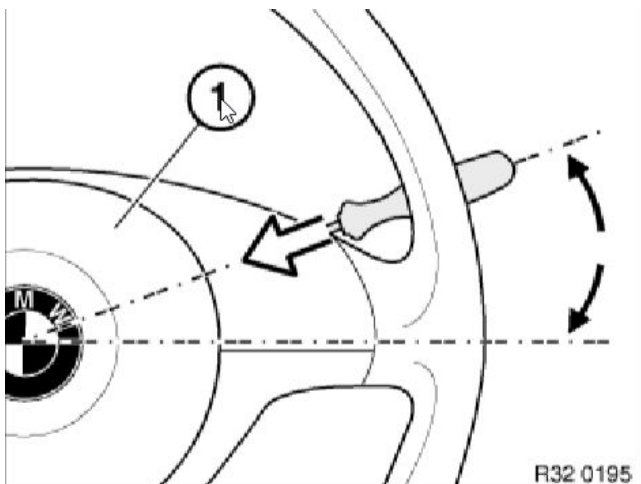
Remove **Sports Drivers air bag** as per

REP 32 34 020 "Removing and installing/replacing the air bag unit (sports steering wheel, inserted air bag unit)"

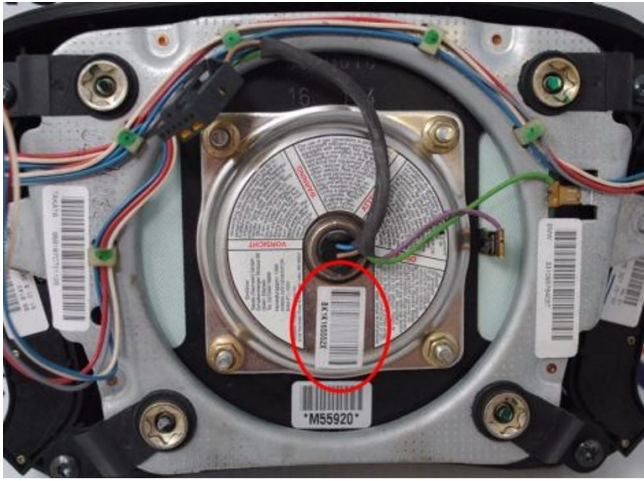
Once the air bag is removed and the wiring is disconnected, turn air bag over to read the parts label(s) on the gas generator on the back.

Basic Driver's air bag, showing the location of the parts label.

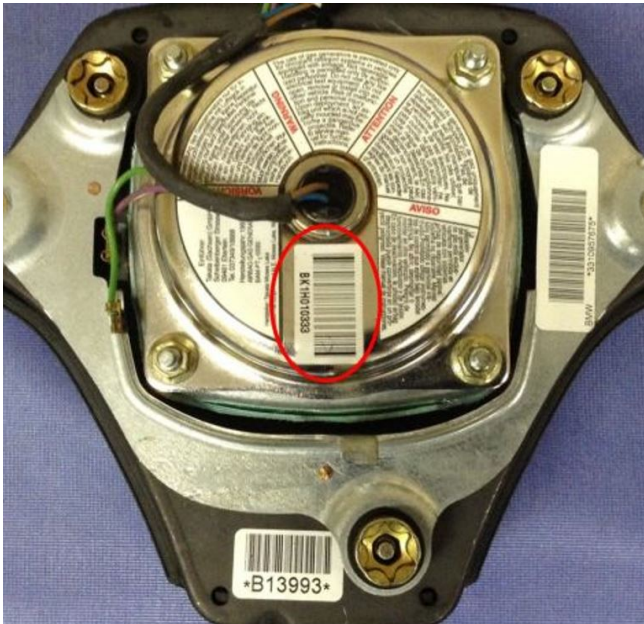
Sport Driver's air bag, showing the location of the parts label.

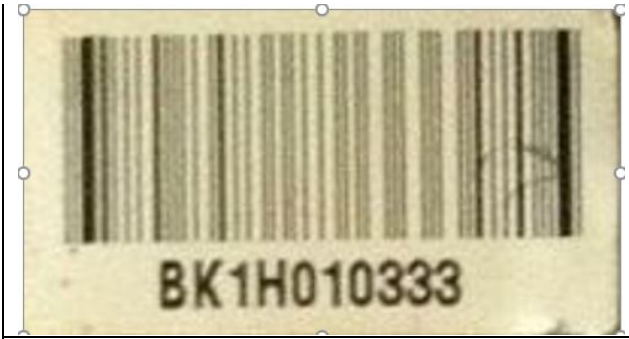
<p>Gas generator serial number decoding:</p> <p>Digits 1-2 = Type of gas generator Digit 3 = Production Line Digit 4 = Production year Digit 5-11* = Serial #</p> <p>*NOTE: The serial number can have 10 or 11 characters. Only the first 10 characters counted from the left are relevant for the check. The 11th digit can be disregarded for the repair covered by this SIB</p>
	<p>EXAMPLE 1: Gas Generator Parts Label</p> <p>All BK1H are Category 2</p>

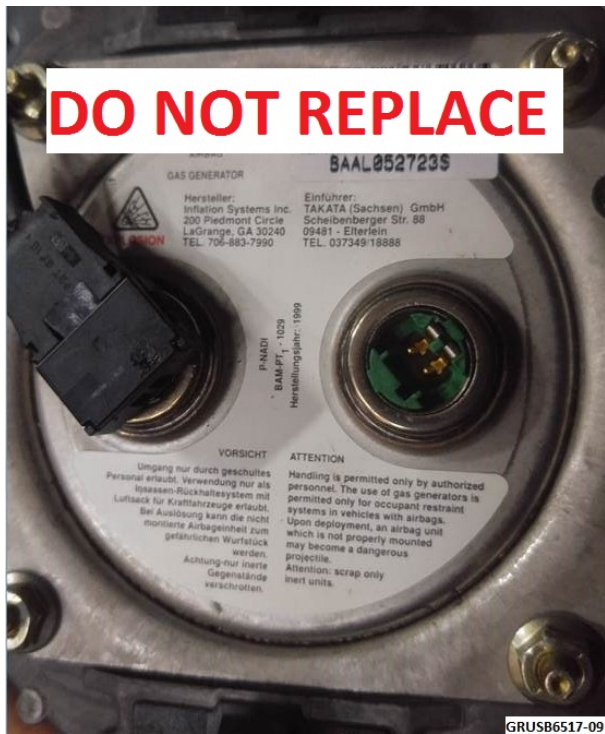
Some vehicles may have air bag control unit

MRS III which was introduced in some models starting September 1999 and supports a dual stage gas generator.

Standard steering wheel gas generator pictured. Takata air bags with different chemical compositions (white label) are not affected by this recall and DO NOT need to be replaced. **Reinstall the driver's air bag.** This is **Category 3**.
