SIB 65 06 20

## RECALL CAMPAIGNS 19V-852/19V-853: INSPECTION DONE; DRIVER'S FRT AIR BAG INFLATOR

This Service Information Bulletin (Revision 9) replaces SI B65 06 20 **dated December 2022**.

## Removing and installing/replacing airbag unit

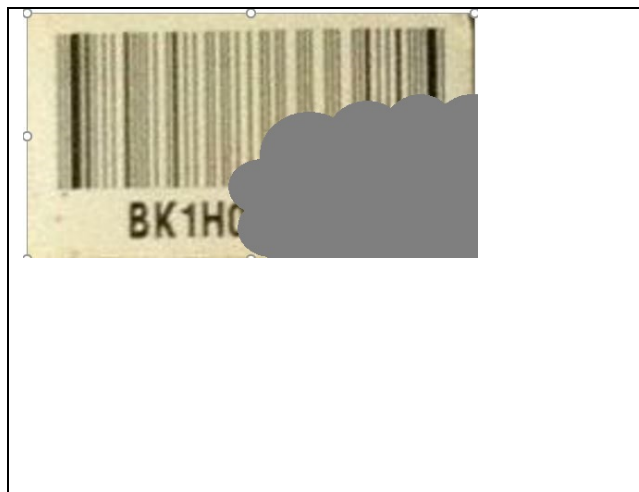
Digits 1-2 = Type of gas generator  
 Digit 3 = Production Line  
 Digit 4 = Production year  
 Digit 5-11\* = Serial #

**\*NOTE:** The serial number can have 10 or 11 characters. Only the first 10 characters counted from the left are relevant for the check. The 11th digit can be disregarded for the repair covered by this SIB

**All original gas generator serial numbers which begin with BK MUST be replaced-** refer to the table below. These are **SINGLE** ignition stage gas generators with a white label.

**Situation 1:** If the serial number is not legible and cannot be identified, or the driver air bag gas-generator is NOT a type BK; submit a Reply Requested TSARA case for support.

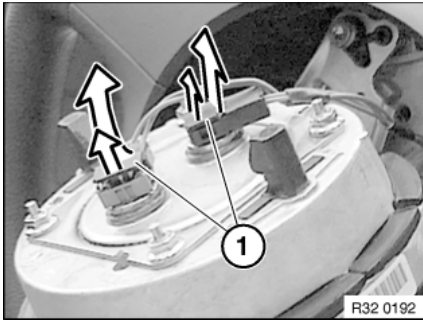
Connect plugs to connections of same colour on airbag unit.
