PRODUCT CAMPAIGN BULLETIN

APPLICABILITY: 2019MY Ascent
 2019MY Crosstrek Hybrid (PHEV)
 2019MY Forester

NUMBER: WUW-08
NHTSA ID: 19V-856
DATE: 12/04/19

SUBJECT: PCV Valve- Design Change

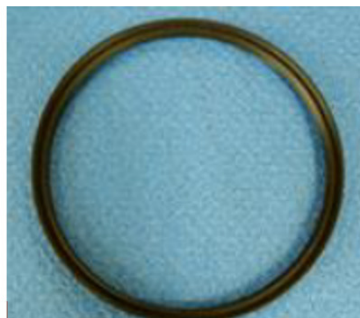
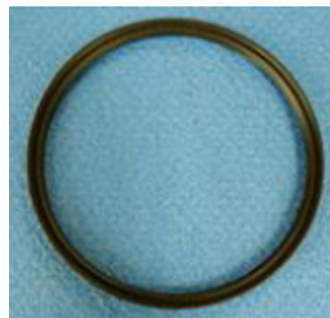
A Service Parts Kit, **p.n. X1181AA010** for use on **ASCENT** models only is currently in transit. When available, the kit will consist of a new PCV valve and the 2- **one-time use** o-rings required to be replaced when removing the intercooler assembly.

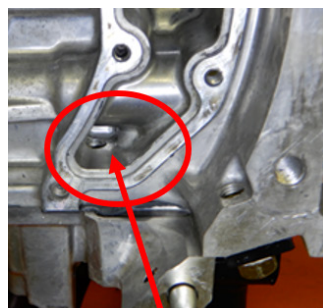
TIP: If any PCV valve components remain in the oil pan-side passage, apply compressed air to the oil pan side passage as shown below.
