Campaign No. 2020020014, February 2020

SUBJECT: **Model GLC-Class (253 platform)**
Model Year 2019
Airbag Warning Labels

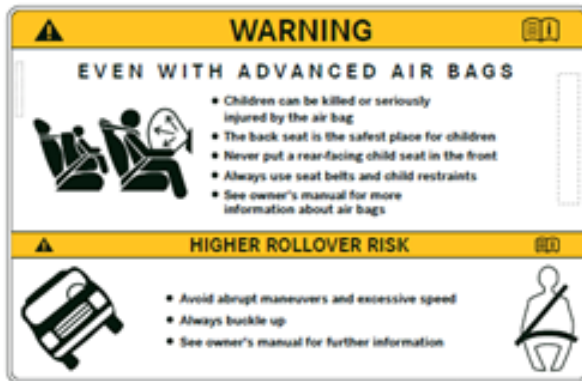
Figure 1

Incorrect versions may have been applied.

The information labels are applied on the inner side and outer side of the front passenger sun visor.(Figure1)

Specified airbag information label below is correct for the US/English version: The airbag information label must match this to be correct.

USA SUV

- A. **Incorrect** version of airbag information label applied: Carry out **work procedure**.
- B. **Correct** US/English version of airbag information label applied: **End measure**.

1. Replace sun visor (**AR68.60-P-5480NKB**) airbag information label is attached.

It is not possible to remove just the airbag information label from the sun visor, as the information label is part of the sun visor. The sun visor must be replaced.
