Mercedes-Benz

Campaign No. 2020040011, June 2020

SUBJECT: **Models C-Class, CLK-Class, E-Class, and CLS-Class (203, 209, 211, and 219 platform)**
Model Years 2001-2011
Sliding Roof Bonding - Phase 2

Order No. P-RC-2020040011

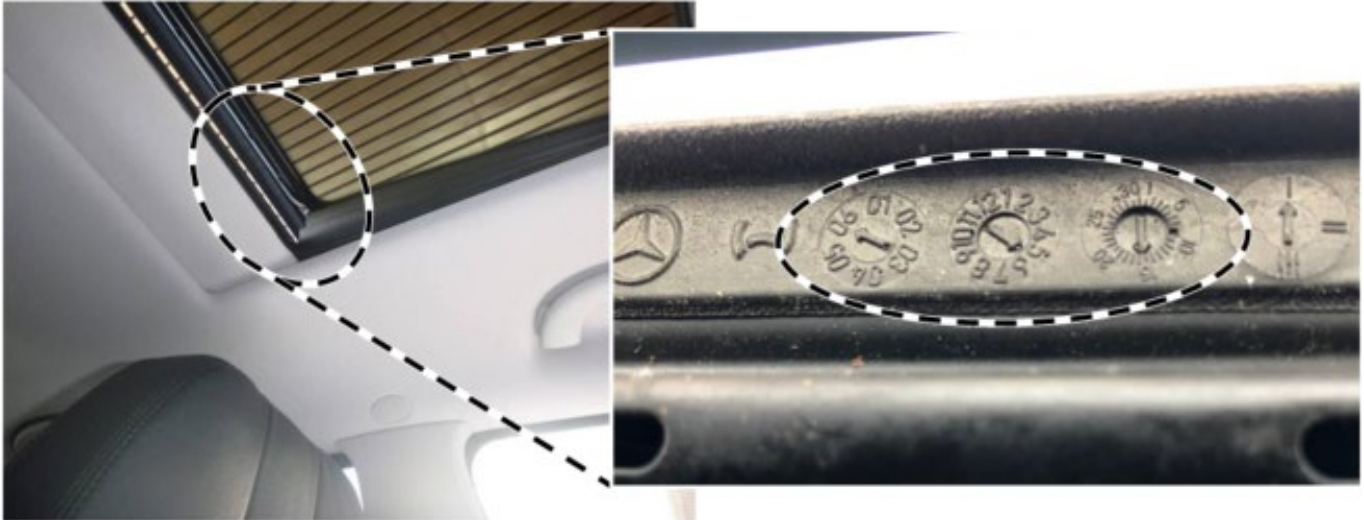
1. Move sliding sunroof to tilt position and check production date (**figure 1**).

i If the production date is **not** at the shown location (**figure 1**), this vehicle is **not** affected.

Figure 1 (The production date in the sample picture is **06 year / 5 month / 15 day**)(5-15-2006)

A. Production date between **12-12-2005** and **07-15-2006**: Carry out **check/test procedure B**.

B. Production date **not** between **12-12-2005** and **07-15-2006**: **End measure**.

C. **No production date present at shown location (figure 1): End measure.**

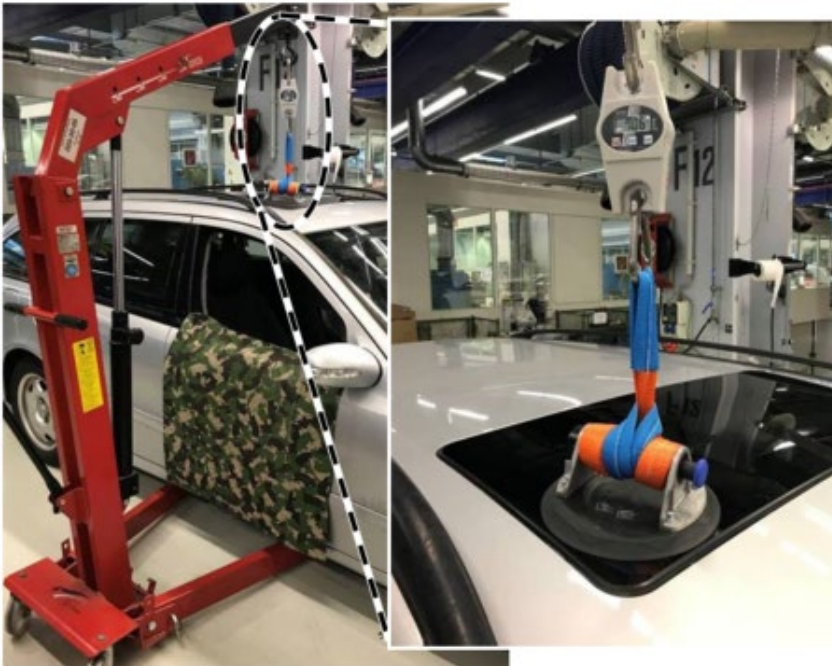
Figure 2

- i** The sliding sunroof must be closed.
 - i** Special caution must be exercised during the check. The cup suction tool may be used for this check.
3. Position cup suction tool (**figure 2**) and pull as **vertically** as possible (tolerance of ± 10 degrees) using lifting tool (hoist/crane).

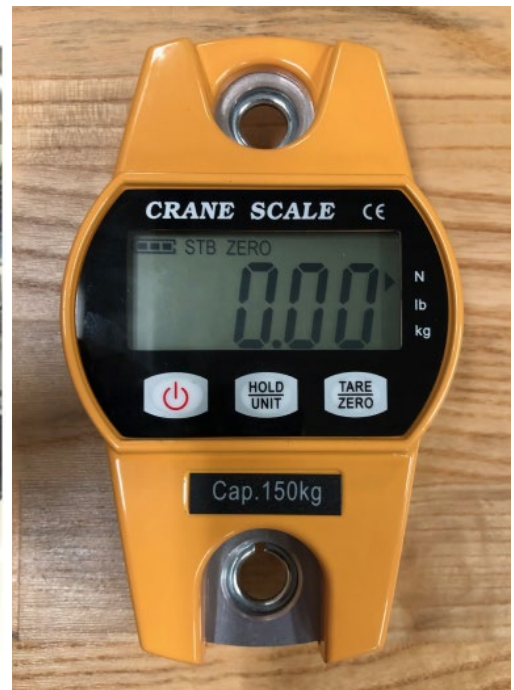
- i** Before the start of the measurement, the "(auto) hold function" of the hanging scale **must** be deactivated and the measurement scale is set to N (see operator's manual). **(See figure 3) for correct scale display.**
No "hold function" may be activated so that the current pulling force is always displayed.

Figure 3 (Correct scale display)

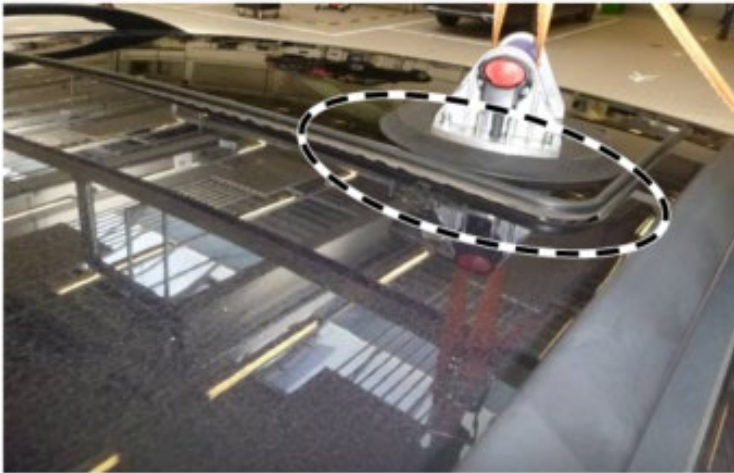
Figure5

- i** The sliding roof panel is lifted out of the roof frame noticeably at the rear test positions 1 and 5 (**figure5**).
- i** If the sliding roof panel detaches from the padding of the tilting/sliding roof frame at one of the test positions (**see figure 6**), the sliding roof panel must be replaced.

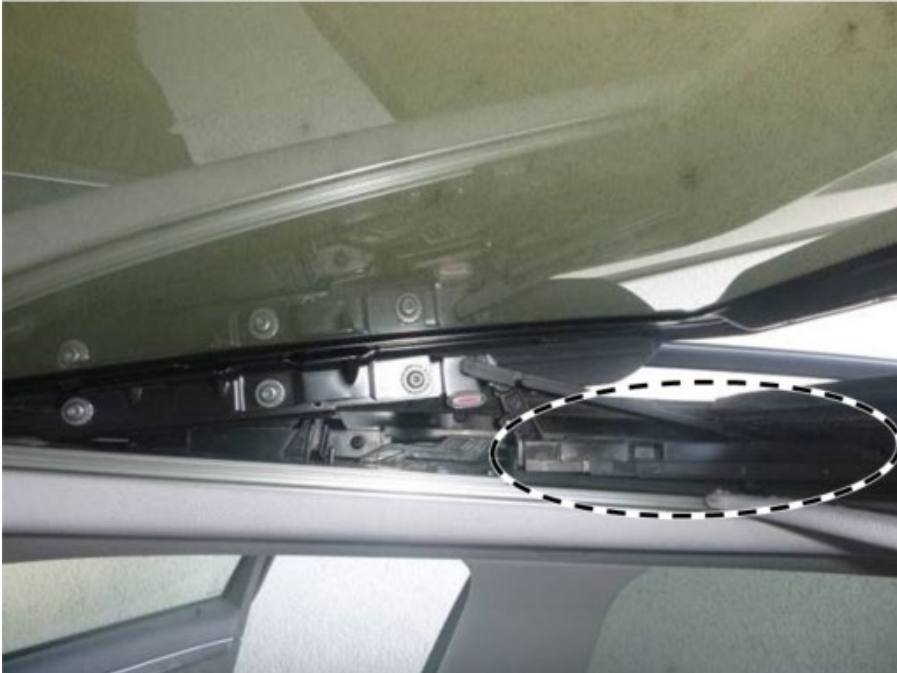
Figure7

i The accordion boot **need** not be removed completely. It is sufficient to slide it back (**figure 7**).

1. Replace sliding sunroof.
