Mercedes-Benz

Campaign No. 2020040011, June 2020  
Revision D 1/20/2023

SUBJECT: **Models C-Class, CLK-Class, E-Class, and CLS-Class (203, 209, 211, and 219 platform)**  
**Model Years 2001-2011**  
**Sliding Roof Bonding - Phase 2**

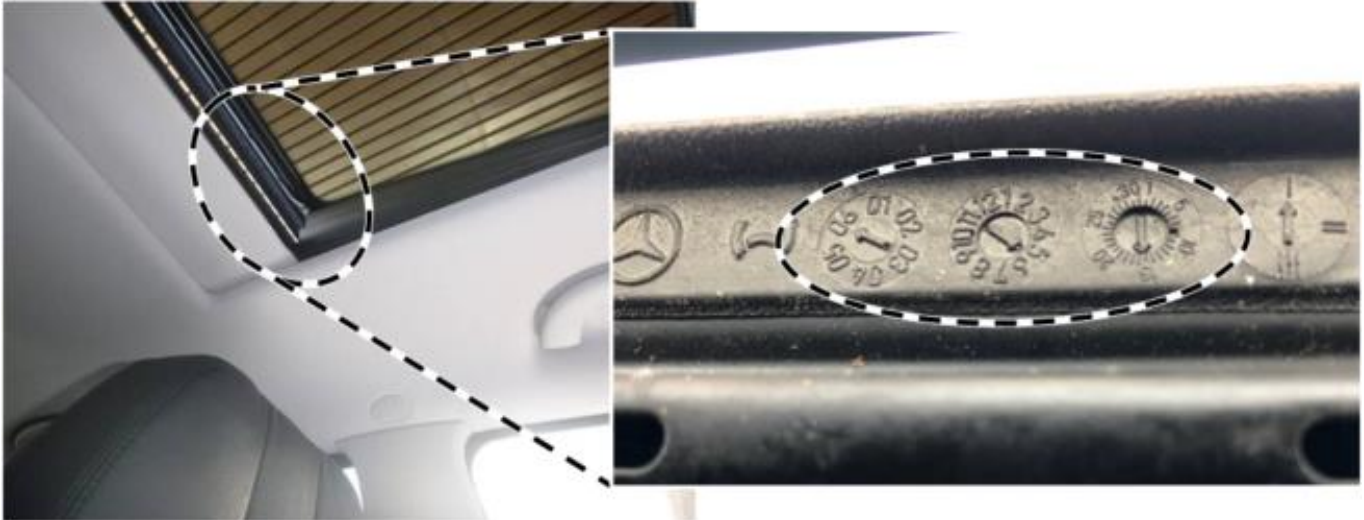
**Figure 1** (The production date in the sample picture is **06 year / 5 month / 15 day**)(5-15-2006)

1. Move sliding sunroof to tilt position and check production date (**figure 1**).

**i** The production date **must** be on or **after** **11-25-2005** or on or **before** **10-31-2007**.

**i** If the production date is **not** at the shown location (**figure 1**), this vehicle is **not** affected.

**A.** Production date between **11-25-2005** and **10-31-2007**: Carry out **check/test procedure B**.

**B.** Production date **not** between **11-25-2005** and **10-31-2007**: **End measure**.

**C.** **No** production date present at shown location (figure 1): **End measure**.

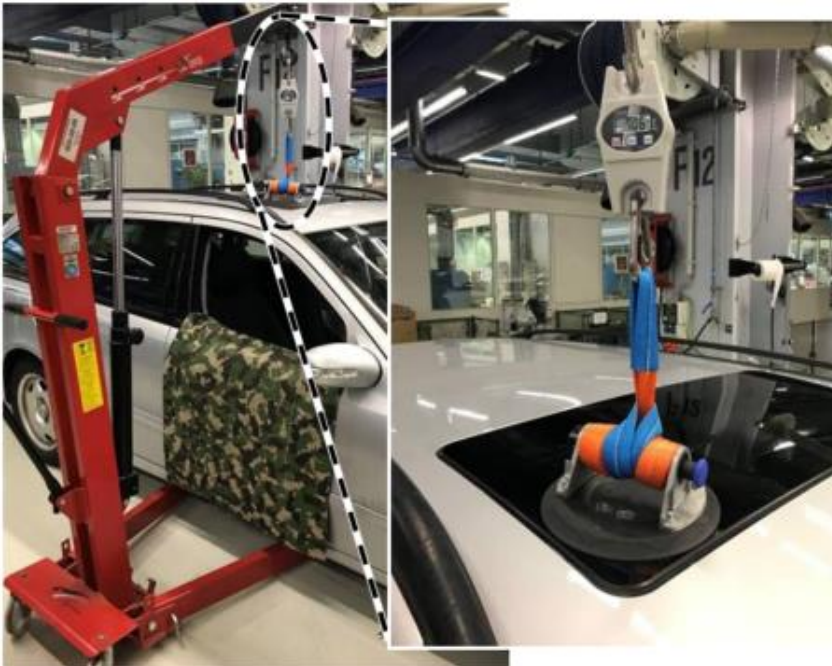
Figure 2

- i** The sliding sunroof must be closed.
  - i** Special caution must be exercised during the check. The cup suction tool may be used for this check.
3. Position cup suction tool (**figure 2**) and pull as **vertically** as possible (tolerance of  $\pm 10$  degrees) using lifting tool (hoist/crane).

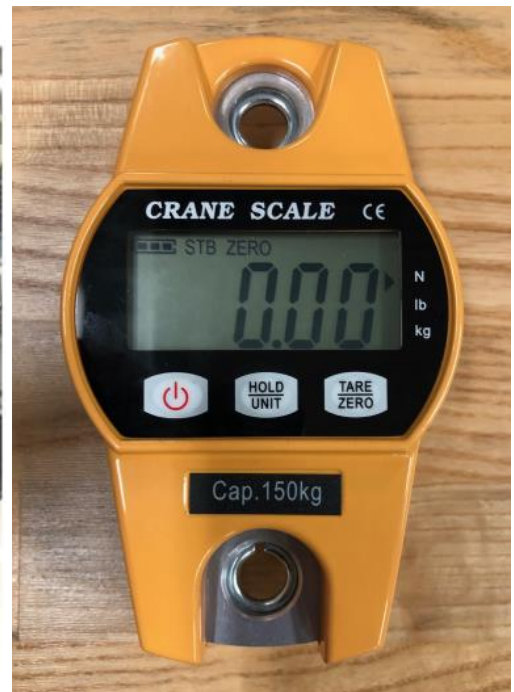
Figure 3 (Correct scale display)

- i** Before the start of the measurement, the "(auto) hold function" of the hanging scale **must** be deactivated and the measurement scale is set to N (see operator's manual). (**See figure 3**) for correct scale display.

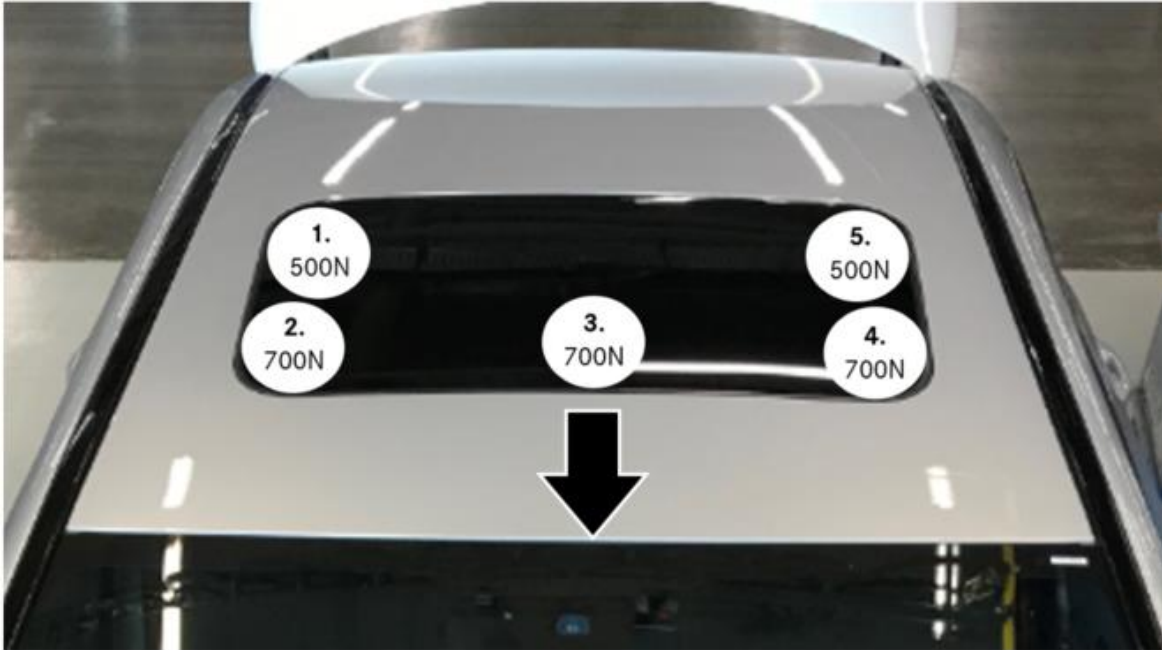
Figure 4 (test sequence 1, 2, 3, 4, 5 – arrow specifies front of vehicle)

- i** Specified force **500 N/700 N (figure 4)**. Please note that the scale is in N (newton) and should be measured in N. **DO NOT attempt to convert to any other measurement. An incorrect conversion could result in an inaccurate test result and/or damage to the testing equipment and/or the vehicle. Any costs associated with an improper repair will be the responsibility of the repairing dealer.**

- No** "hold function" may be activated so that the current pulling force is always displayed.
- i** Position cup suction tool at 5 positions in the sequence **1, 2, 3, 4, 5: (Figure 4)**.

- i** The specified force **must be monitored during the first minute** and adjusted if necessary (tolerance  $\pm 10$  N) **The specified force must not be exceeded**. Pull as vertically as possible (tolerance  $\pm 10$  degrees) at the specified force. There must not be a person inside the vehicle during the check, and the vehicle must not be touched if possible.

- i** The holding time per position must be exactly **10 min**.

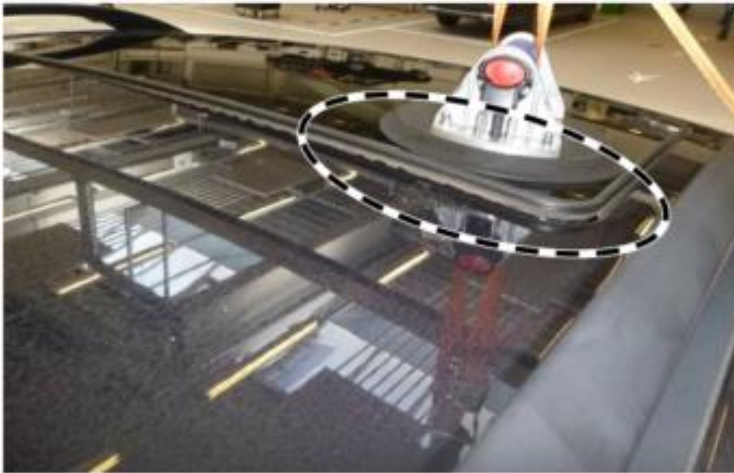
Figure5

**i** The sliding roof panel is lifted out of the roof frame noticeably at the rear test positions 1 and 5 (**figure5**).

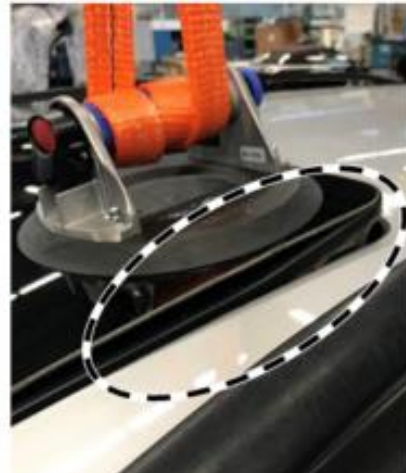
Figure 6 (NOT OK)

**i** If the sliding roof panel detaches from the padding of the tilting/sliding roof frame at one of the test positions (**see figure 6**), the sliding roof panel must be replaced.

**D.** If the sliding roof panel detaches from the padding: Carry out **work procedure**.

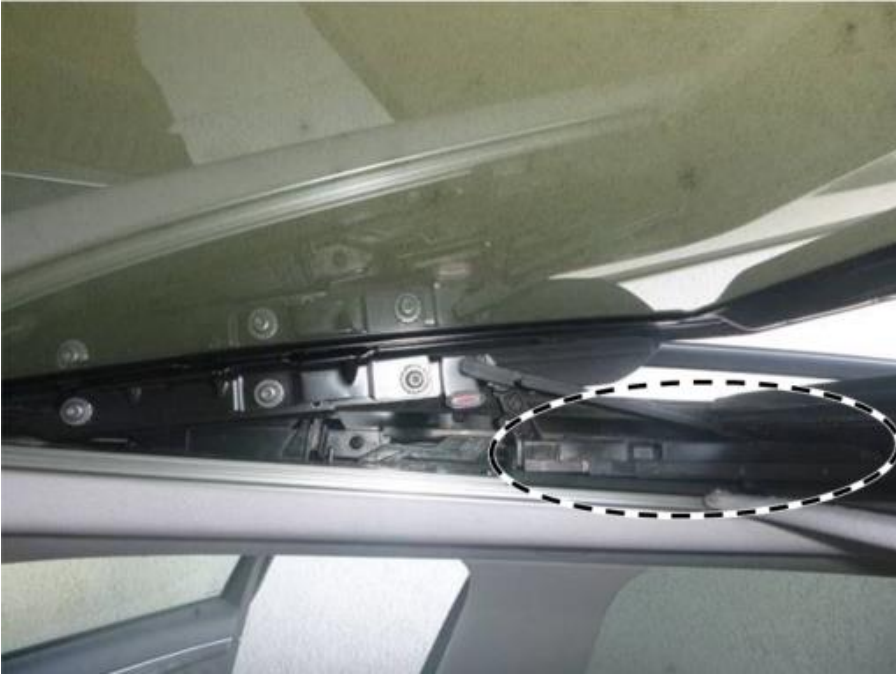
**Figure7**

**i** The accordion boot **need** not be removed completely. It is sufficient to slide it back (**figure 7**).

1. Replace sliding sunroof.
