R19AA

ADDITIONAL NOTICE

DATE: March 14, 2023
TO: Blue Bird Owners
Subject: R19AA, Bendix ADB22X LH Rear Caliper

R19AA - BENDIX® ADB22X™ AIR DISC BRAKE RECALL REPAIR KIT

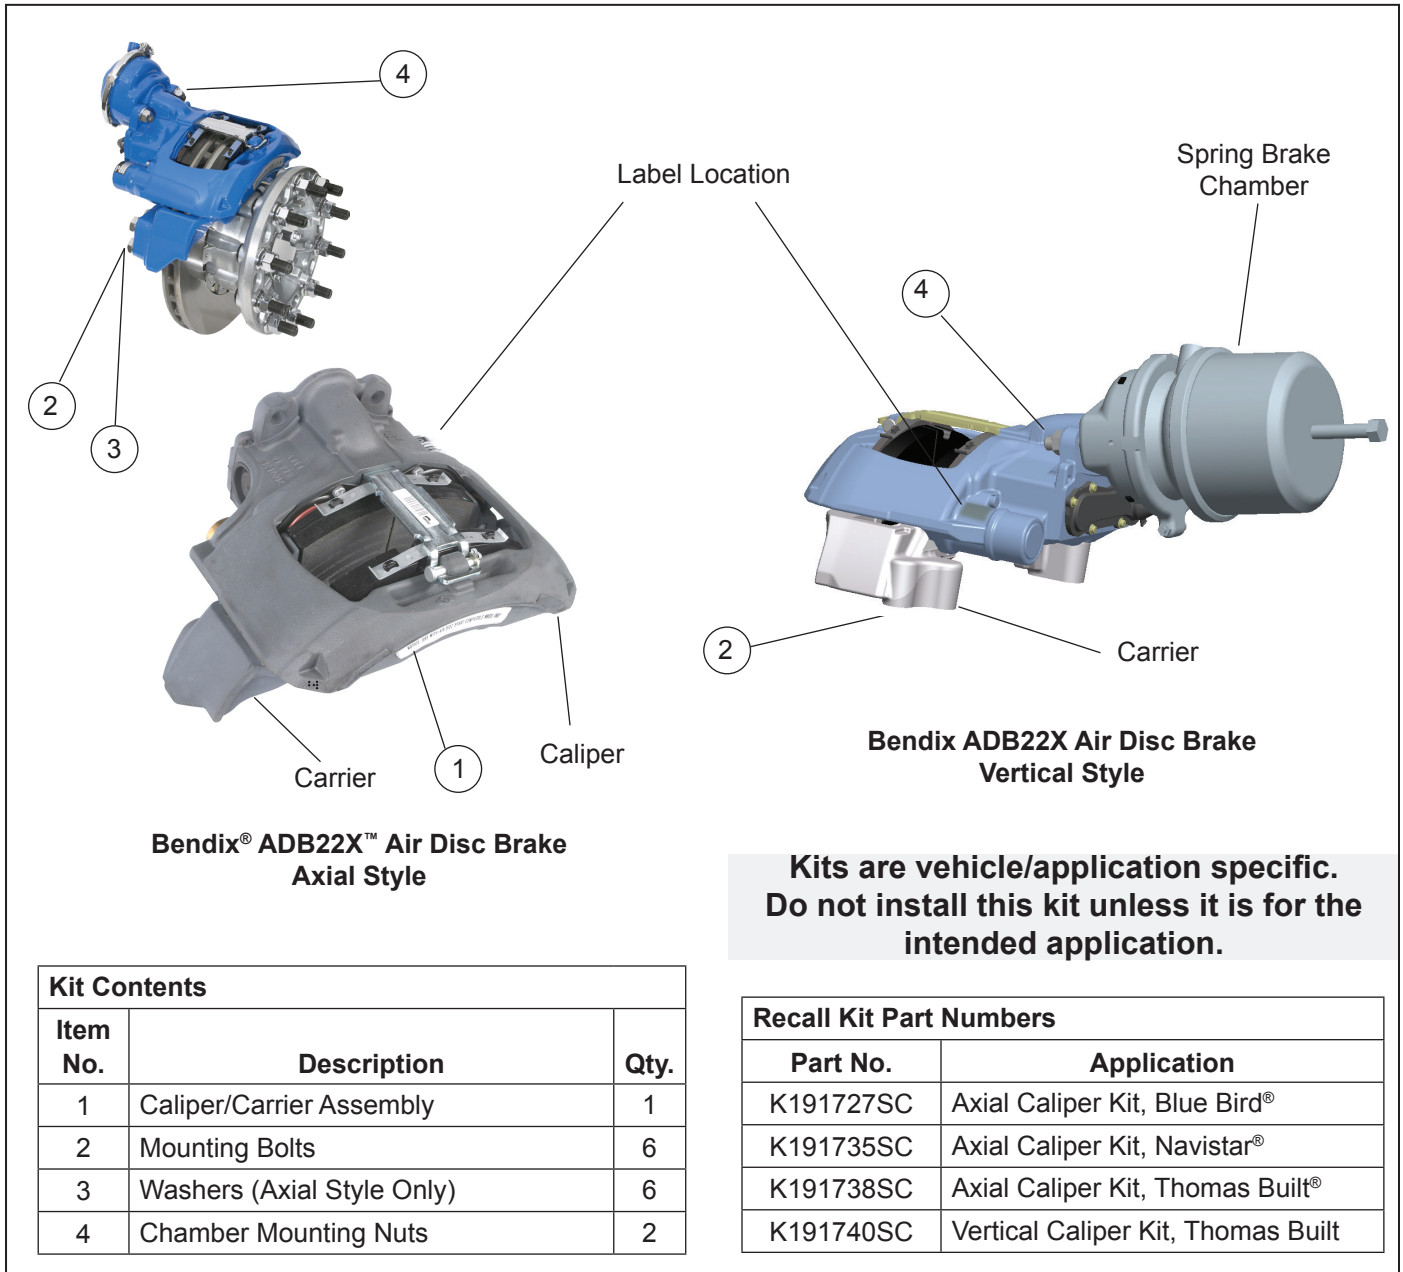
Figure 1 – Bendix® ADB22X™ Air Disc Brake Recall Repair Kit

are installed on the left (driver's side) rear axle of a school bus. This kit contains the components shown in Figure 1. All of the kit contents must be used for the installation. Do not reuse the removed hardware (Items 2 through 4).

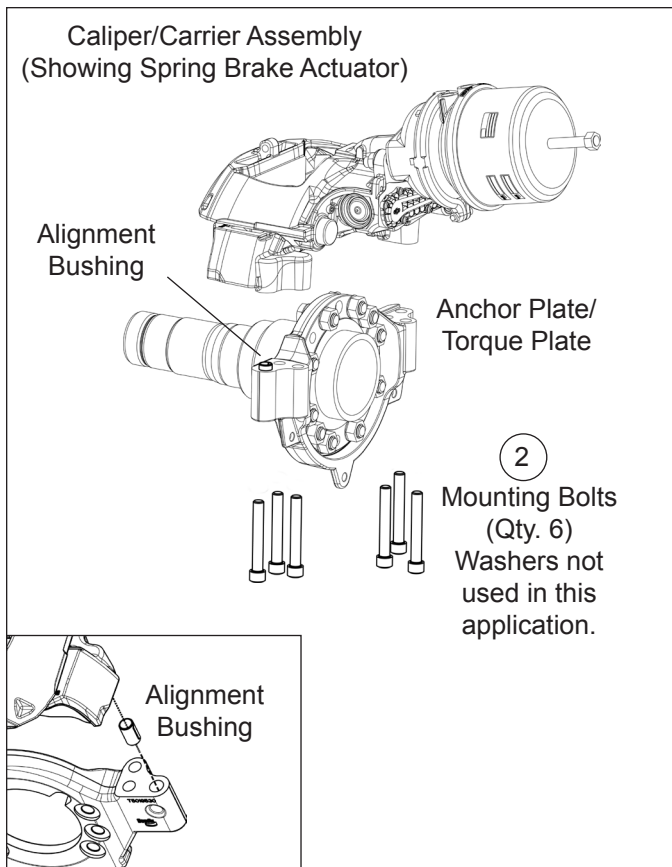
Figure 9 – Vertical Mount Caliper/Carrier

1. (See Figure 9). Supporting the air disc brake by necessary means, remove and discard the six mounting bolts (Item 2). Lift the caliper up off the anchor plate. (See Figure 9).
2. The vertical bolt assembly includes an alignment bushing. **This bushing must be saved for reuse during reassembly of the brake.** The bushing mounts in the torque plate and maintains the correct alignment of the brake assembly relative to the rotor.
3. If the brake assembly does not separate from the anchor plate it may be helpful to install an M16X2.0 screw longer than 120 mm at the bushing locations and tap the end of the bolt with a hammer to free the brake assembly. Remove the caliper/carrier assembly.

1. Supporting the air disc brake by necessary means, attach the brake to the anchor plate using six bolts (Item 2) and, if included, washers (Item 3). Do not reuse the removed bolts and washers. Torque to the values shown in Table 1.

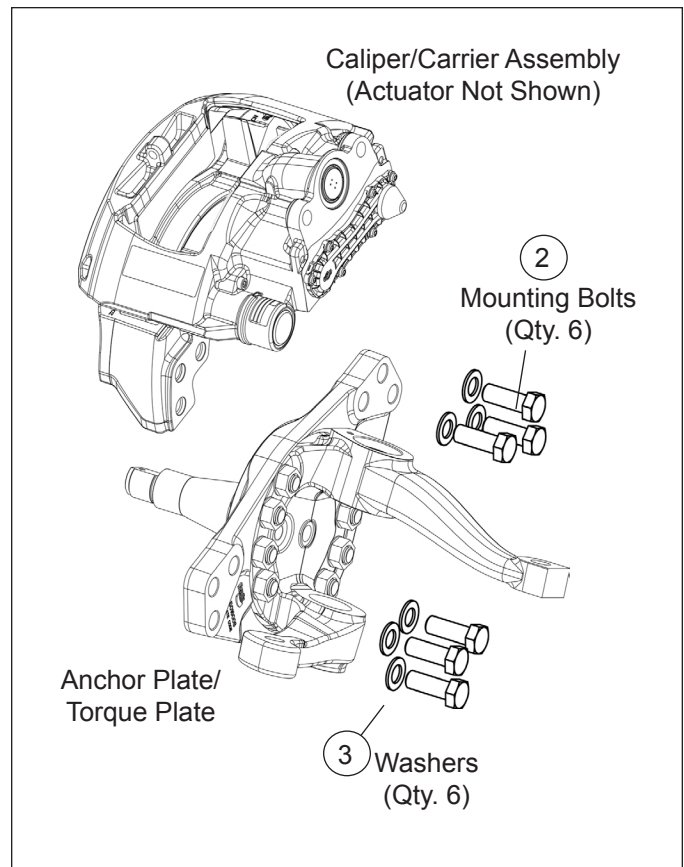
Figure 10 – Axial Mount Caliper/Carrier

1. (See Figure 10). Supporting the air disc brake by necessary means, remove and discard the six bolts (Item 2) and washers (Item 3) attaching the brake to the anchor plate and remove the caliper/carrier assembly from the vehicle.

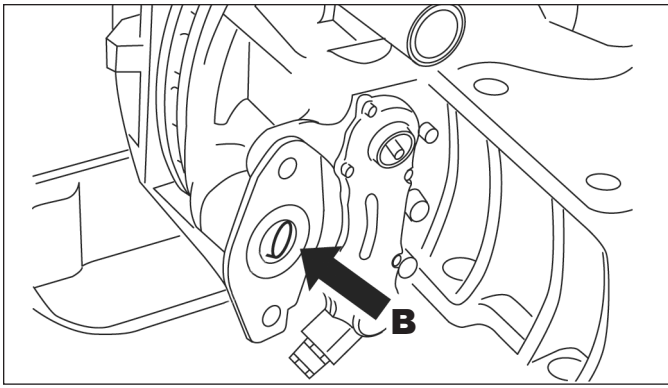
Figure 11 – Spring Brake Installation

1. Ensure the spring brake chamber mounting area is clean and free of any debris. (See B in Figure 11).

2. Position the spring brake chamber in the same orientation it was removed. Secure the chamber with the spring brake chamber mounting nuts (Item 4). See Figure 3. Alternately tighten both the nuts step-by-step up to a final torque of 133 ± 7 ft-lbs (180 ± 10 Nm). **Do not reuse the nuts that were removed during the disassembly.**
3. If the air hoses were disconnected, reconnect the air hoses as marked and be sure that each hose is not twisted or in contact with moving vehicle components. The air hose routing must allow for full caliper travel. Note that for spring brake service chambers the ports are indicated by: “11” Service Brake Port and “12” Spring Brake Port. (See Figure 12).

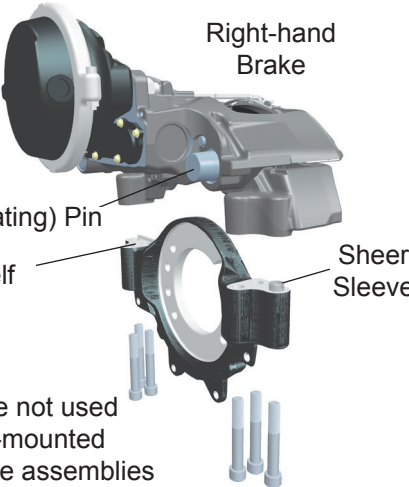
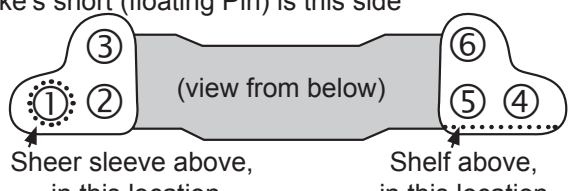
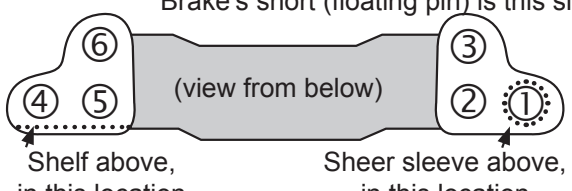
Table 1 – Torque Plate Fasteners and Torque Recommendations (see manufacturer’s recommendations)

Air Disc Brake Attachment Hardware	
Vertical Mount	Fastener & Torque*
<p style="text-align: center;">Service Actuators Shown</p> <div style="display: flex; justify-content: space-around;"> <div style="text-align: center;"> <p>Left-hand Brake</p>

</div> </div> <p style="text-align: center;">Short (floating) Pin</p> <p style="text-align: center;">Sheer Sleeve</p> <p style="text-align: center;">Shelf</p> <p style="text-align: center;">Washers are not used on vertical-mounted ADB22X™ brake assemblies</p>	<p>Thomas Built®</p> <p>Mounting Bolts (Item 2): M16 x 2.0 x 110 mm, Class 12.9. <i>Use the new fasteners included.</i></p> <p>Washer (Item 3): None used.</p> <p>Torque: Using the torque pattern below, pre-torque to between 40-50 ft-lbf [54-68 N·m], with a final torque of 229 ft-lbf [310 N·m].</p>
Left-Hand Brake Torque* Pattern (Viewed from Below)	Right-Hand Brake Torque* Pattern (Viewed from Below)

<p style="text-align: center;">Anchor Plate/Torque Plate</p>	<p>Blue Bird®</p> <p>Mounting Bolts (Item 2): M20 x 50 mm Class 10.9.</p> <p>Torque: Pre-torque to 20-60 ft-lbf [27-81 N·m], with a final torque of 350-400 ft-lbf [475-542 N·m].</p> <p>Navistar®</p> <p>Mounting Bolts (Item 2): M20 x 60 mm Class 10.9.</p> <p>Torque: Pre-torque to 20-60 ft-lbf [27-81 N·m], with a final torque of 350-400 ft-lbf [475-542 N·m].</p> <p>Thomas Built</p> <p>Mounting Bolts (Item 2): M20 x 60 mm Class 10.9.</p> <p>Torque: Pre-torque to 20-60 ft-lbf [27-81 N·m], with a final torque of 375 ft-lbf [510 N·m].</p> <p>Washer (Item 3): Use the new mounting bolts and washers included.</p>

Torque* Pattern
	<p>Any cross-pattern, see the example below:</p> <div style="display: flex; justify-content: space-around; align-items: center;"> <div style="text-align: center;"> <p>① ⑤</p> <p>③</p> </div> <div style="text-align: center;"> <p>⑥ ④</p> <p>②</p> </div> </div>
<p>*Use the new fasteners included in the kit when installing the air disc brake caliper. Ensure that the brake caliper guide pins slide freely once the final torque has been achieved on all fasteners. Refer to the OE maintenance manuals for vehicle specific installation recommendations.</p>
