**DATE:** June 25, 2020  
**TO:** Blue Bird Owners  
**Subject:** RECALL R19AF, Safe Fleet Prolo Roof Hatch Handle

**SUBJECT: RECALL R19AF, Safe Fleet Prolo Roof Hatch Handle**

Subject: Safety Recall 19E-042 – Prolo Hatches

**OUTER HANDLE REPLACEMENT**

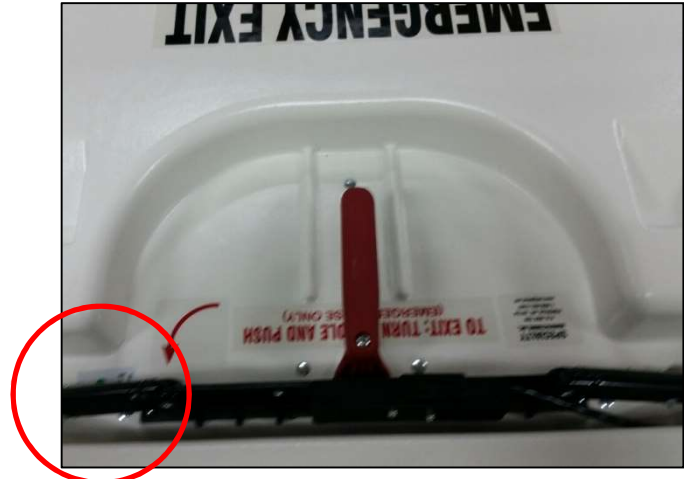
**Step 2. Locate the silver “build date” sticker on the inside of the lid (located in red circle shown above)**

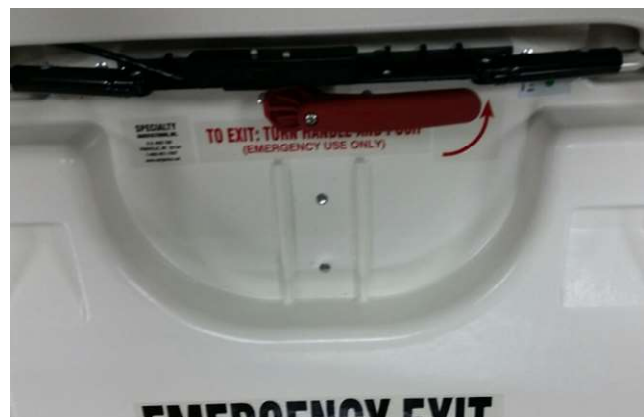
**Step 4: REWORKING THE HATCH**  
Rotate the handle into the orientation shown

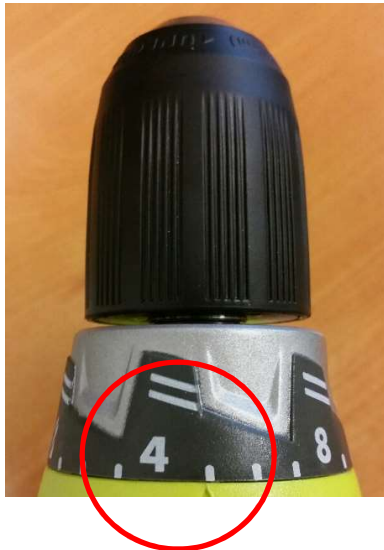
**Step 5: Set the torque setting to 4-5, or the minimum needed to set the screw.**

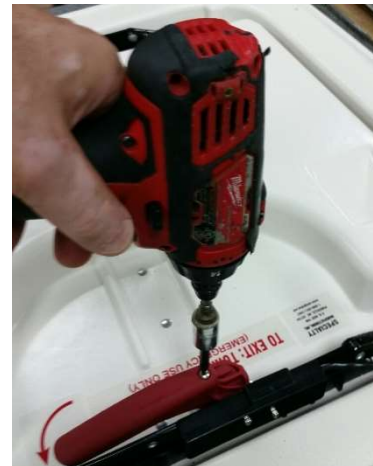
**Step 6: Insert the 1/8" Allen bit into the 008798 screw and remove screw from red handle.**

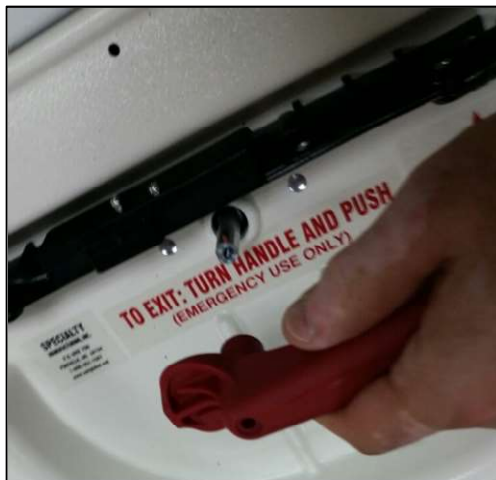
**Step 7: Pull down to remove the red handle**

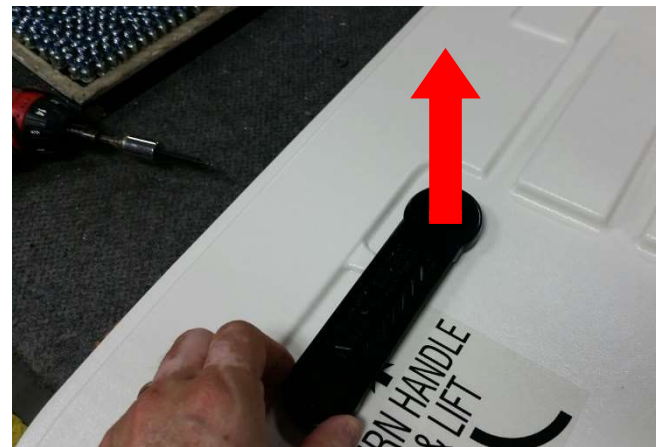
**Step 8: Open the lid 5-6 inches, reach around and lift the black handle out of the bushing.**

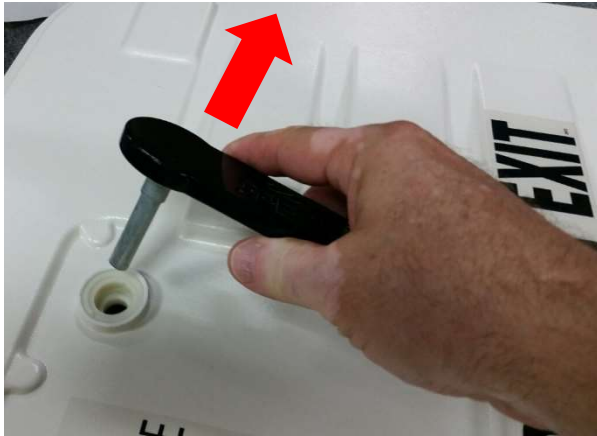
**Step 9: Remove outer handle**

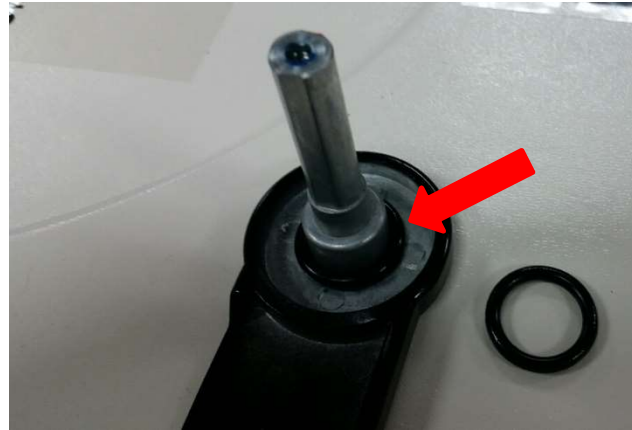
**Step 10: Ensure that the 009321-5 O-ring is secured around the base of the handle stem. If it is not there, check to see if it is in the lid bushing. If it is not in either location, replace with a new o-ring.**

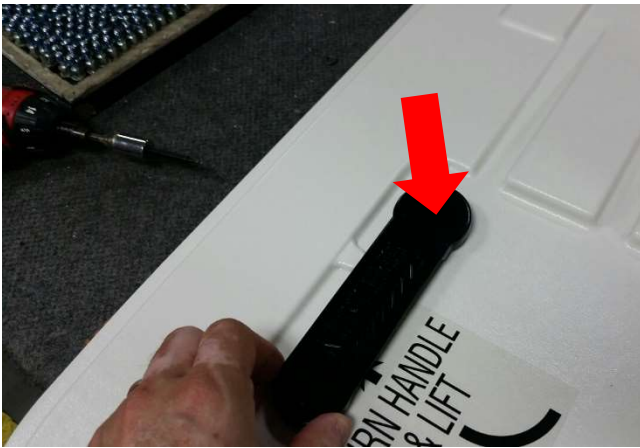
**Step 11: Insert the new handle into the bushing and orient as shown.**

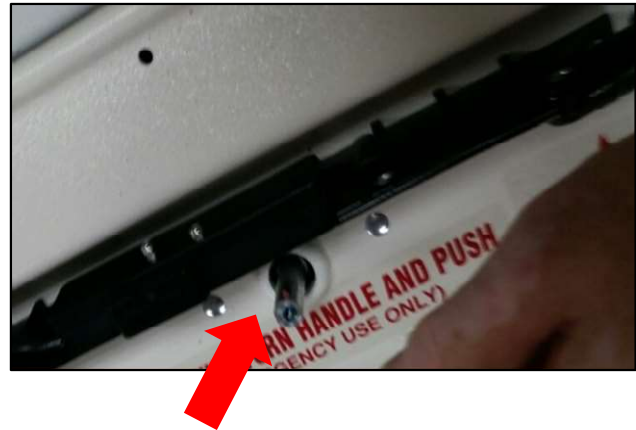
**Step 12: From inside the lid, you will see the shaft of the outer handle**

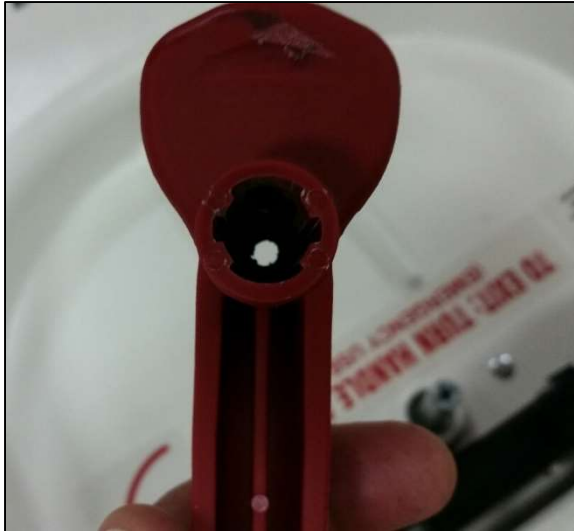
**Step 13: The inside of the red handle has ribs to self-orient the red handle on the outer handle.**

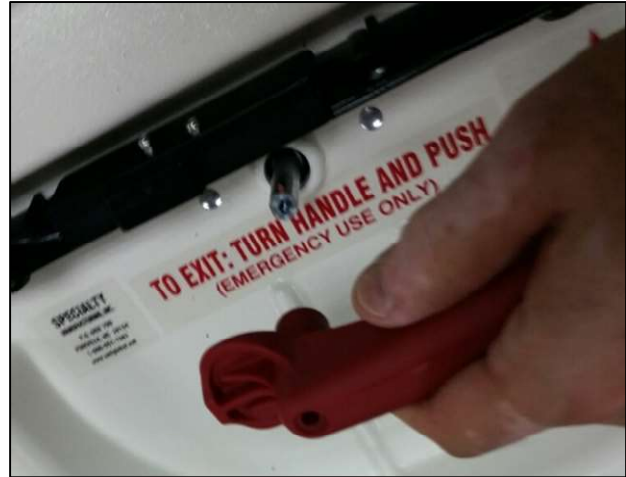
**Step 14: Place the handle onto the stem of the outer handle (oriented as shown).**

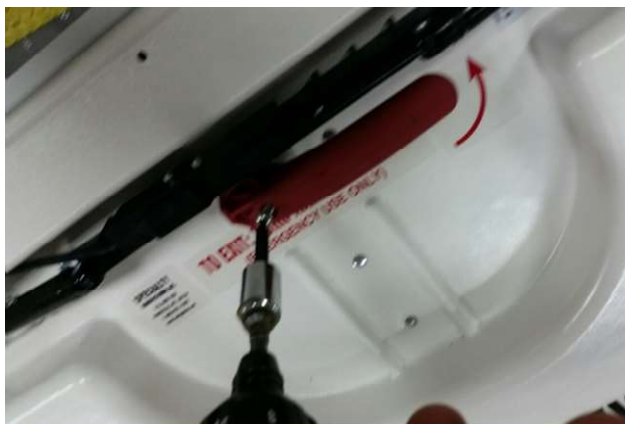
**Step 15: Insert the 008798 screw into the red handle and thread the screw into the outer handle stem. Approximately 10-12 in-lbs to secure. Setting of 4-5 on driver**

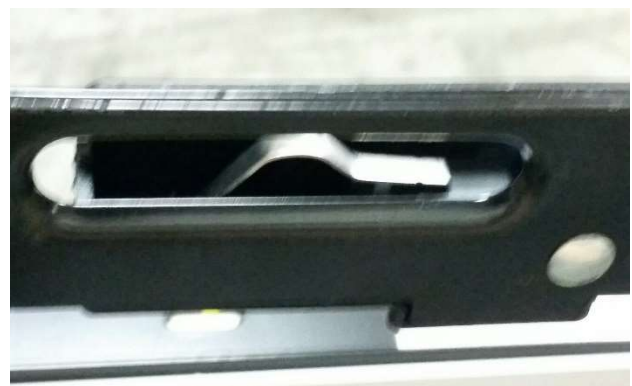
**Step 16: The black metal bracket has a switch level secured to it. The red handle activates the switch when the handle is oriented 90 degrees to the bracket**

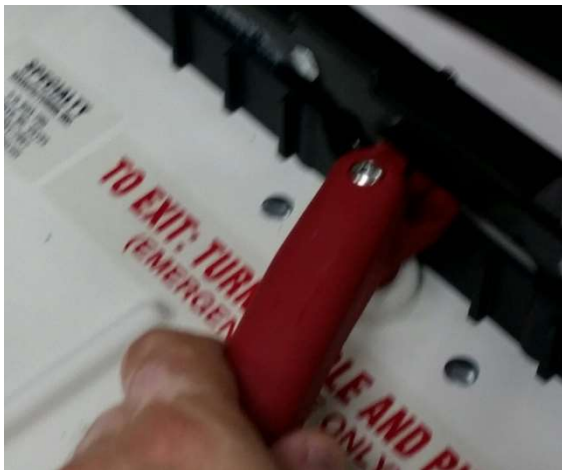
**Step 17:** Secure the lid to the trim subassembly by rotating the handle into position. There should be a “click” when the switch is activated. If a switch does not occur, the switch will need to be replaced.
