Product Safety Recall

N182206630 Airbag Inflator Rupture

| Condition | General Motors has decided that a defect which relates to motor vehicle safety exists in certain 2010 - 2011 model year Chevrolet Malibu vehicles. These vehicles were equipped with an ARC front-driver airbag inflator that could over pressurize during airbag deployment and rupture. If the front-driver airbag inflator ruptures during deployment, the airbag may not fully inflate, and the release of high-pressured gas may propel pieces of the inflator and airbag module into the occupant compartment, causing or increasing the risk of injury to occupant(s) in a crash. |
| Correction | Dealers will replace the front-driver airbag module. |

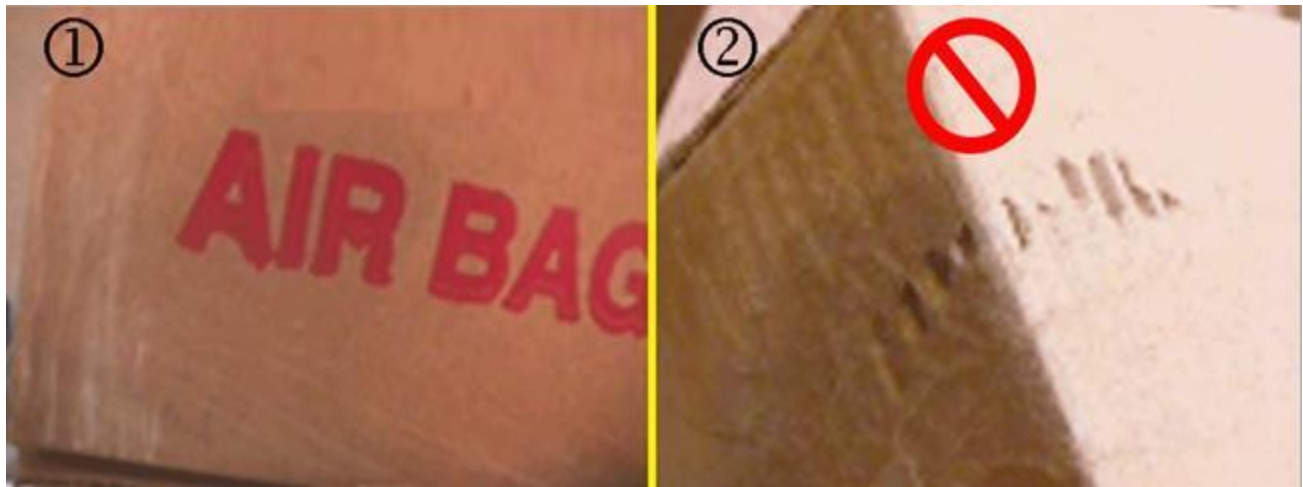
3961561

- **Abrasions:** Abrasions result from sliding the package against a rough surface (e.g. concrete floors). Major abrasions (2) are NOT acceptable. Note the flutes are visible.

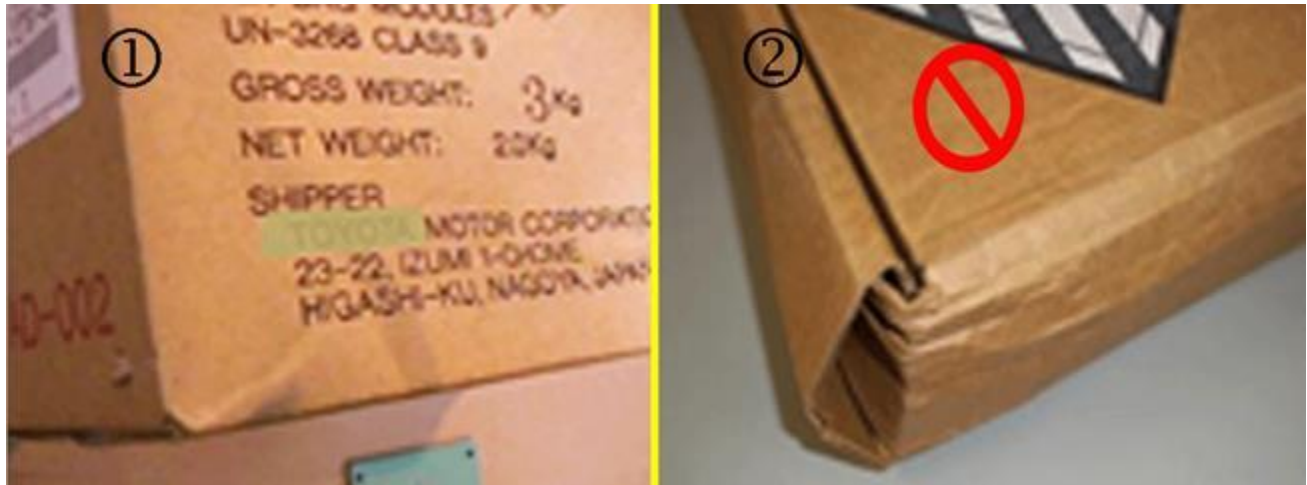
3961563

- **Compressions:** Compressions result from superimposed weights (e.g. stacked too high) or from dropping the packages. Small dimples (1) are acceptable.

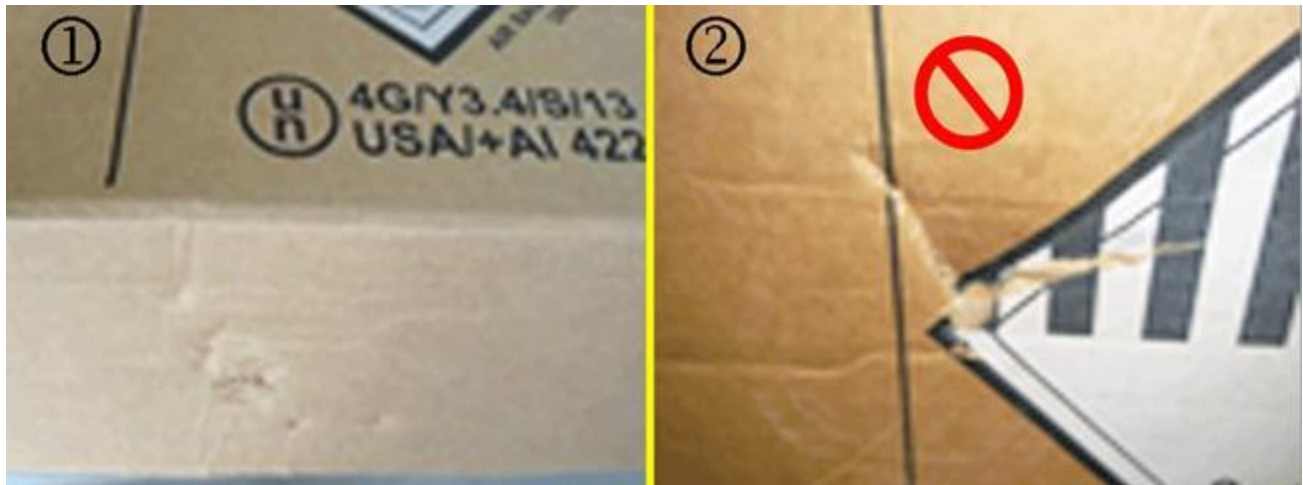
3961564

- **Dents:** Minor dents (1) occur through normal handling and picking (e.g. pulling from bin locations) and are acceptable. Major dents (2) result from impacts with others objects (e.g. pallet impacts).

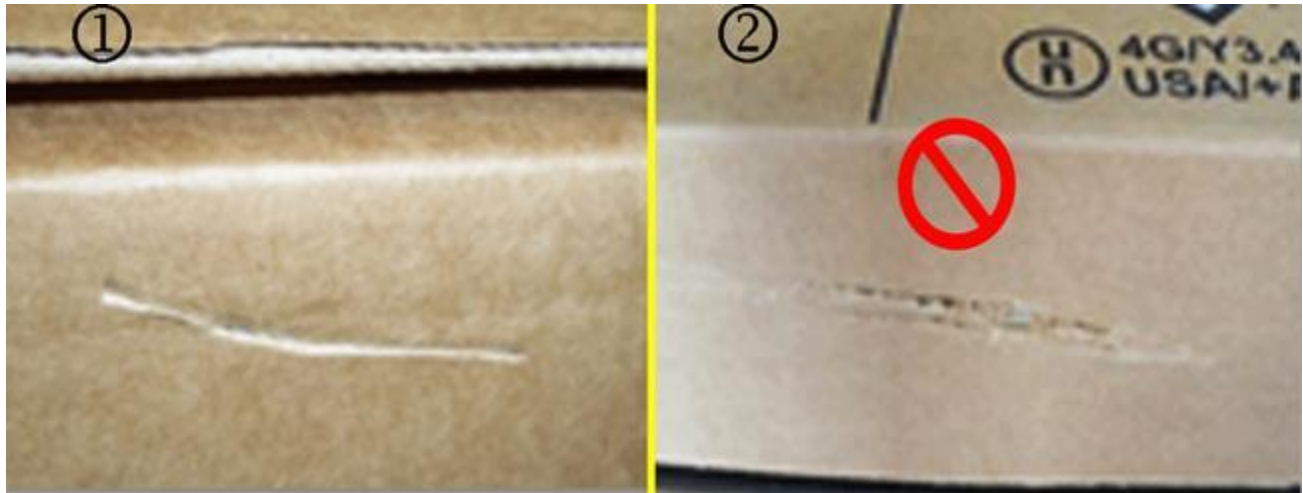
3961565

- **Incisions:** Minor incisions (1) are acceptable. Major incisions (2) (e.g. pallet box cut open with **utility** knife) are NOT acceptable.

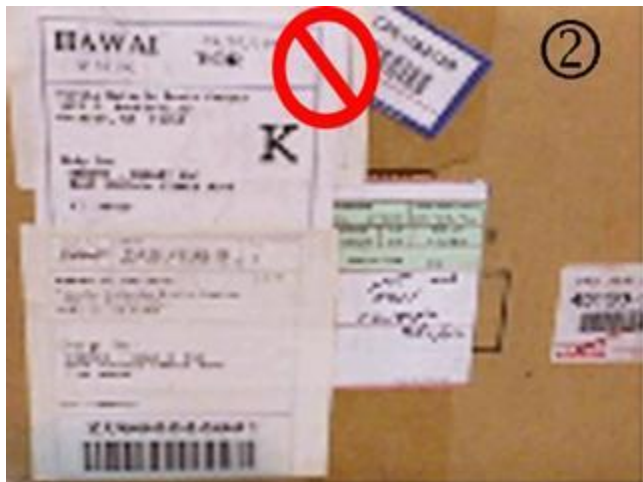
3961566

- **Labeling:** Packages with excessive labeling are NOT acceptable, particularly if the labels obscure other required marks and labels.

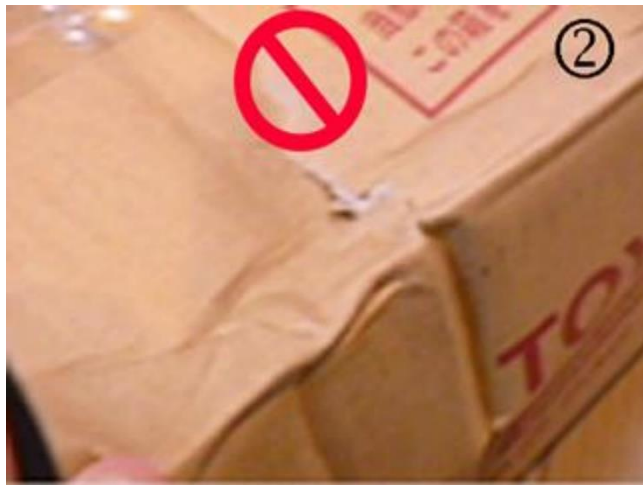
3961567

- **Other Damages:** Multiple damages, such as those shown above, may affect the integrity of the packages, and are NOT acceptable. Others that are not as severe may be acceptable. If questionable, repackage the material.

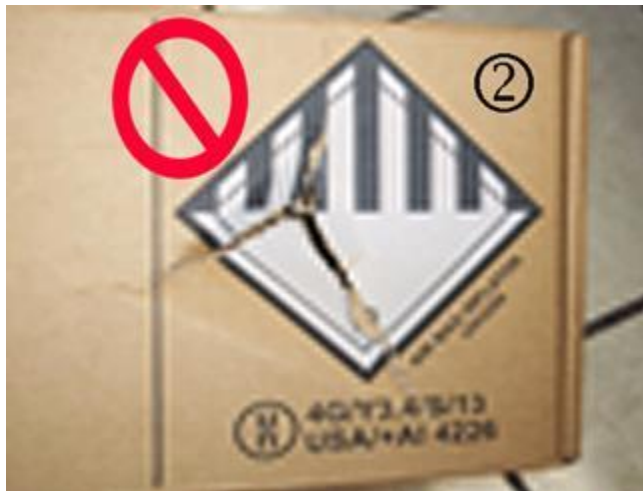
3961568

- **Punctures:** Any punctures, even minor ones, are NOT acceptable.

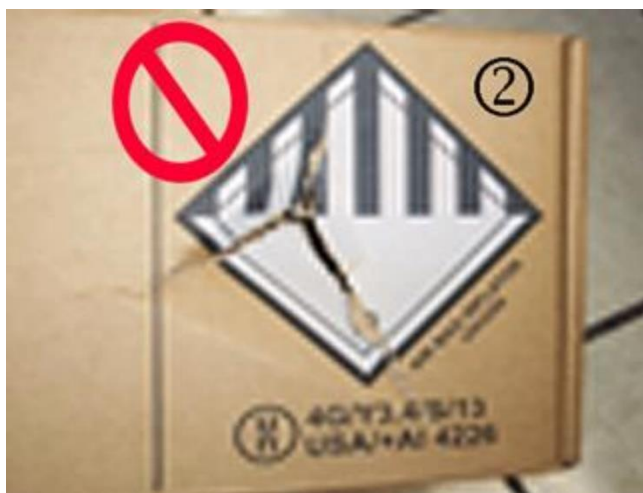
3961568

- **Tears:** Minor tears will not generally affect the structural integrity of the packaging and are considered to be normal "wear and tear", however, large tears or rips are NOT acceptable.

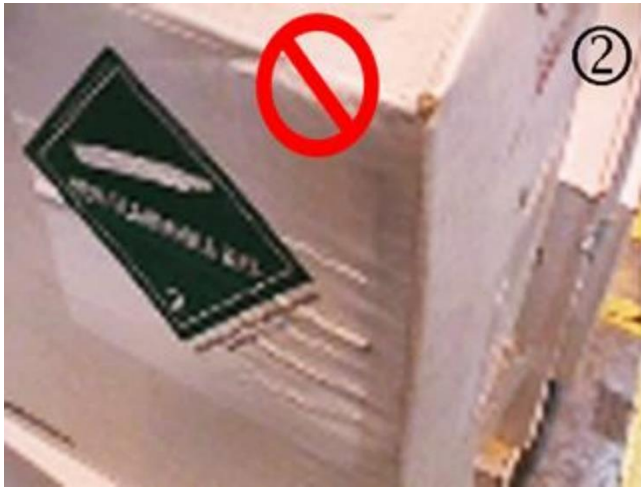
3961569

- **Water Damages:** Water Damages, such as the example shown above, are NOT acceptable. Water damages will affect the structural integrity of the packaging. These packages should be repacked in appropriate specification packages.
