PREVOST

**SAFETY
RECALL**

SR19-03

DATE :	April 2019	SECTION :	23 ACCESSORIES
SUBJECT:	EXTINGUISHER CONTROL HEAD INSPECTION

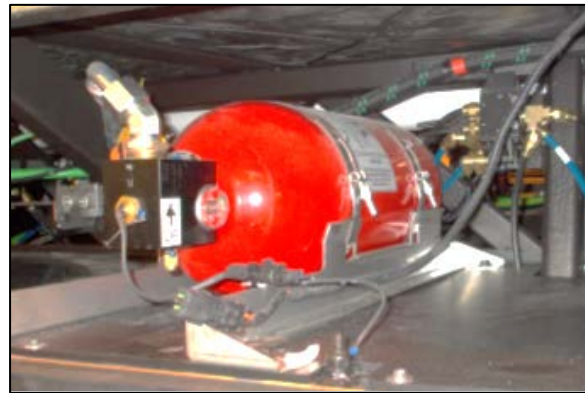
Figure 1

1. Locate the 25 lbs. extinguisher tank behind the driver side rear fender or inside the baggage compartment.

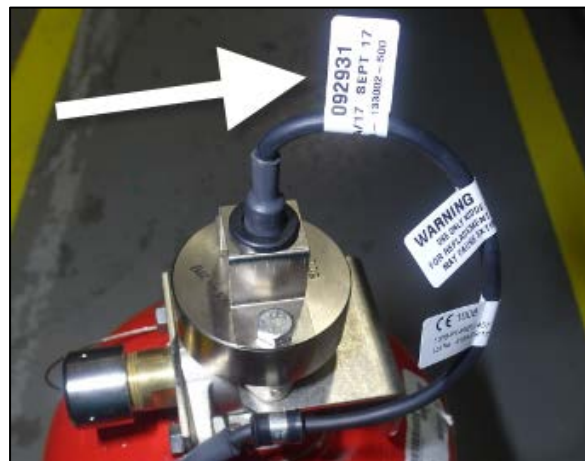
Figure 2

2. Locate the piston actuator identification label.

- Record the batch code from the label on the certification sheet at the end of this document.

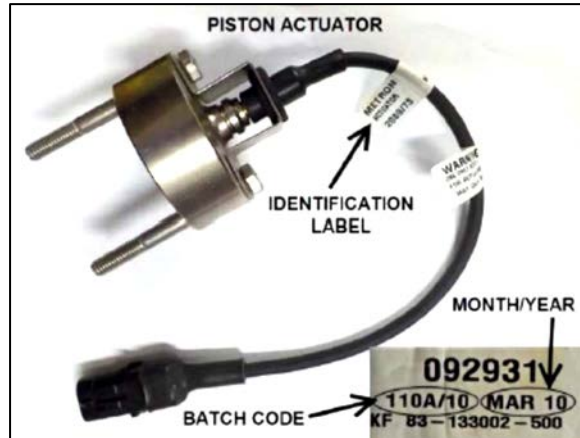
Figure 3

The batch code is located beside the Month/Year information on the label shown in Figure 3.

Both tags on this particular extinguisher are the same. Typically only one information label and one warning label will be found on the piston actuator.

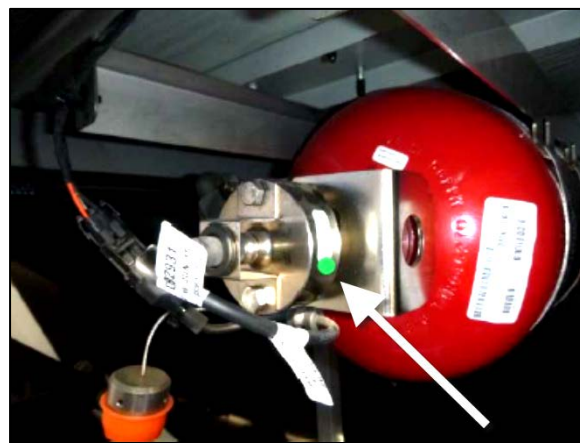
Figure 4

- If the batch code DOES NOT match any of the recall batch codes shown in the table below, place a GREEN dot decal or a small piece of GREEN tape on the control head. The piston actuator is functional.

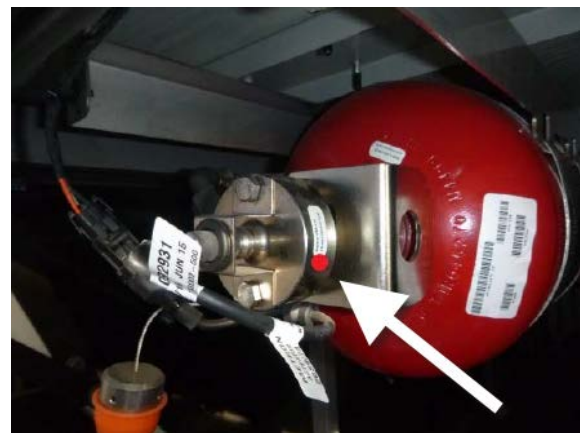
Figure 5

- Close up the extinguisher compartment.
- If the batch code matches any of the recall batch codes shown in the table ABOVE, place a RED dot decal or a small piece of RED tape on the control head. The piston actuator has to be replaced.
- If the labels are missing on the extinguisher control head, replace the piston actuator.
- Call a Prevest Service Center and make an appointment to replace the control head.

Replacement of the control head has to be performed by a certified worker.
