PREVOST

SAFETY RECALL

SR19-03P-B

| SUBJECT: | EXTINGUISHER CONTROL HEAD INSPECTION | |

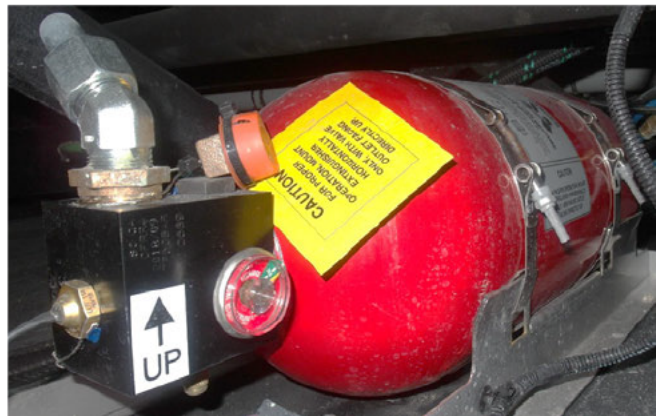
Extinguisher with a black box control head is not impacted. Do not replace this control head.

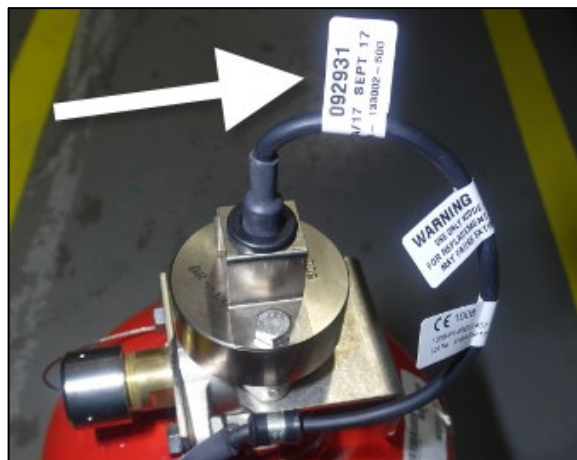
Figure 1

1. Locate the 25 lbs. extinguisher tank:
 - Prevost vehicles, for H3 models, it is behind the driver side rear fender and for X3 models, it is inside the baggage compartment.

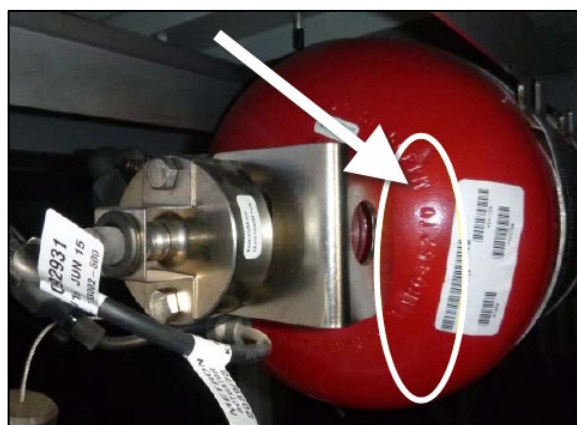
Figure 3

The piston batch code is located beside the Month/Year information on the label (see Figure 3).

The batch code is located beside the Month/Year information on the label shown in Figure 3.

5. If the batch code DOES NOT match any of the recall batch codes shown in the table below, place a GREEN dot decal or a small piece of GREEN tape on the control head. The piston actuator is functional.

6. Close up the extinguisher compartment.
7. If the batch code matches any of the recall batch codes shown in the table ABOVE, place a RED dot decal or a small piece of RED tape on the control head. The piston actuator has to be replaced.
8. If the labels are missing on the extinguisher control head, replace the piston actuator.
9. Call a Prevost Service Center and make an appointment to replace the control head.
