Condition	General Motors has decided that a defect which relates to motor vehicle safety exists in certain 2017-2019 model year Chevrolet Trax and 2017-2020 Chevrolet Tracker vehicles. In some of these vehicles, a joint in one or both front lower-control arms may have been improperly welded. Over time and in rare cases, an improperly welded joint can fatigue and break, causing the lower-control arm to partially separate from the vehicle.
Correction	All lower control arms will be inspected using a gauge tool to determine if they meet manufacturing specifications. Please note, this is for the Trax only in the USA and Canada. Dealers will replace lower control arms that do not pass the gauge inspection.

## Product Safety Recall

A182202370 Lower Control Arm Weld

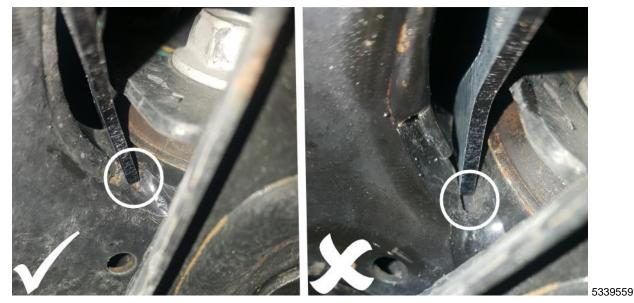
3. Inspect the welds on the rearward side of the driver's side front control arm bushing barrel using the provided gauge.

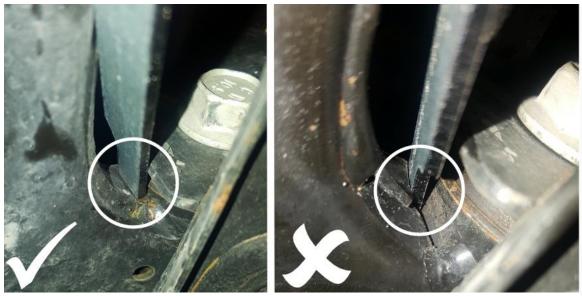
5339561

- 4. Inspect the Gap (1) in the weld using the number one (1) side of the gauge. With the gauge oriented as shown, slide the top of the tool along the barrel of the bushing until it contacts the upper weld. Then, pivot the bottom of the gauge in while holding the top against the upper weld until the bottom of the tool is also contacting the bushing barrel or weld.
  - If the inspection gauge does **not** fit in the gap between the welds (check mark), the control arm is good.
  - If the inspection gauge **does** fit in the gap between the welds (X), the control arm is <u>bad</u> and must be replaced.

- 6. Replace any front control arms that failed inspection. Refer to Lower Control Arm Replacement in SI.
- 7. Lower the vehicle. Refer to Lifting and Jacking the Vehicle in SI.
