Product Safety Recall

N182206311 Diesel Engine Block Heater Cord

Release Date: October 2019

Condition	General Motors has decided that a defect which relates to motor vehicle safety exists in certain 2017-2019 model year Chevrolet Silverado 2500/3500 vehicles, certain 2017-2019 model year GMC Sierra 2500/3500 vehicles and certain 2019 Chevrolet Silverado 4500/5500/6500. In vehicles equipped with the Duramax diesel 6.6 liter engine and the optional engine-block heater cord, a short-circuit condition may develop in the engine-block heater cable or in the terminals that connect the heater cable to the block heater. A short-circuit condition can cause damage to engine components and, in rare cases, start a fire in the engine compartment.
Correction	For Silverado 2500/3500 and Sierra 2500/3500: Dealers are to replace the engine-block heater and cord. For Silverado 4500/5500/6500: Dealers are to replace the engine-block heater.

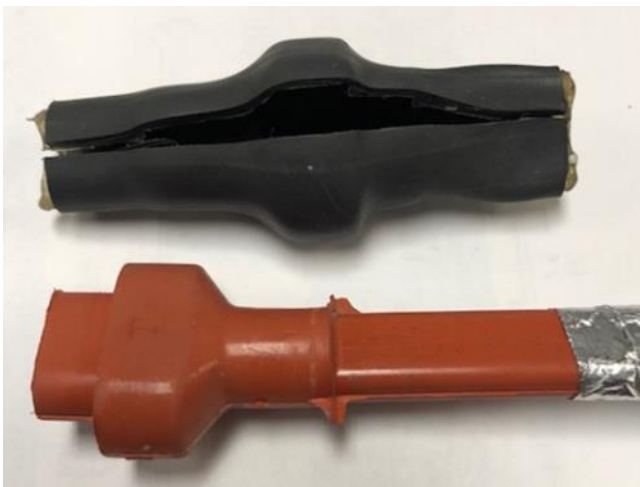
2. Using an appropriate cutting tool, carefully slice the shrink tube from the power cord. Use care to cut away from the harness itself to ensure that you do not cut into the harness or body of the connector.
3. Inspect the connector cavities and mating surface for any heat shrink tube adhesive. Carefully remove the adhesive if required.

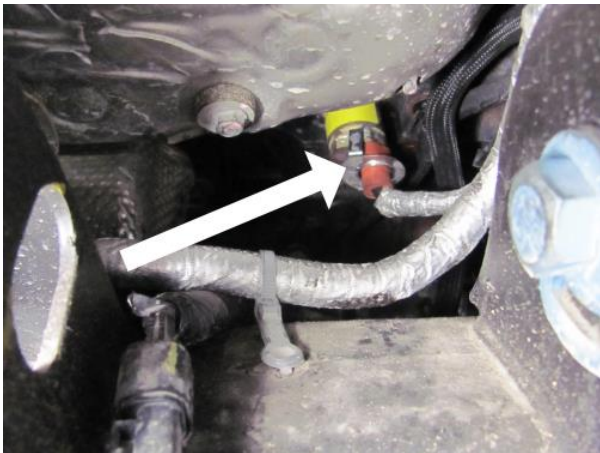
5420809

4. Looking through the area between the wheel house liner and the suspension, locate the engine block heater.
5. Disconnect the engine block heater plug from the heater element by releasing the retainer clip and unplugging.
6. Remove any existing engine heater power cord fasteners and remove the power cord. Discard the power cord.

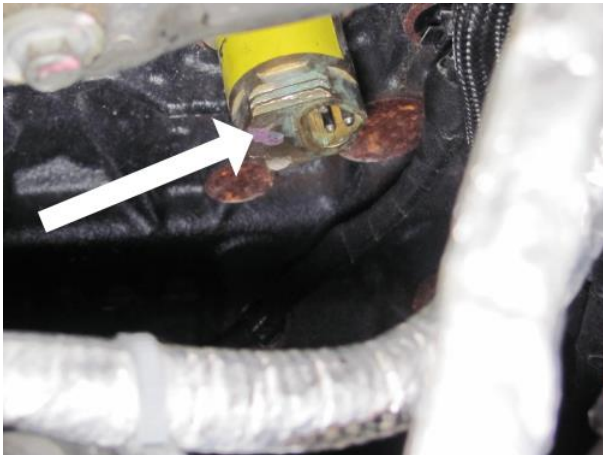
7. Place a drain pan under the vehicle to capture the coolant. Remove the engine coolant heater. Refer to *Engine Coolant Heater Replacement (L5P)* in SI.

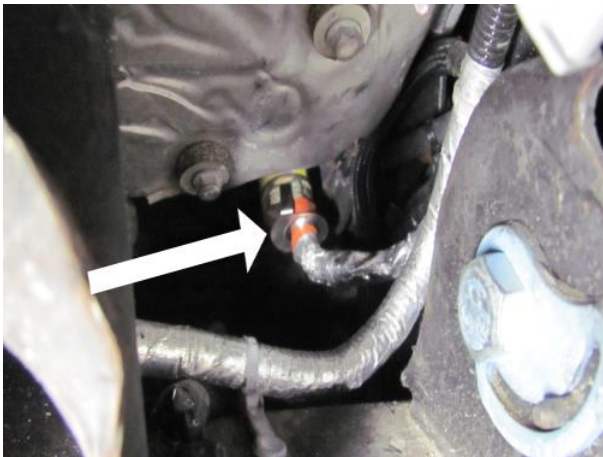
9. Plug the new engine coolant heater cord assembly into the heater and secure it with the metal clip.

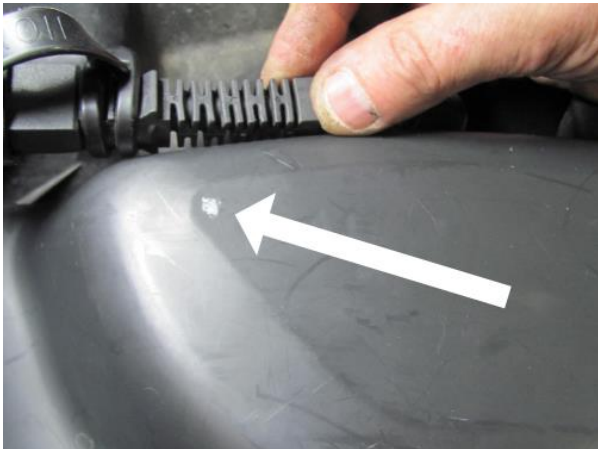
5420818

16. Locate the drill location on the front compartment site-shield. Mark the location.

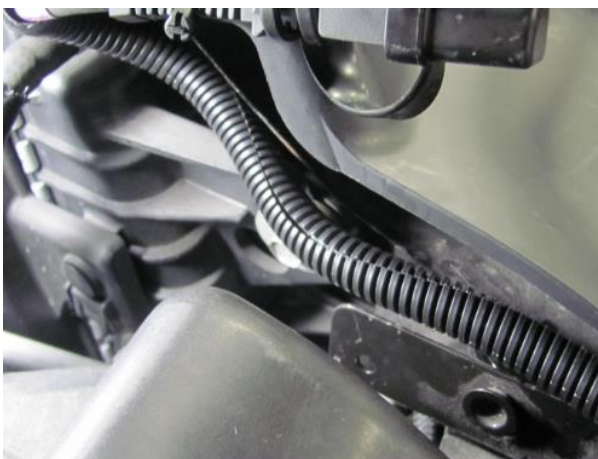
5420820

19. Create a gentle bend in the power cord and place the power cord plug over the hole in the site shield. Ensure the prongs on the power cord plug are facing toward the right fender.

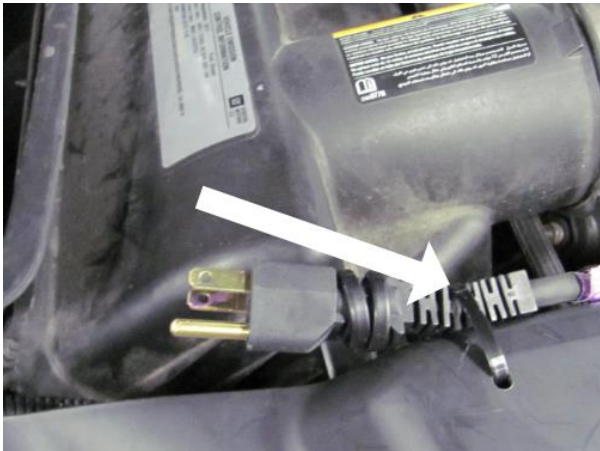
20. Secure the power cord plug to the to the front compartment shield with a wire tie as shown.

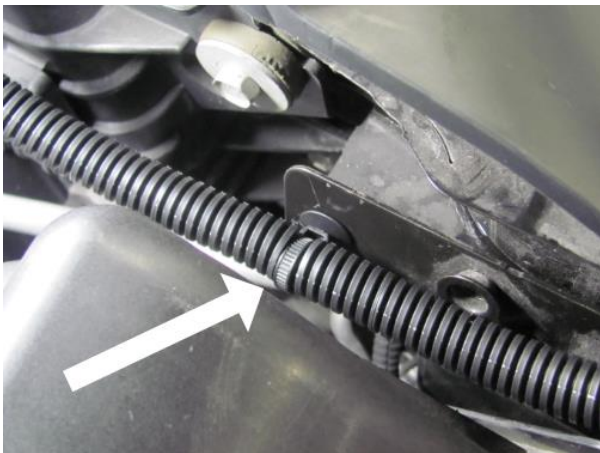
22. Position the harness up under the front compartment site shield and secure it using the second (closest to the electrical plug) push pin wire tie on the harness.
23. Trim all wire ties as necessary.
24. Fill the cooling system. Refer to *Cooling System Draining and Filling* in SI.
