F/CMVSS Noncompliance Recall

N192218960 Incorrect Rear Quarter Glass

Release Date: July 2019

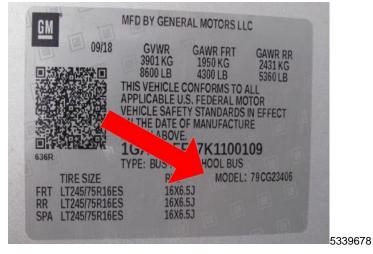
NOTE: Locate the model number on the information label positioned in the lower rear area of the driver door (example shown above only - see the correct model numbers for short and long wheel base model numbers below).
