CR180 – Breather valve kit part no.69929001A installation

1199 Superleggera Model Year 2014

1299 Superleggera Model Year 2017

Safety Recall Bulletin SRV-RCL-19-002

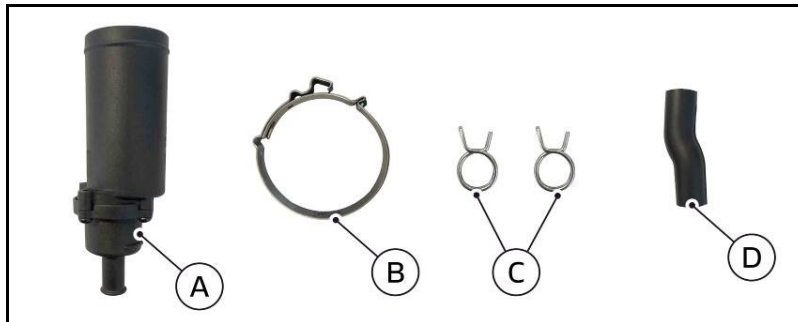
The kit part no.69929001A is made up of the following components:

Part no.	Reference	Description	Quantity
69929001A	A	Cyclone separator	1
	B	Click clamp	1
	C	Clamps	2
	D	Rubber hose	1

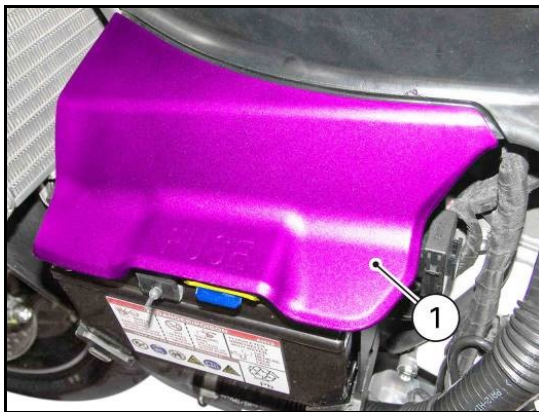
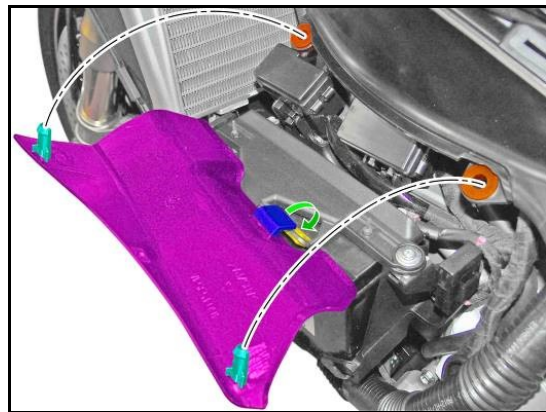
1. Position the vehicle on the rear paddock stand
2. Remove the LH side fairing (see Sec. 5: "Fairing installation – Fairing" of the Workshop Manual)
3. Remove the ignition switch cover (see Sec. 5: "Fairing installation – Headlight Fairing" of the Workshop Manual)
4. Remove both right and left air conveyer covers (see Sec. 5: "Fairing installation – Headlight Fairing" of the Workshop Manual)
5. Remove the battery cover (1)

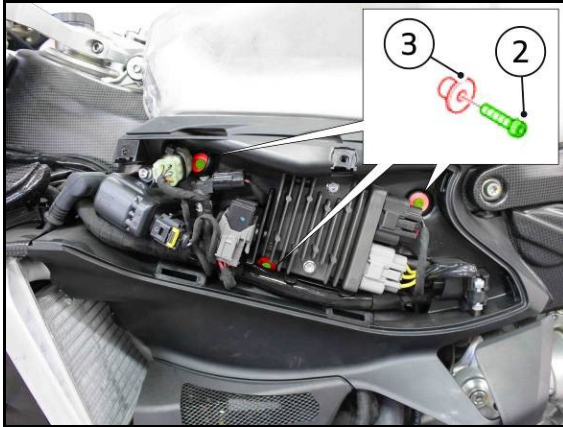
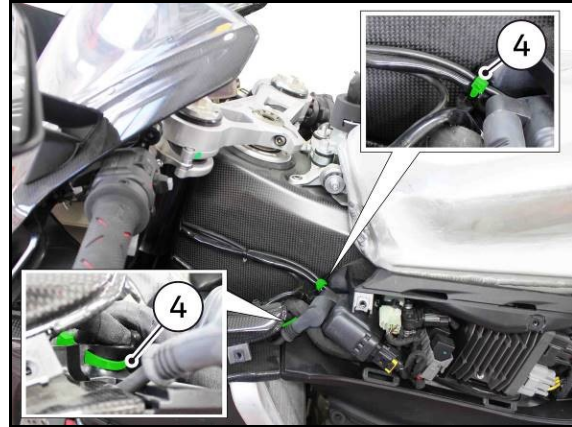
6. Remove the 3 M5x22 screws (2) and the relevant spacers (3) securing the electrical components support
7. Remove the 2 big self-locking ties (4)

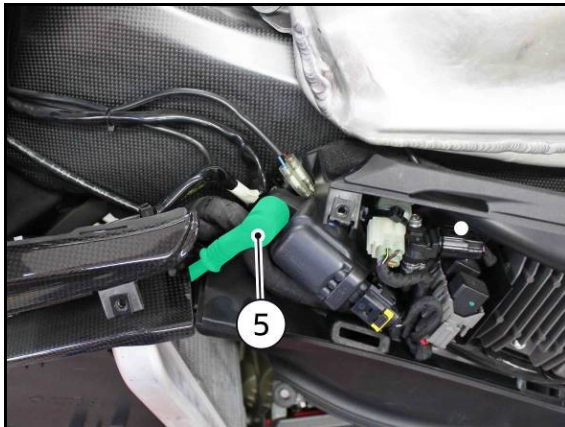
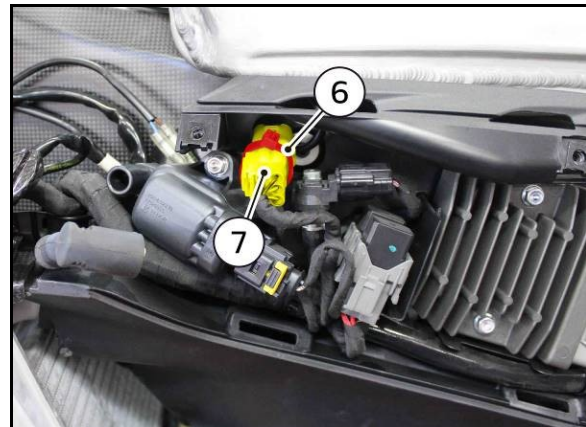
8. Disconnect the spark plug cable (5) from the horizontal cylinder coil
9. Remove the big self-locking tie (6) securing the ignition switch connector (7) to the electrical components support and disconnect the connector

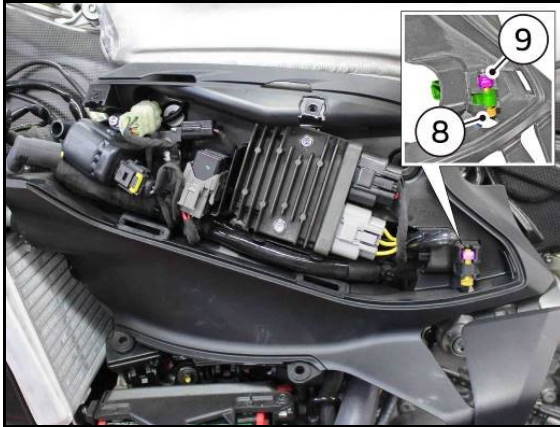
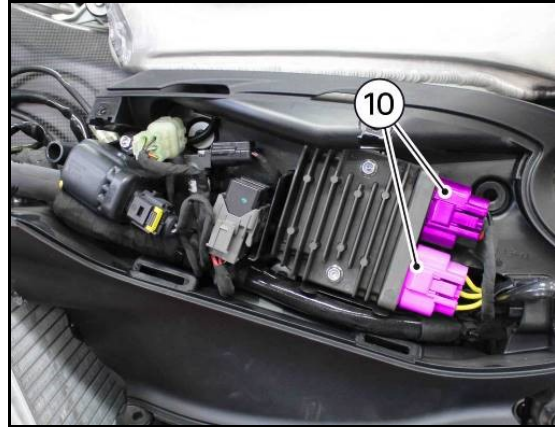
10. Remove the **M6x22 screw (8)** securing the pressure sensor to the electrical components support and slide **nut (9)** out
11. Remove the **2 connectors (10)** of the voltage regulator

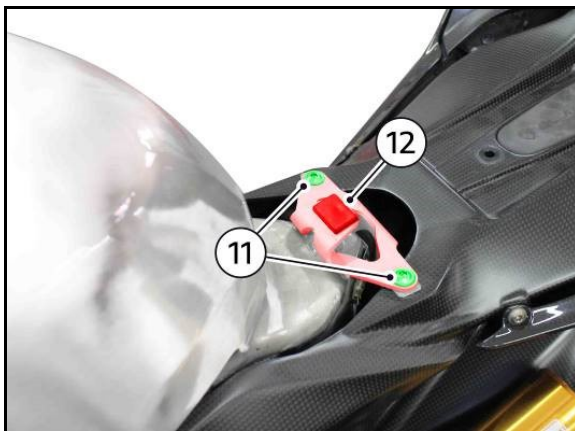
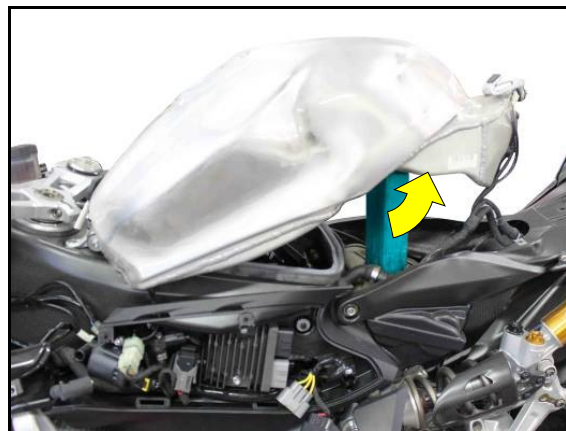
12. Remove the rider seat (see Sec.5: "Fairing installation – Seat" of the Workshop Manual)
13. Remove the **2 M6x14 screws (11)** that retain the fuel tank **bracket (12)** to the rear subframe
14. Lift the fuel tank and keep it lifted using a suitable support taking care not to damage components with the support or impinge the fuel tank into any other components, as shown in the figure

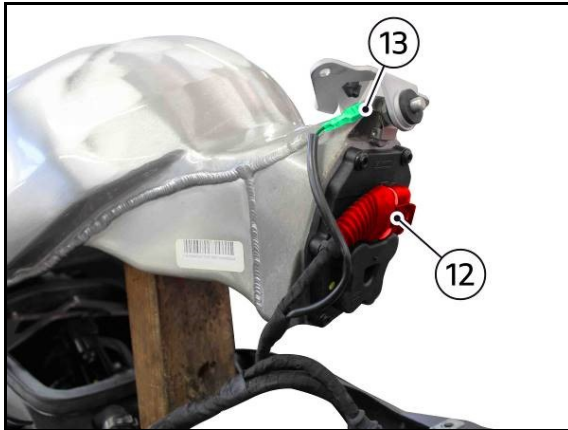
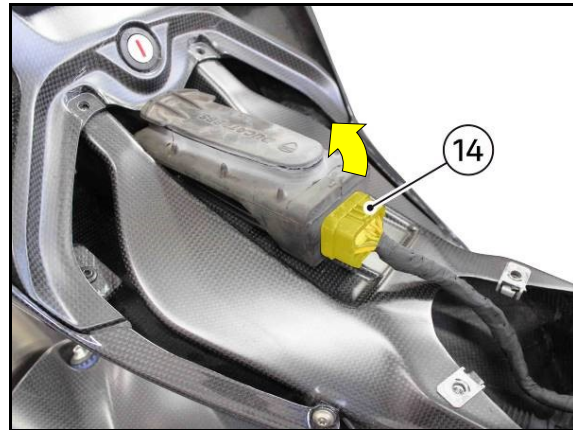
15. Disconnect fuel level sensor **connector (12)** and **ground cable (13)**

16. Release the BBS control unit from the rear subframe and disconnect **connector (14)**

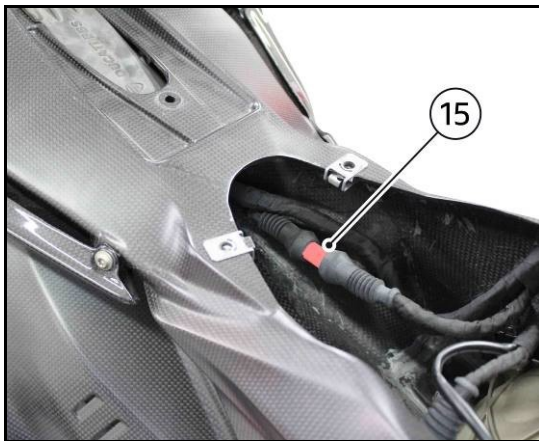
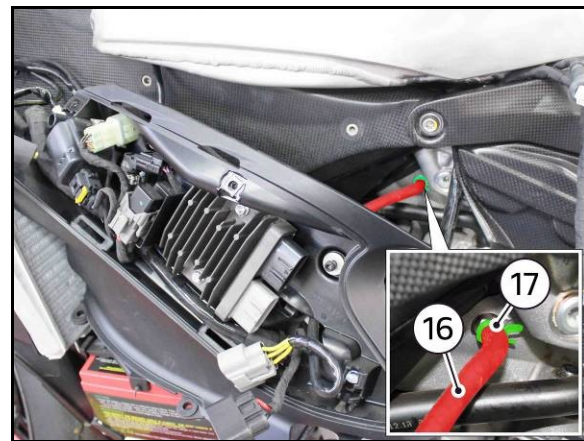
17. Disconnect the rear wiring **connector (15)**

18. Pull out the vertical head pressure sensor **hose (16)** by removing the **clamp (17)**

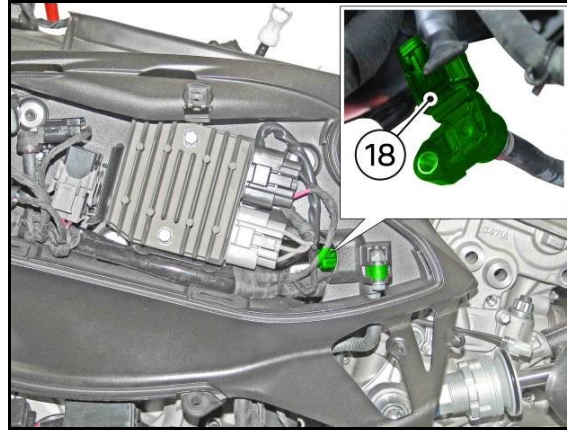
19. Disconnect vertical head pressure sensor connector (18)

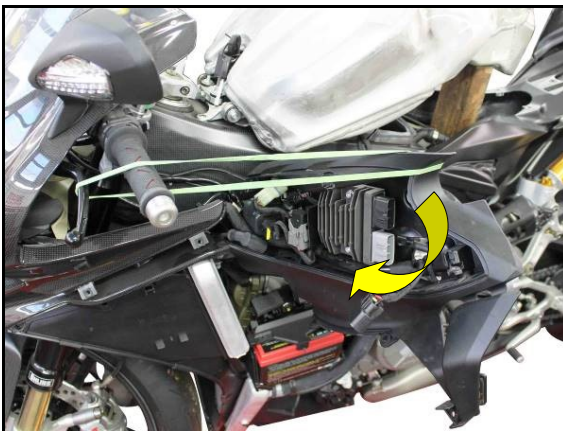
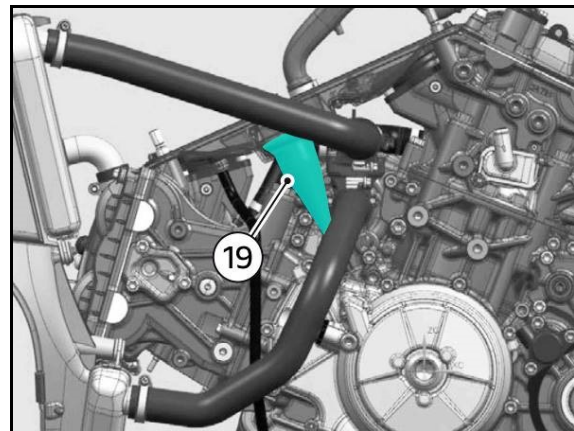
20. To access the cyclone hose (19), rotate the electrical components support towards the front side and fasten it with an elastic band, as shown in the figure

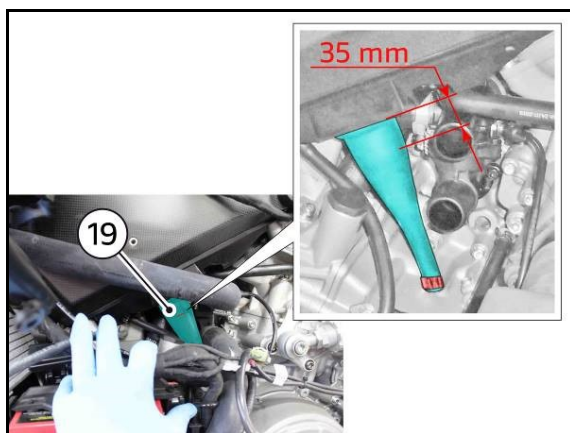
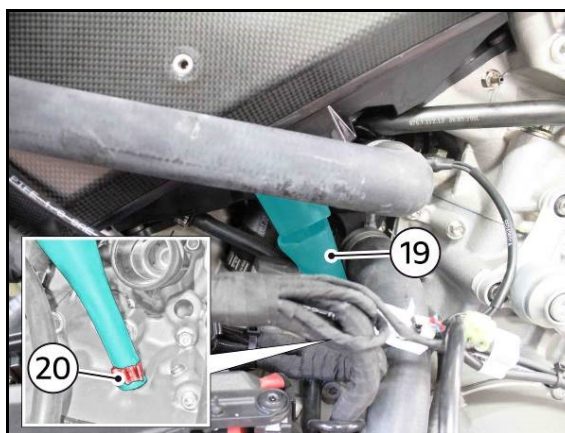
21. To install the Breather valve kit part no.69929001A it is necessary to modify the cyclone **hose (19)** installed on the vehicle.

Use a marker to make a mark on the cyclone **hose (19)** at a length of **35 mm** measured from the Airbox bottom; use a cutter or workshop scissors to cut the hose in correspondence of the mark previously made with the marker.

22. Remove the click **clamp (20)** and pull out the lower part of the cyclone **hose (19)** from the crankcase

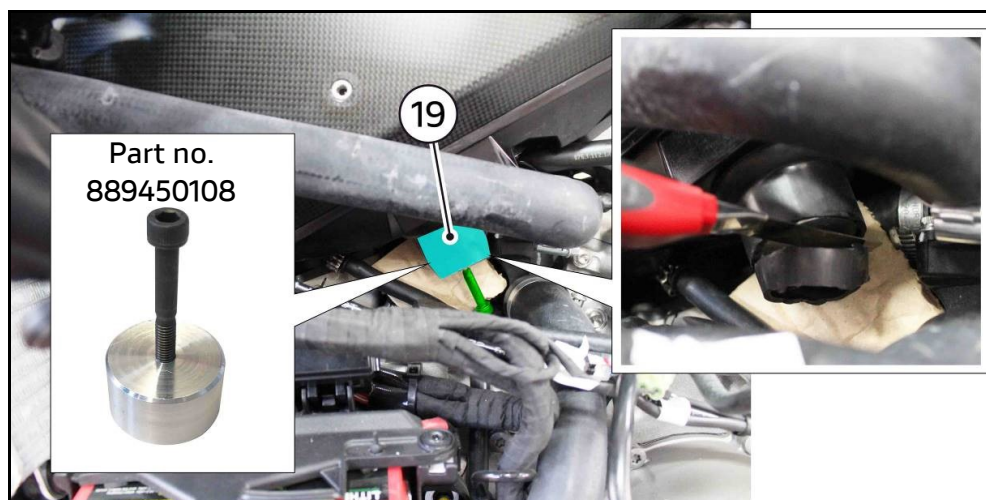
23. Take the tool part no.889450108, insert the buffer in the cyclone **hose (19)** driving it fully home and remove the excessive section of hose using a cutter.

During the trimming operation, protect the surrounding components around the cyclone hose to avoid damaging the coolant hoses

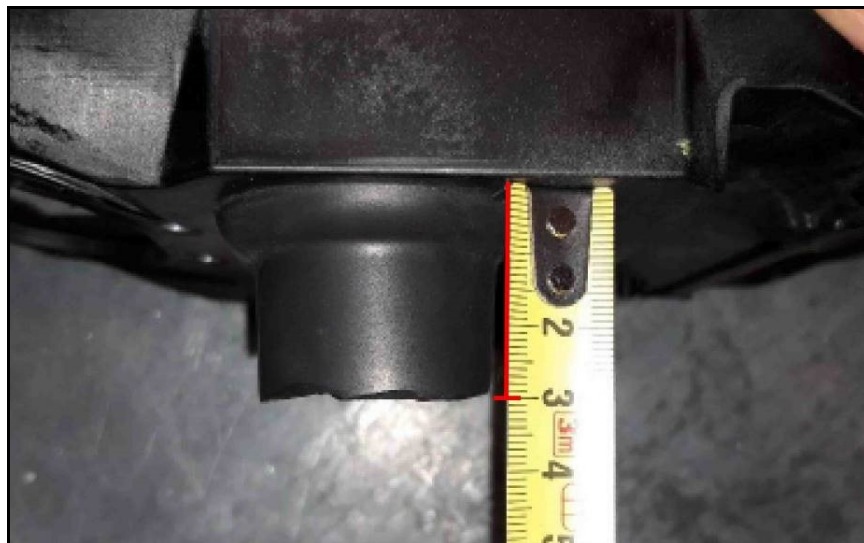
Check that the remaining length of the cyclone **hose (19)** is equal to approx. 30 mm and remove both the protection used and the tool part no.889450108.

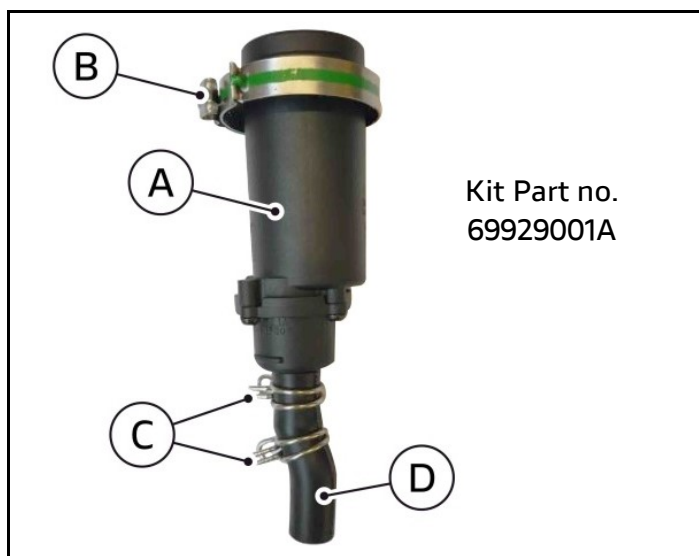
24. Take the kit part no.69929001A and assemble the **cyclone separator (A)**, the **click clamp (B)**, the **rubber hose (D)** and the **2 clamps (C)** as shown in the figure

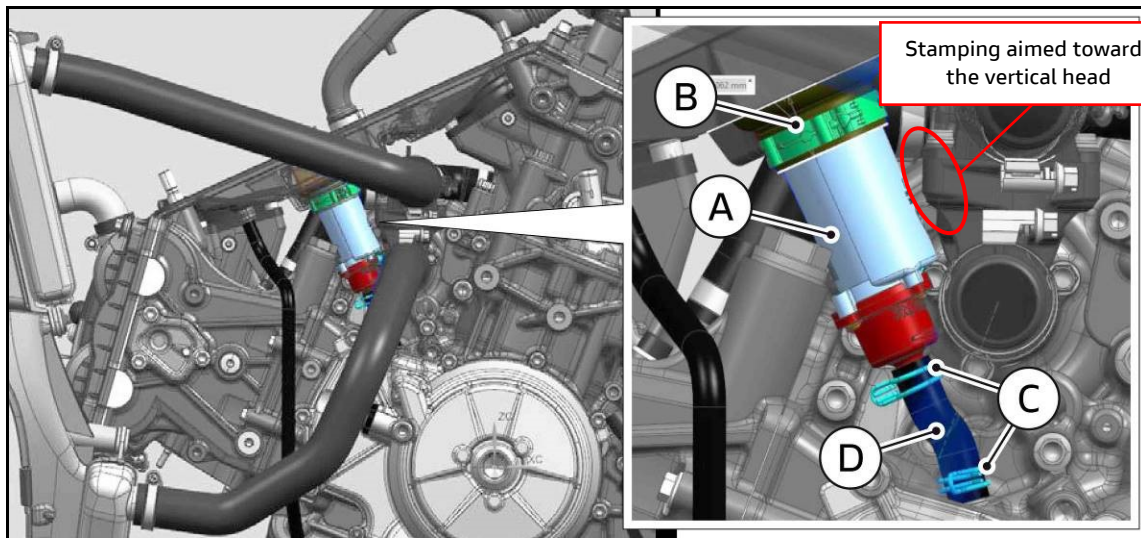
25. Install the **cyclone separator (A)** inside the cyclone hose aiming the stamping towards the vertical head, as shown in the figure. Fasten the cyclone separator using the **click clamp (B)**
26. Insert the terminal part of the **hose (D)** in the crankcase and aim the **2 clamps (C)** as shown in the figure

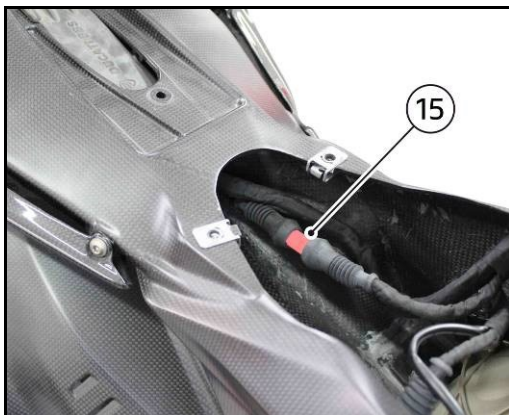
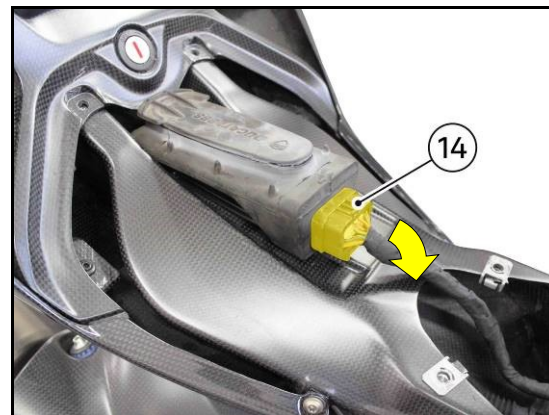
27. Remove the elastic band used to rotate the electrical components support
28. Connect the rear wiring **connector (15)**
29. Connect **connector (14)** and reposition the BBS control unit inside the rear subframe

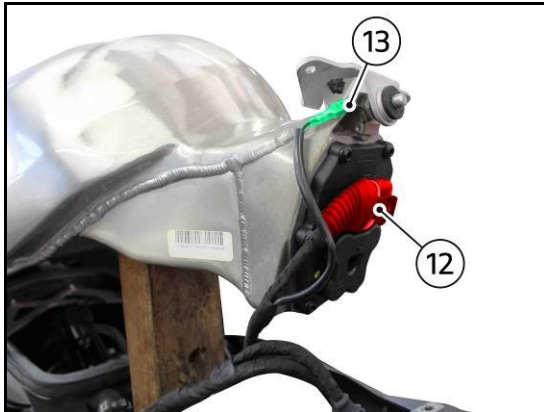
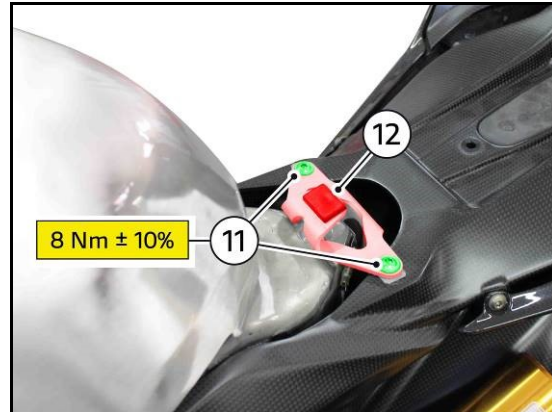
30. Connect fuel level sensor **connector (12)** and **ground cable (13)**

31. Remove the fuel tank support and fit **bracket (12)** tightening **2 M6x14 screws (11)** to **8 Nm \pm 10%**

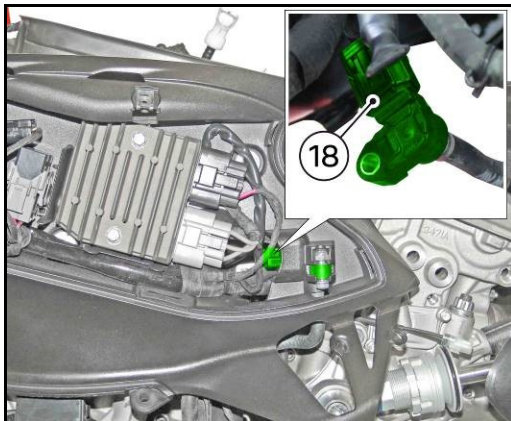
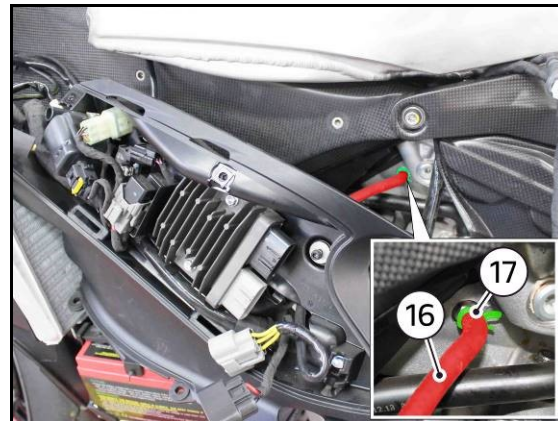
32. Connect vertical head pressure sensor **connector (18)**

33. Connect the vertical head pressure sensor **hose (16)** and fasten it with **clamp (17)** aiming it as shown in the figure

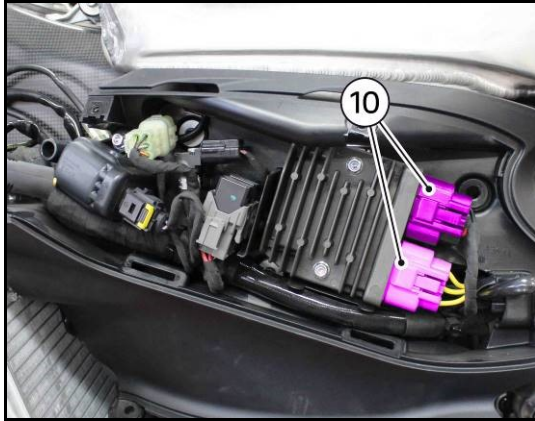
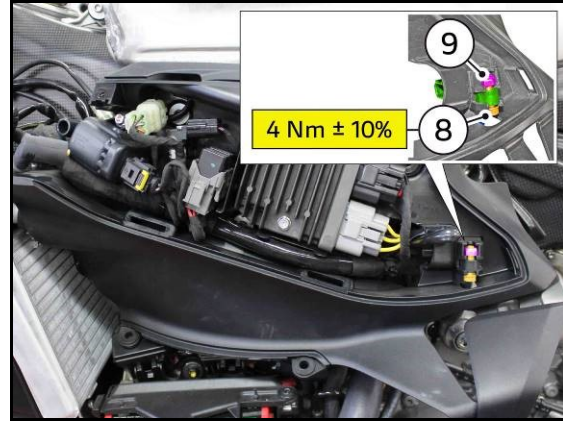
34. Fit the **2 connectors (10)** of the voltage regulator

35. Fasten the pressure sensor to the electrical components support by fitting **nut (9)** and tightening **M6x22 fastening screw (8)** to **4 Nm \pm 10%**

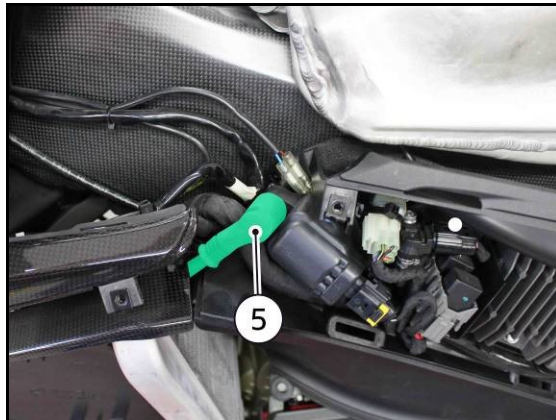
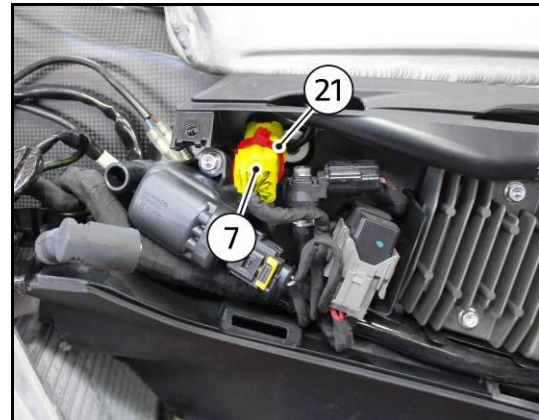
36. Connect the **spark plug cable (5)** of the horizontal cylinder coil

37. Connect ignition switch **connector (7)** and fasten it to the electrical components support using a new **self-locking tie (21)** and aim it as shown in the figure

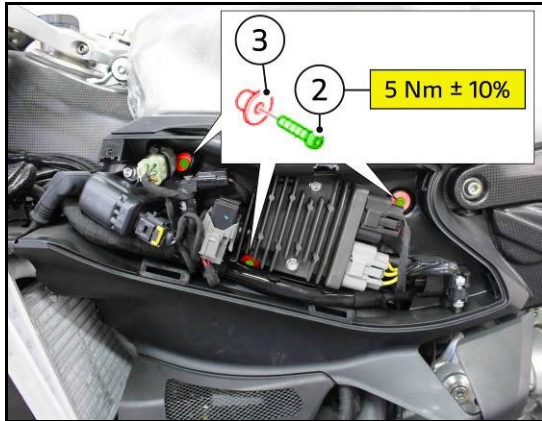
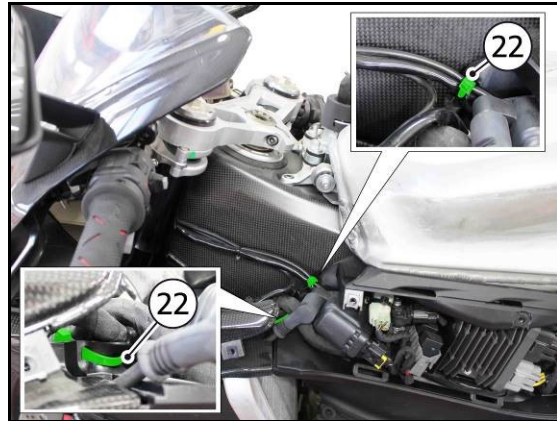
38. Install the electrical components support by starting the **3 M5x22 screws (2)** with the relevant **spacers (3)**. Tighten the **3 M5x22 screws (2)** to **5 Nm ± 10%**

39. Install the 2 new big self-locking **ties (22)** as shown in the figure

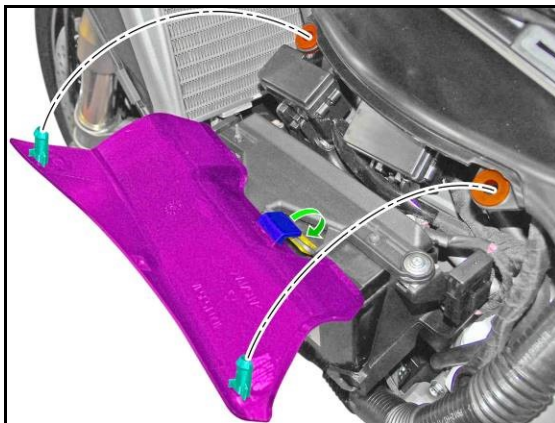
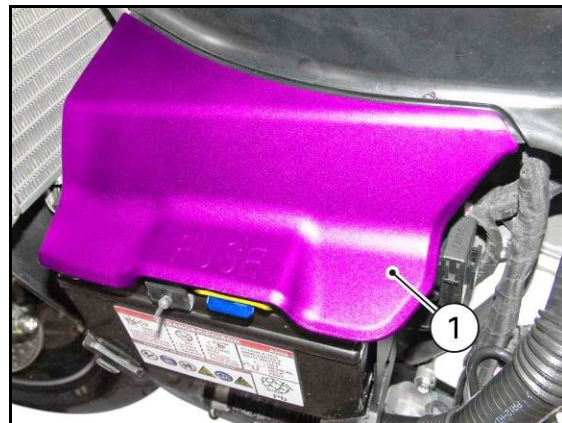
40. Install the battery **cover (1)** as shown in the figure
