Dealer Service Instructions for:

Safety Recall VB2 / NHTSA 19V-818

Engine Cooling Fan

2015-2018 (VF) Ram ProMaster

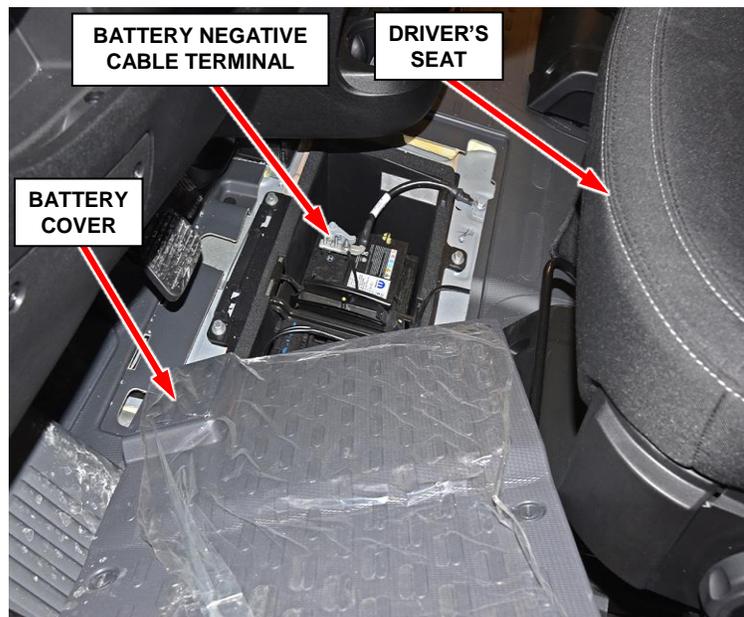
Figure 1 – Battery Cover and Negative Cable

1. Turn the ignition switch to the “Off” position. Be certain that all electrical accessories are turned off.
2. Remove the battery cover (Figure 1).
3. Loosen the battery negative cable terminal clamp then remove and isolate the negative cable terminal from the battery post (Figure 1).

41. Connect and secure the battery negative cable terminal clamp to the battery negative post (Figure 1).
42. Install the battery cover (Figure 1).
43. Start the engine and set the air conditioning (A/C) to high / maximum cold.
44. Visually verify that both fans in the engine cooling fan module are functioning. If either fan does not operate, check and ensure that the fan electrical connectors are fully connected and latched before performing further diagnosis.
45. Stow the hood prop-rod then close the hood.
46. Set the date/time on the instrument panel information center.
47. Complete the Proof of Correction form for California residents **Page 23**.
48. Return the vehicle to customer or vehicle inventory.
49. Ensure the old fan module has been rendered **UNUSABLE** and **DISCARD**.

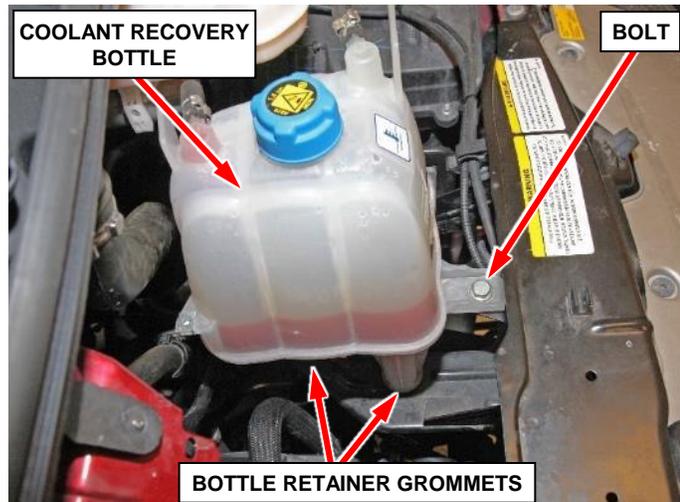
Figure 2 – Coolant Recovery Bottle

2. Remove the bolt and position aside the pressurized coolant recovery bottle (Figure 2).

27. Position the pressurized coolant recovery bottle in the proper location then install the bolt. Tighten the bolt to 12 N·m (9 ft. lbs.) (Figure 2).
28. Connect and secure the battery negative cable terminal clamp to the battery negative post (Figure 1).
29. Install a battery charger and verify that the charging rate provides 13.2 to 13.5 volts. Set the battery charger timer (if so equipped) to continuous charge.

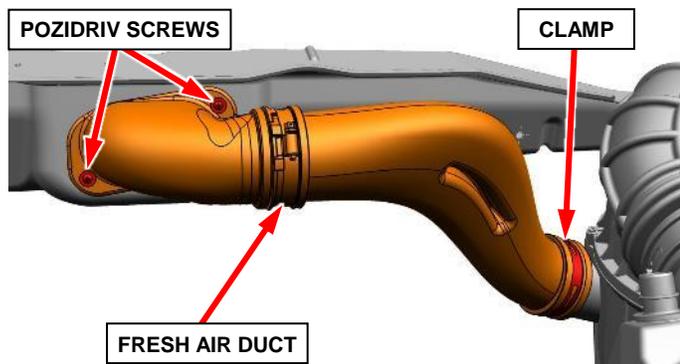
Figure 3 – Fresh Air Duct

3. Remove the two Pozidriv screws securing the fresh air duct to the upper radiator core support (Figure 3).

4. Loosen the clamp securing the fresh air duct to the air cleaner housing (Figure 3).

5. Remove the fresh air supply duct from the vehicle (Figure 3).

24. Position the fresh air duct to the vehicle (Figure 3).
25. Install the two Pozidriv screws securing the fresh air duct to the upper radiator core support, tighten securely (Figure 3).

26. Tighten the clamp securing the fresh air duct to the air cleaner housing, tighten to 5 N·m (44 in. lbs.) (Figure 3).

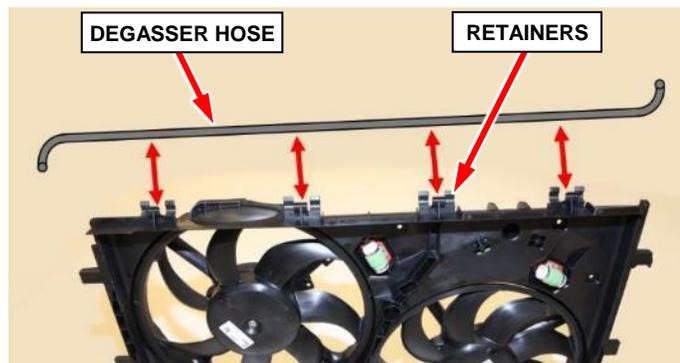
Figure 4 – Coolant Degasser Hose

6. Release the coolant degasser hose from the four retainers along the top edge of the cooling fan module then position the hose out of the way (Figure 4).

- From below or above as necessary, install the coolant recovery hose to the four retainers on the fan module (Figure 5).
23. Install the coolant degasser hose to the four retainers along the top edge of the cooling fan module (Figure 4).

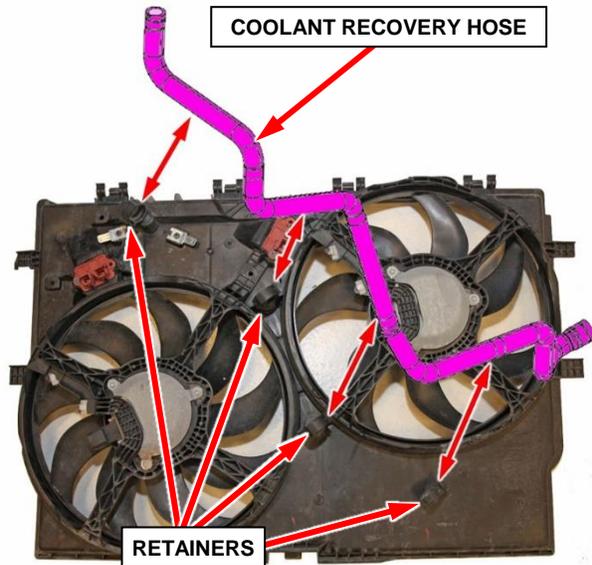
Figure 5 – Coolant Recovery Hose

- From above or below as necessary, release the coolant recovery hose from the four retainers on the fan module (Figure 5).
- From above or below as necessary, disconnect the wire harness connectors from the cooling fan relays (1), the resistors (2) and the cooling fan motors (3) (Figure 6).
- From above or below as necessary, separate the wire harness (1) retainers from the cooling fan shroud (Figure 7).

14. As necessary, transfer any coolant recovery hose retainers from the old cooling fan module to the **NEW** cooling fan module (Figure 5).

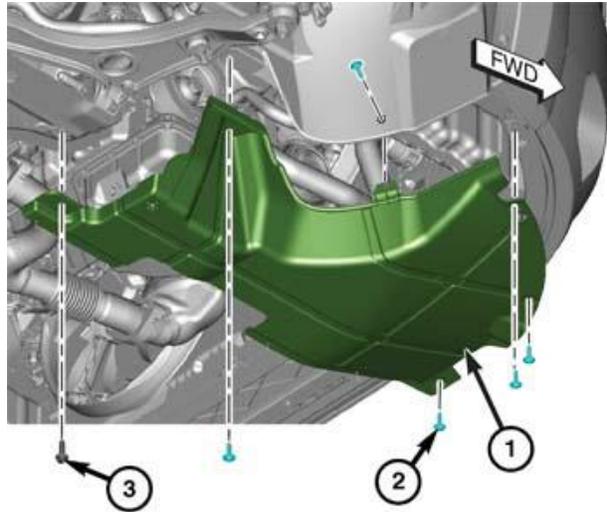
Figure 8 – Right Side Underbody Shield

9. Remove the fastener (3) that secures the right side underbody shield (1) to the cradle (Figure 8).
10. Remove the five fasteners (2) that secure the right side underbody shield (1) to the fascia and wheel liner (Figure 8).
11. Remove the right side underbody shield (1) from the vehicle (Figure 8).

19. Install the right side underbody shield (1) to the vehicle (Figure 8).
20. Install the five fasteners (2) that secure the right side underbody shield (1) to the fascia and wheel liner, tighten securely (Figure 8).

21. Install the fastener (3) that secures the right side underbody shield (1) to the cradle, tighten to 20 N·m (15 ft lbs). (Figure 8).
22. The following cooling fan module steps may be performed together; some connectors or retainers may be more easily accessible from above or below. Connect any that are accessible from below first then lower the vehicle to access those accessible from above (Figures 5 through 7).

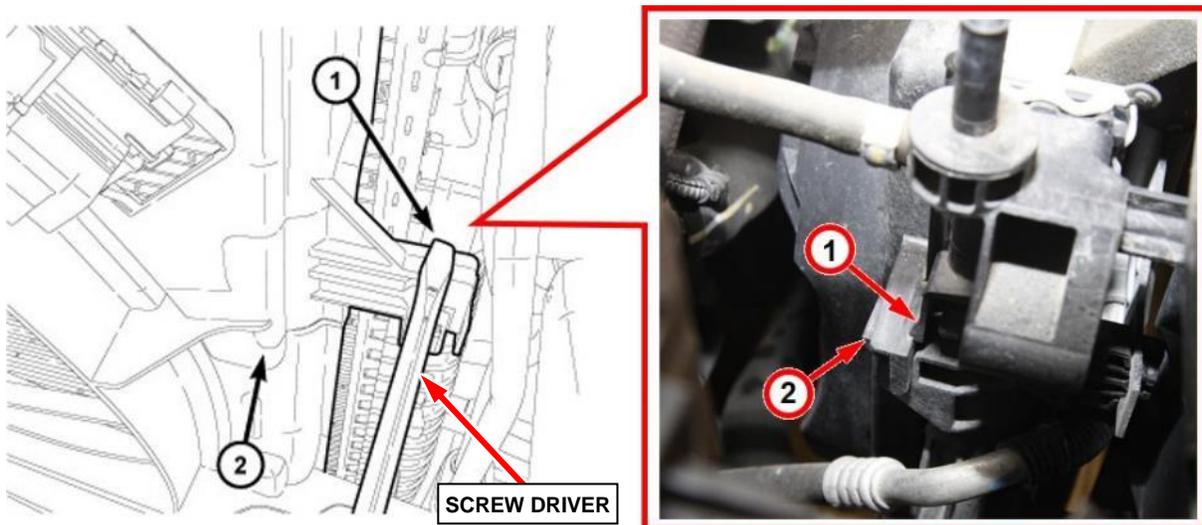
Figure 9 – Cooling Fan Module Mount Retaining Clip

12. From above or below as necessary for access, on each side of the cooling fan module, use a screwdriver or equivalent tool to depress the retaining clip (1) then lift upward to release the cooling fan module (2) from the mounts (Figure 9).

NOTE: The retaining clips (1) are only present on the upper right and upper left cooling fan module mounts. The lower right and lower left cooling fan module mounts do not have a retaining clips (Figure 9).

18. Position the cooling fan module (2) into the four mounting locations. Push the cooling fan module downward into the mounts and ensure to fully engage the two retaining clips (1) that are only present on the upper right side and upper left side cooling fan module mounts (Figure 9).

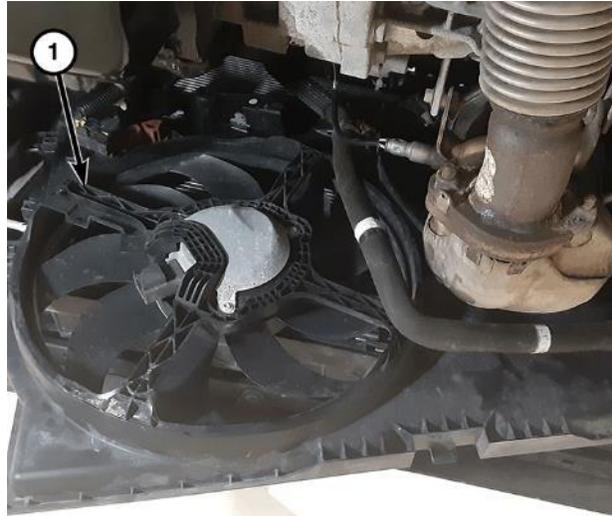
Figure 10 – Cooling Fan Module

13. Remove the cooling fan module (1) from the bottom of the vehicle (Figure 10).

17. Install the **NEW** cooling fan module (1) to the vehicle from the bottom (Figure 10).

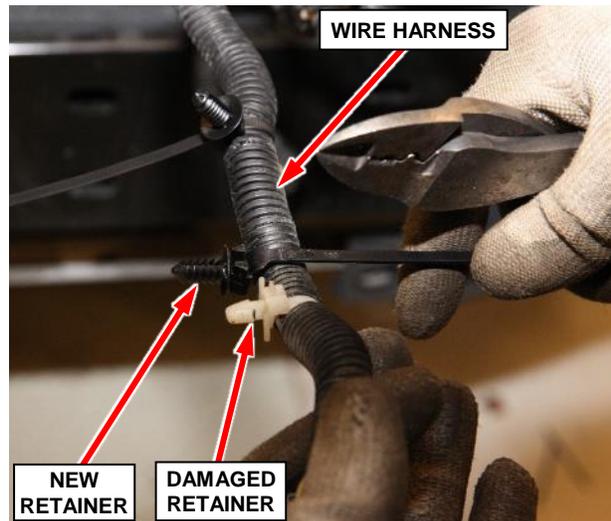
Figure 11 – Wire Harness Retainers

16. Replace any damaged retainers on the cooling fan module wire harness. Install the replacement retainers in the same location and direction as the original retainer (Figure 11).

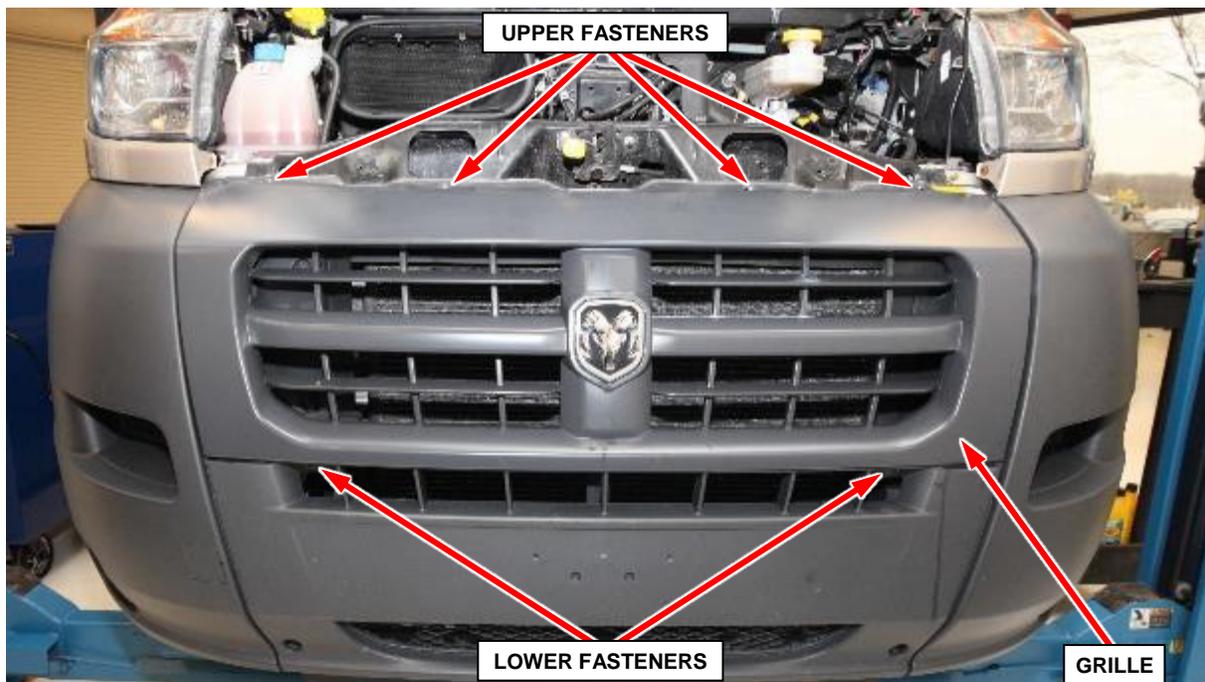
Figure 12 – Radiator Grille

1. Open and support the hood.
2. Remove the two lower fasteners securing the radiator grille (Figure 12).
3. Remove the four upper fasteners securing the radiator grille (Figure 12).
4. Remove the radiator grille from the vehicle (Figure 12).

37. Install the two lower fasteners securing the center bumper fascia and tighten securely (Figure 13).
38. Position the radiator grille to the vehicle (Figure 12).

39. Install the four upper fasteners securing the radiator grille and tighten securely (Figure 12).
40. Install the two lower fasteners securing the radiator grille and tighten securely (Figure 12).

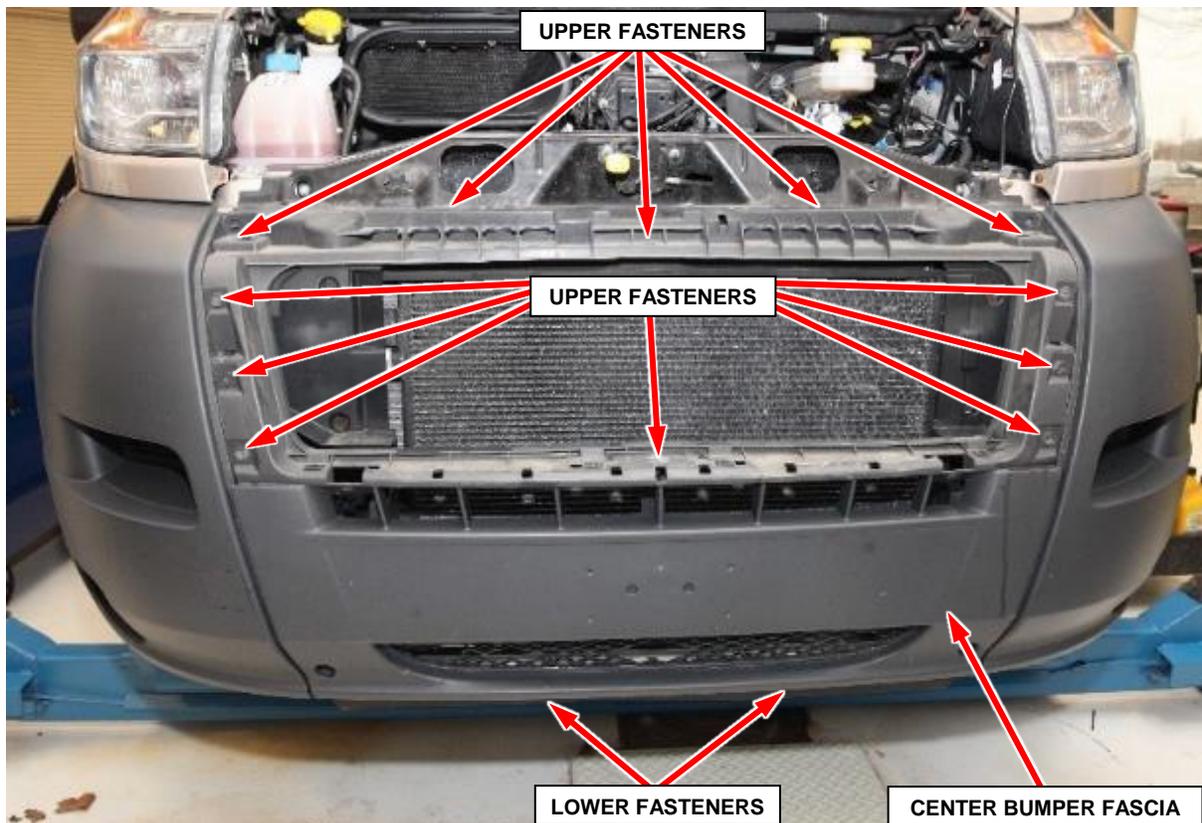
Figure 13 – Front Center Bumper Fascia

5. Remove the two lower fasteners securing the center bumper fascia (Figure 13).
6. Remove the twelve upper fasteners securing the center bumper fascia (Figure 13).
7. Remove the center bumper fascia from the vehicle (Figure 13).

34. Connect the fresh air duct and secure the band clamp (Figure 14).
35. Position the center bumper fascia to the vehicle (Figure 13).
36. Install the twelve upper fasteners securing the center bumper fascia and tighten securely (Figure 13).

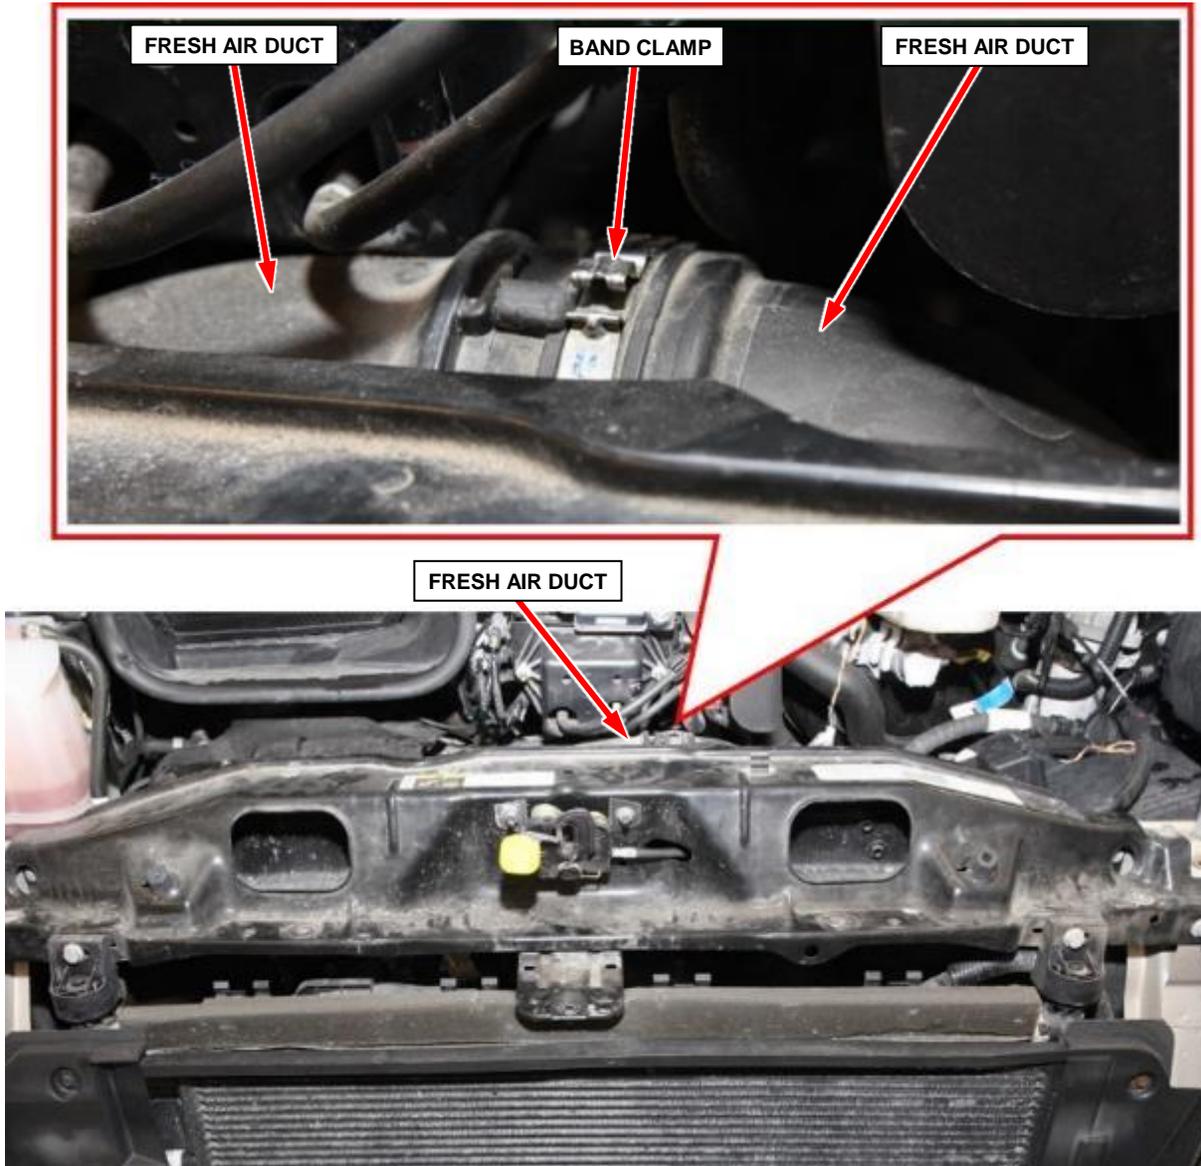
Figure 14 – Fresh Air Duct Band Clamp

8. Release the band clamp then separate the fresh air duct connection (Figure 14).

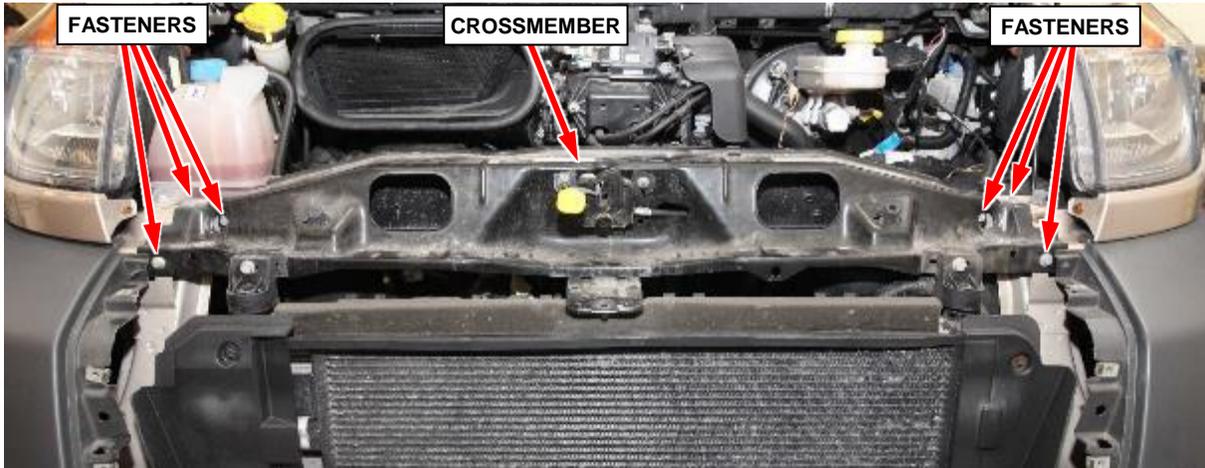
Figure 15 – Upper Radiator Crossmember

9. Remove the six fasteners securing the upper radiator crossmember (Figure 15).

10. Reposition the upper radiator crossmember and secure it to the hood hinges (Figure 15).

32. Position the upper radiator crossmember back in its proper location (Figure 15).
33. Install the six fasteners securing the upper radiator crossmember. Tighten the fasteners to 45 N·m (33 ft. lbs.) (Figure 15).

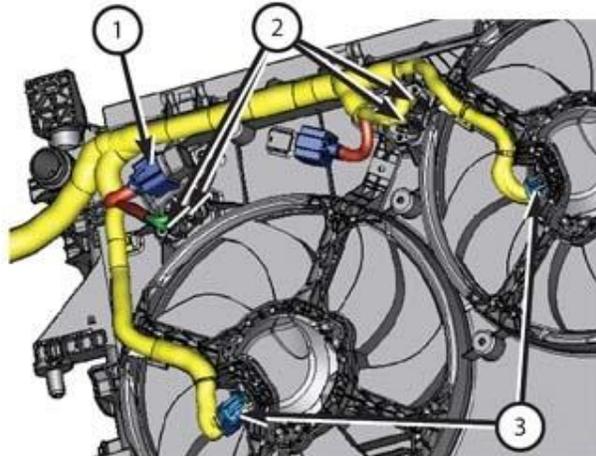
Figure 17 – Coolant Recovery Hose

- From above or below as necessary, disconnect the wire harness connectors from the cooling fan relays (1), the resistors (2) and the cooling fan motors (3) (Figure 17).

- From below or above as necessary, install the wire harness (1) retainers to the cooling fan shroud (Figure 18).
 - From below or above as necessary, connect the wire harness connectors to the cooling fan relays (1), the resistors (2) and the cooling fan motors (3) (Figure 17). **NOTE: Ensure the connectors are fully connected.**

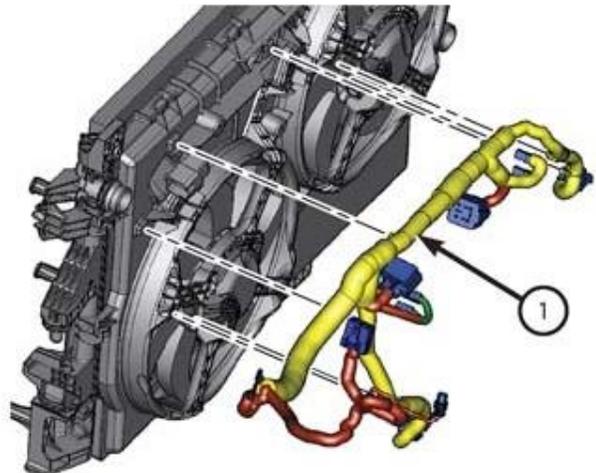
Figure 18 – Coolant Recovery Hose

- From above or below as necessary, separate the wire harness (1) retainers from the cooling fan shroud (Figure 18).

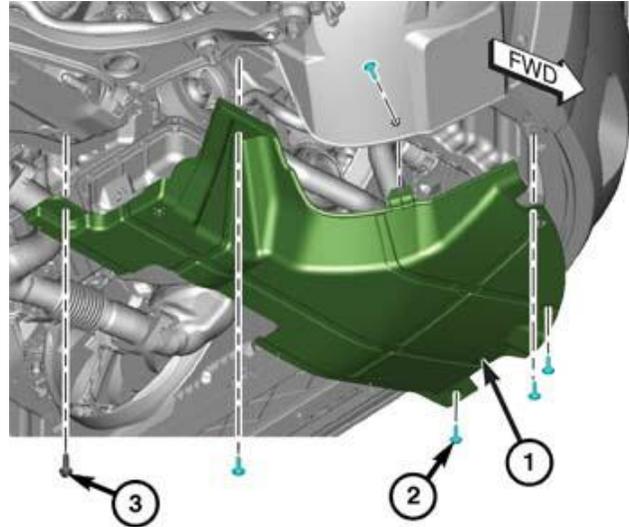
Figure 19 – Right Side Underbody Shield

13. Remove the fastener (3) that secures the right side underbody shield (1) to the cradle (Figure 19).

14. Remove the five fasteners (2) that secure the right side underbody shield (1) to the fascia and wheel liner (Figure 19).

15. Remove the right side underbody shield (1) from the vehicle (Figure 19).

28. Install the right side underbody shield (1) to the vehicle (Figure 19).

29. Install the five fasteners (2) that secure the right side underbody shield (1) to the fascia and wheel liner, tighten securely (Figure 19).

30. Install the fastener (3) that secures the right side underbody shield (1) to the cradle, tighten to 20 N·m (15 ft lbs). (Figure 19).

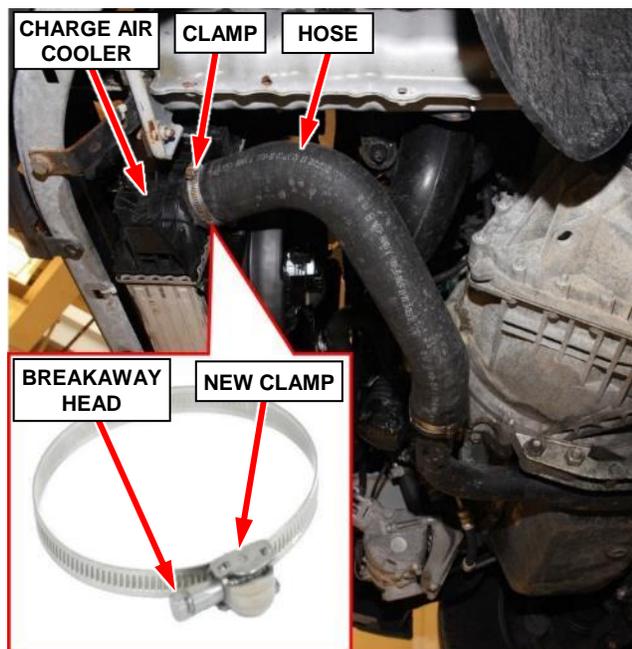
Figure 20 – Charge Air Cooler Hose

16. Release the hose clamp from the lower charge air cooler hose. A **NEW** hose clamp is supplied with this campaign (Figure 20).

17. Disconnect the lower charge air cooler hose from the charge air cooler (Figure 20).

18. Remove and **DISCARD** the old clamp from the charge air cooler hose (Figure 20).

25. Install a **NEW** hose clamp on the lower charge air cooler hose (Figure 20).

26. Connect the lower charge air cooler hose to the charge air cooler (Figure 20).

27. Tighten the **NEW** hose clamp until the outer breakaway head snaps off, this will set the clamp to the proper torque specification, no further tightening is needed. Clamp head breakaway torque is approximately 3 N·m (27 in. lbs.) (Figure 20).

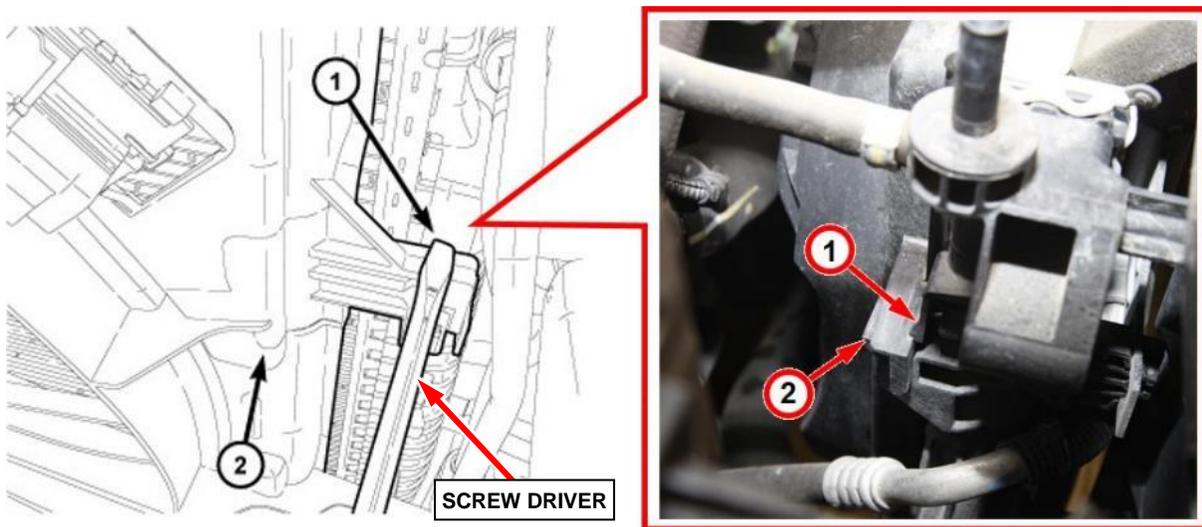
Figure 21 – Cooling Fan Module Mount Retaining Clip

19. From above or below as necessary for access, on each side of the cooling fan module, use a screwdriver or equivalent to depress the retaining clip (1) then lift upward to release the cooling fan module (2) from the mounts (Figure 21).

NOTE: The retaining clips (1) are only present on the upper right and upper left cooling fan module mounts. The lower right and lower left cooling fan module mounts do not have a retaining clips (Figure 21).

24. Position the cooling fan module (2) into the four mounting locations. Push the cooling fan module downward into the mounts and ensure to fully engage the two retaining clips (1) that are only present on the upper right side and upper left side cooling fan module mounts (Figure 21).

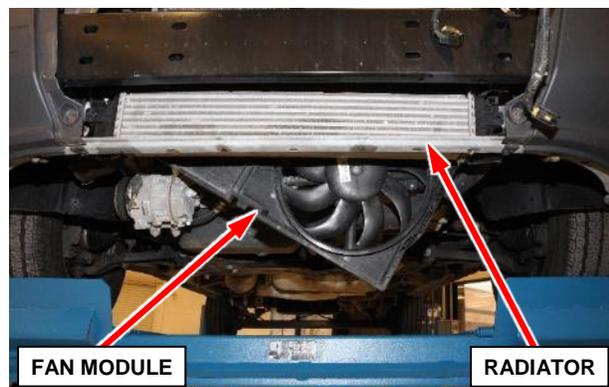
Figure 22 – Cooling Fan Module

20. Remove the cooling fan module from the bottom of the vehicle (Figure 22).

23. Install the **NEW** cooling fan module to the vehicle from the bottom (Figure 22).

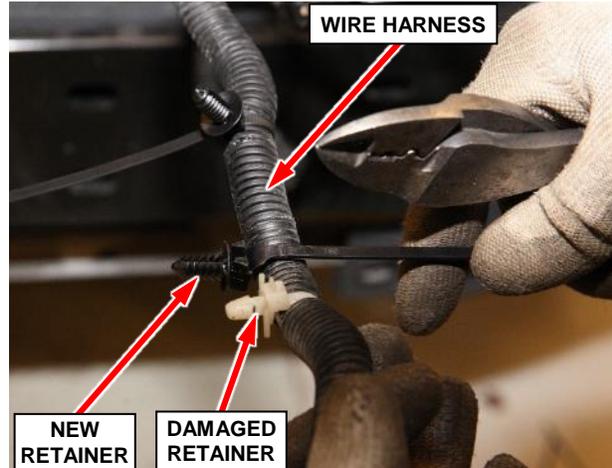
Figure 23 – Wire Harness Retainers

22. Replace any damaged retainers on the cooling fan module wire harness. Install the replacement retainers in the same location and direction as the original retainer (Figure 23).
