Subject: **3 New Takata Recalls (Effective Today, January 16, 2020)**

SIB 65 03 20

RECALL CAMPAIGN 20V-017: REPLACE DRIVER'S FRONT AIR BAG MODULE

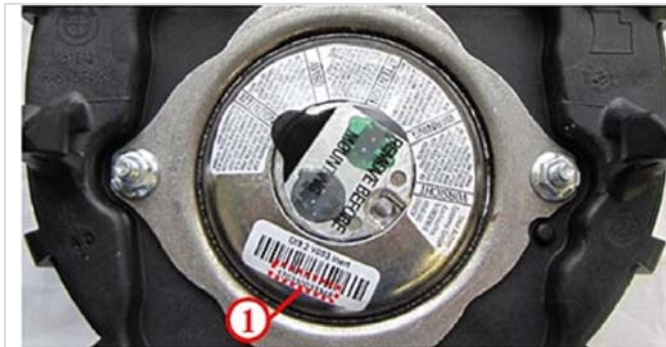
It is necessary to document which gas generator goes into which vehicle. Therefore, the technician is required to note on the repair order the serial number of the new gas generator. The serial number should also be entered into the warranty claims comment section. The serial number can be found on the gas generator below the barcode.

Serial Number location (1).

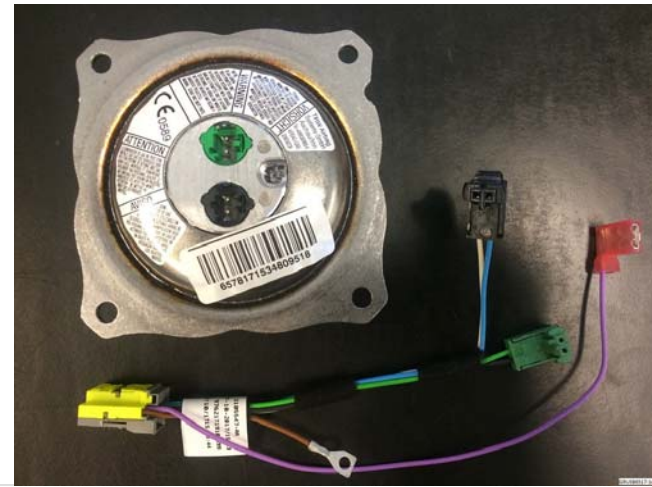
The new Repair Kit gas generator P/N 32 30 6 888 429 is installed utilizing a new jumper wiring harness that is installed between the generator and the steering wheel assembly.

Note: This harness **MUST BE USED** with this generator!

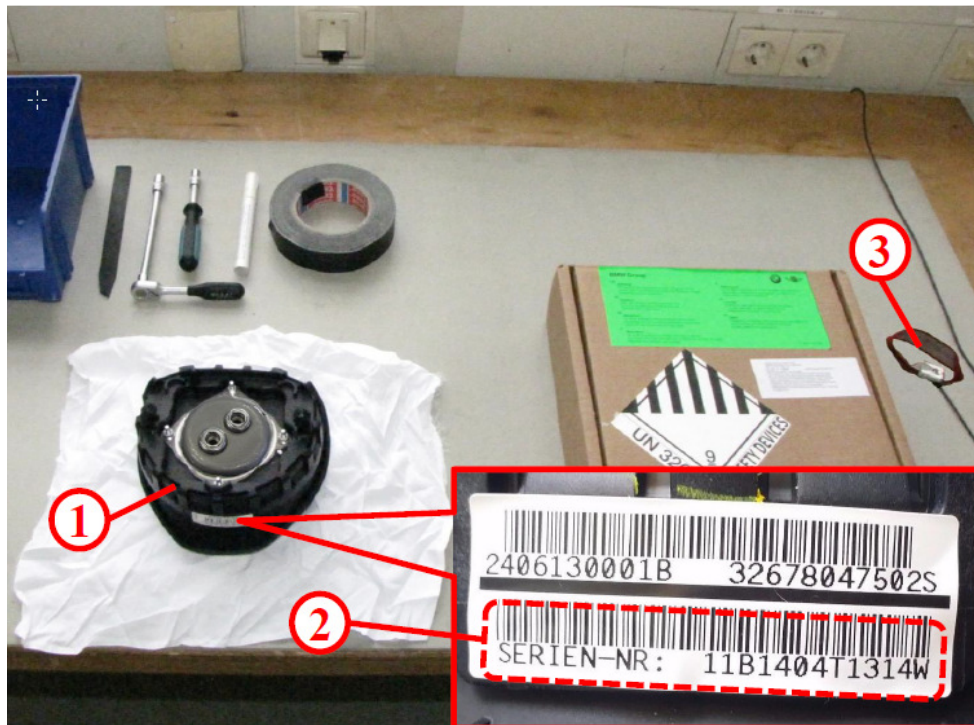
Tools required (4) for the Generator exchange:

- Plastic bone tool (SWZ 0 490 539)
- Ratchet with extension and 8 mm socket
- Small torque wrench with 8 mm socket (5 NM)
- Felt tip marker (sharpie)
- Duct tape (.25 mm wide)

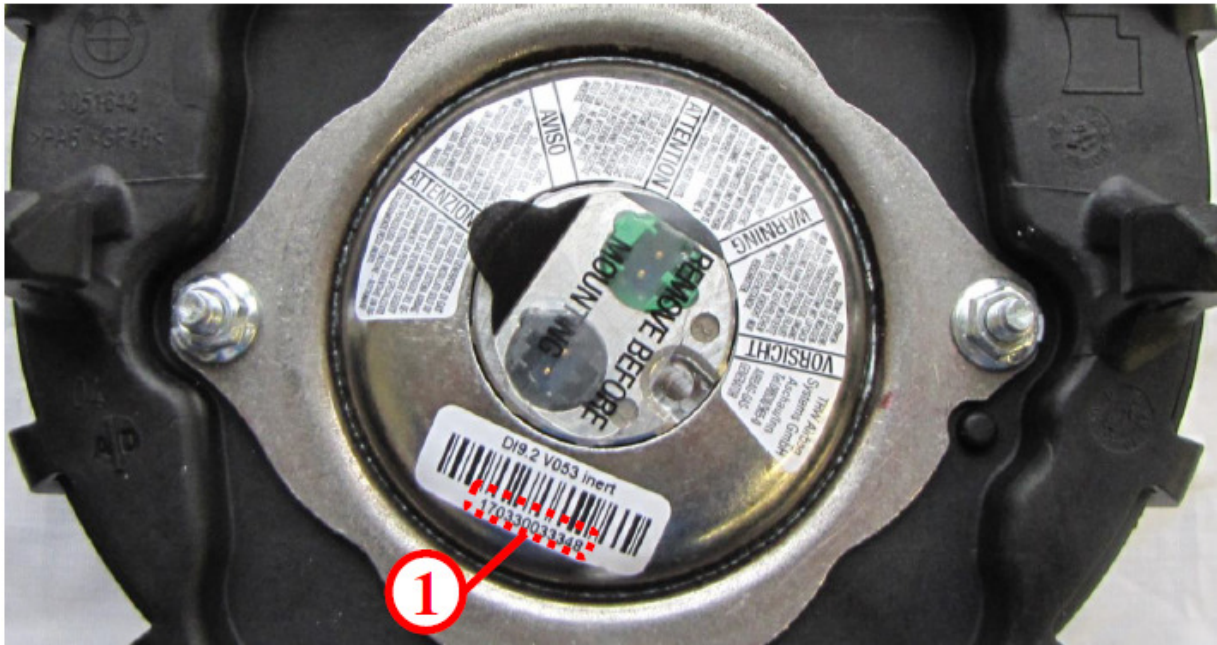
[18] Note serial number of the new Air Bag unit (1) on the Repair Order.

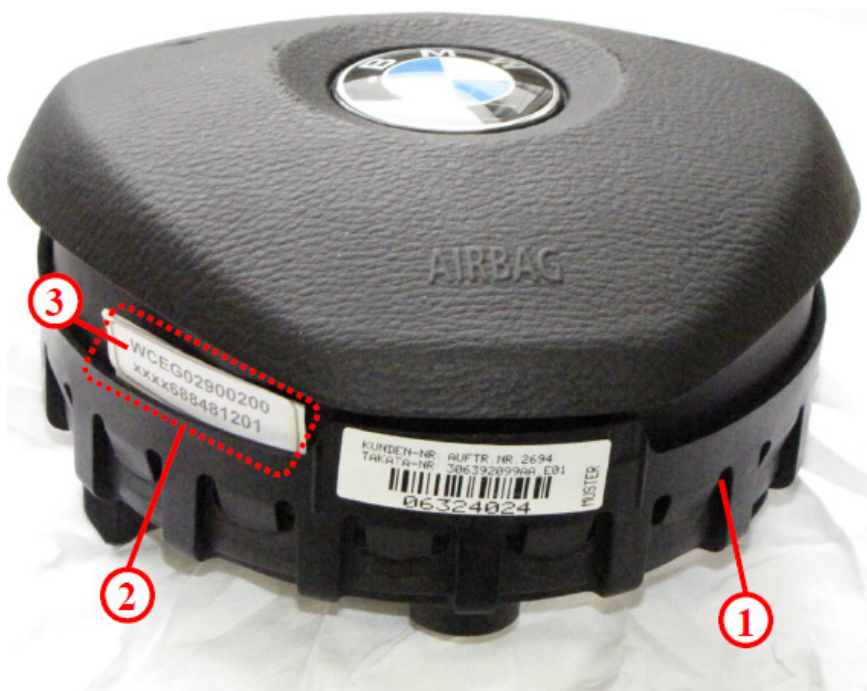
[18] Remove the 2 supplied stickers [18] Place the 1st airbag sticker onto the Air Bag in location (2) shown.

The 2nd serial number sticker of the new Generator must be placed on the Repair Order

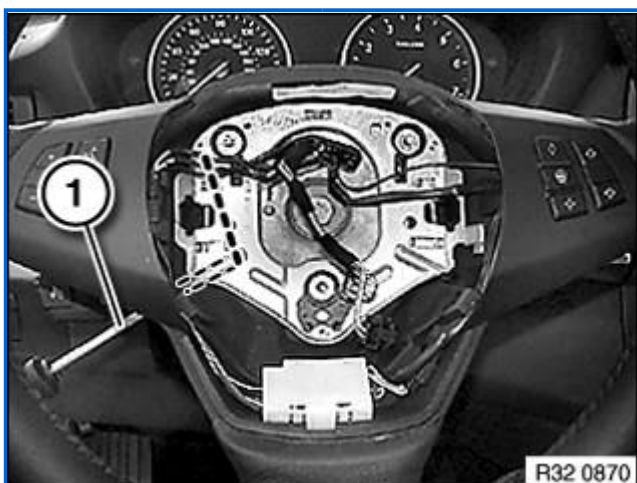
Insert Torx screwdriver T30 (1) at an angle into concealed opening on reverse side of steering wheel until a spring resistance is felt (approx. 2 cm).

Increase pressure with Torx screwdriver T30 (1) on spring leg until airbag unit is unlocked.

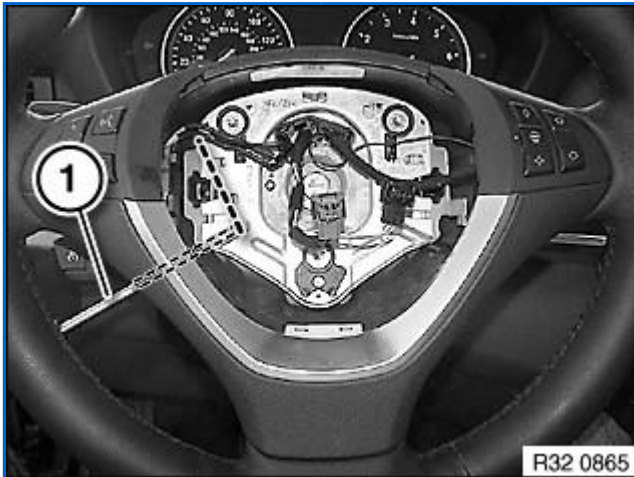
Insert Torx screwdriver T30 (1) at an angle into concealed opening on reverse side of steering wheel until a spring resistance is felt (approx. 2 cm).

Increase pressure with Torx screwdriver T30 (1) on spring leg until airbag unit is unlocked.
