TO: Mercedes-Benz Dealer Principals, General Managers, Sales Managers, Service Managers, Parts Managers	FROM: Gregory Gunther, Department Manager, Vehicle Compliance and Analysis, Engineering Services
RE: <b>Recall Campaign Launch Notification</b> <b>Check Differential Locking System</b> <b>MY19-20 463(G-Class)</b>	DATE: August 14, 2020

**Check Differential Locking System**

SUBJECT: **Model G-Class vehicles (463 platform)**  
**Model Year 2019-2020**  
**Check Differential Locking System**

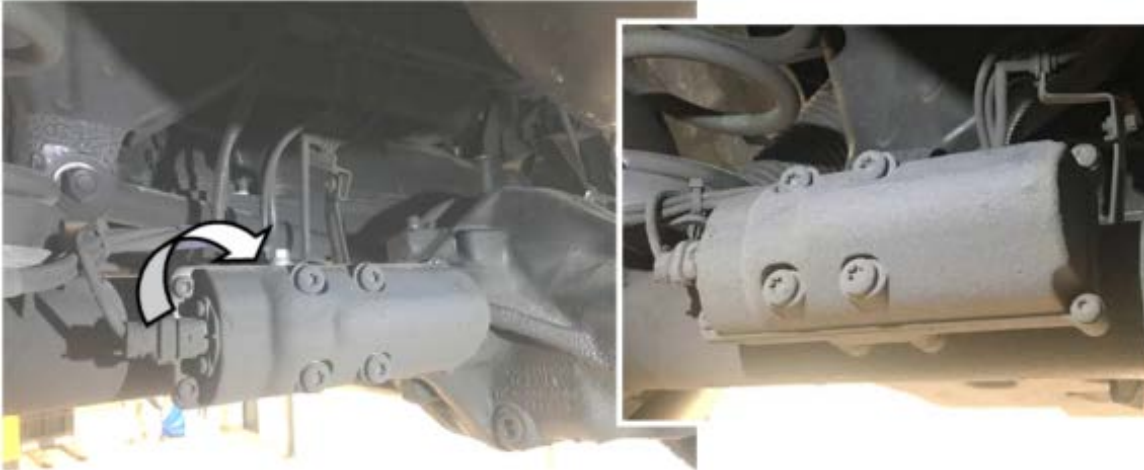
Figure 2

3. Check part number at top at actuator of differential lock of **rear axle** using a mirror (**Figure 2**).

**i** No actuator with the part number **A 463 906 34 01** may be installed.

**i** If part number of actuator at rear axle cannot be read off due to undercoat / paint coat or parts sticker is no longer legible, the actuator will be replaced.

- a. Part number **illegible** or **corresponds to A 463 906 33 01** and/or **A 463 906 34 01**: Perform **work procedure**.
- b. Part number does **NOT** correspond to **A 463 906 33 01** and does **NOT** correspond to **A 463 906 34 01**: **End measure**.

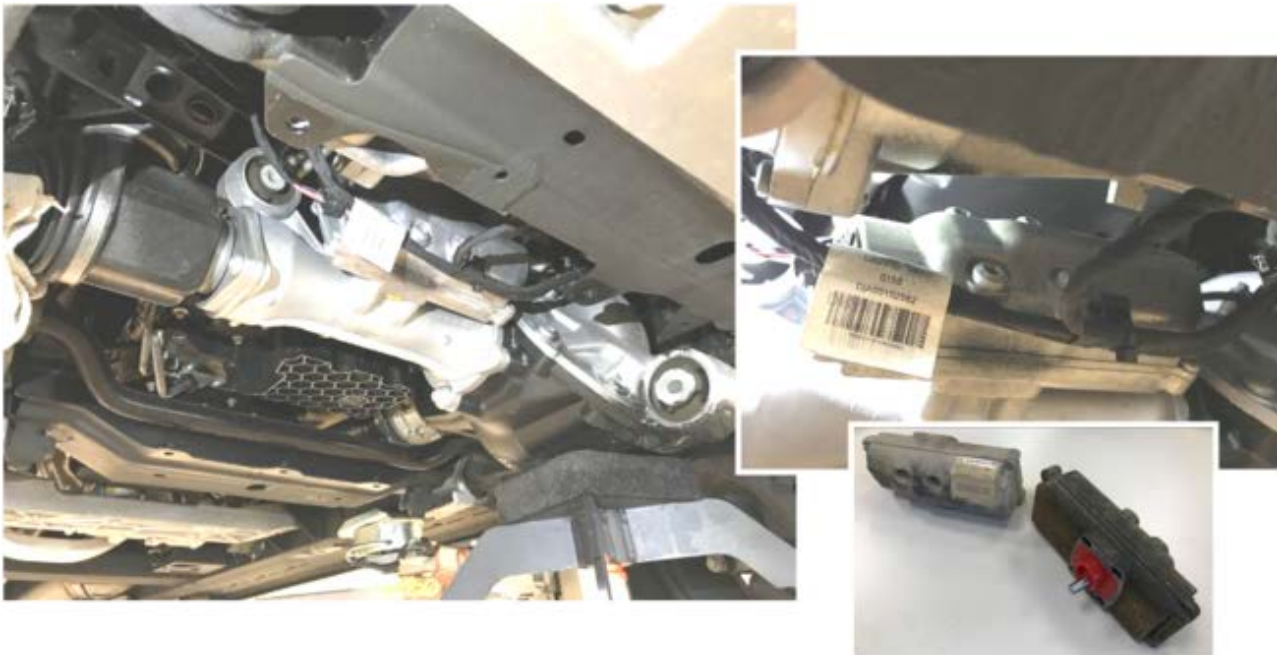
**Figure 3**

**i** **New actuator must *not be painted*. (Figure 3)**

1. Replace actuator of differential lock at front axle **and/or** rear axle.

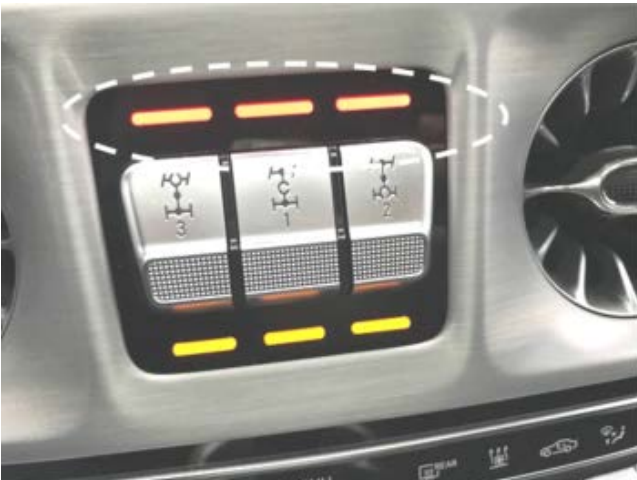
Figure 7

**i** For this purpose, start the engine – engage low range "N" position – actuate transfer case differential lock switch/rear axle differential lock switch/front axle differential lock switch – drive in gentle figure 8 lines at walking pace in an open area until the **red feedback of all three locks** appears on **operating switch (figure 7)** – deactivate locks and low range.

2. Check differential locks of front and rear axle for proper operation.
