David J. Johnson
 Director
 Service Engineering Operations
 Ford Customer Service Division

- TO:** All U.S. Ford and Lincoln Dealers
- SUBJECT:** **Safety Recall 20S08 –Supplement #1**
 Certain 2015 - 2016 Model Year F-150 Vehicles Equipped with 3.5L GTDI Engines and Engine Block Heaters
 Engine Block Heater Cable Inspection

CERTAIN 2015-2016 MODEL YEAR F-150 VEHICLES EQUIPPED WITH 3.5L GTDI ENGINES — BLOCK HEATER CABLE INSPECTION

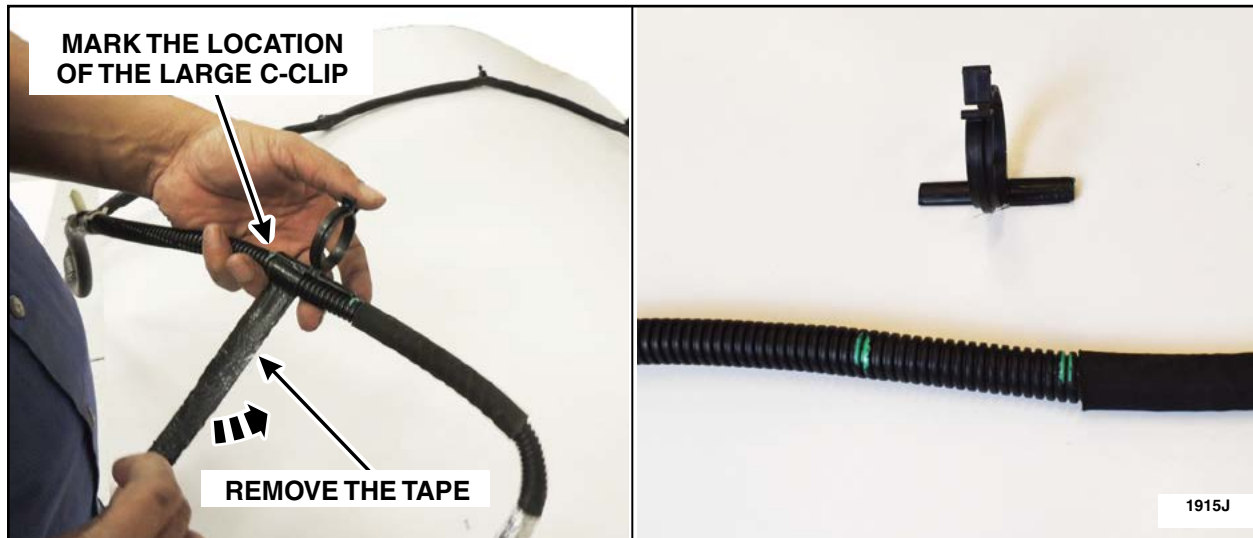
FIGURE 14

15. Before installing, lay out the *new* block heater cable. Mark the location of the large C-clip on the block heater cable as shown in Figure 14. Then, remove the tape holding the large C-clip to the block heater cable and set the clip to the side to be attach back to the block heater cable later in this procedure. See Figure 14.

21. Using electrical tape, retape the large C-clip to the block heater cable where it was previously marked for removal. See Figure 14.
22. Secure the small C-clip back into the zip tie base on the block heater cable. See Figure 16.

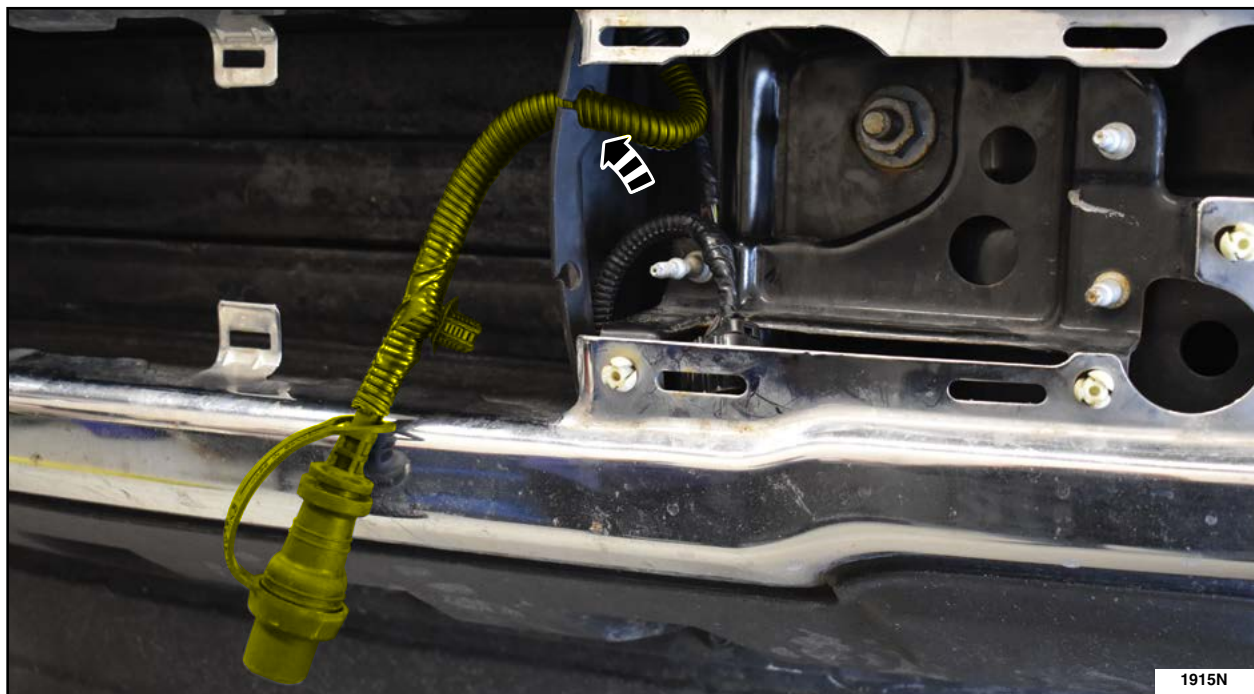
FIGURE 18

29. Route the block heater cable through the upper slot in the grill shutter air diverter as shown in Figure 18.
