### **Recall Campaign Bulletin**

Campaign No. 2020050034, June 2020

#### SUBJECT: Model G-Class vehicles (463 platform) Model Year 2019-2020 Labeling Child Safety Lock

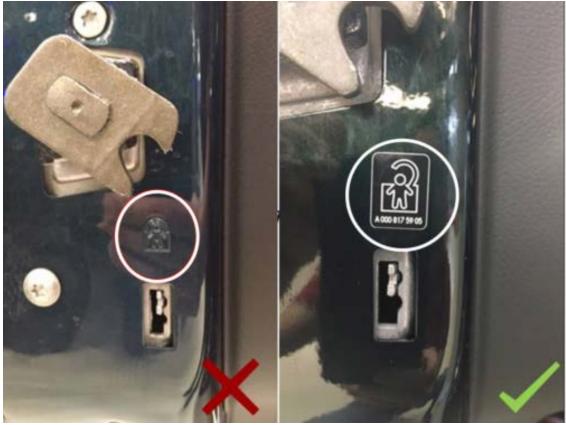
#### Figure 1

Mercedes-Benz AG ("MBAG"), the manufacturer of Mercedes-Benz vehicles, has determined that on certain Model Year ("MY") 2019-2020 G-Class vehicles (463 platform), the embossed lock symbol for the child safety lock operating lever on the rear doors might indicate the incorrect locking status of the child safety lock. In this case, the incorrectly embossed symbol could lead to a misinterpretation of the locking status of the child safety lock. As a result, the rear doors could be opened from the inside despite the indication of a locked door. Conversely, the rear doors could not be opened from the inside despite the symbol indicating that the rear door is unlocked. This could increase the risk of injury to the occupants in the second seat row. In the Operator's Manual, the operating direction of the child safety lock is stated and described correctly. An authorized Mercedes-Benz dealer will install a label on the rear doors with the correct child safety lock status.

- 1. Open both rear doors
- 2. Clean the area and affix, in each case, one label from the label set completely over the pictogram embossed in the sheet metal (figure 1) at both rear doors.
