September 2021
FL856A-J
NHTSA #20V-404

Subject: FCCC Motorhome Chassis Rear PDMs

Models Affected: Specific Model Year 2016-2020 Freightliner Custom Chassis X-Line chassis manufactured November 23, 2015, through June 3, 2019, and equipped with a certain PDM.

PDM Inspection and Replacement

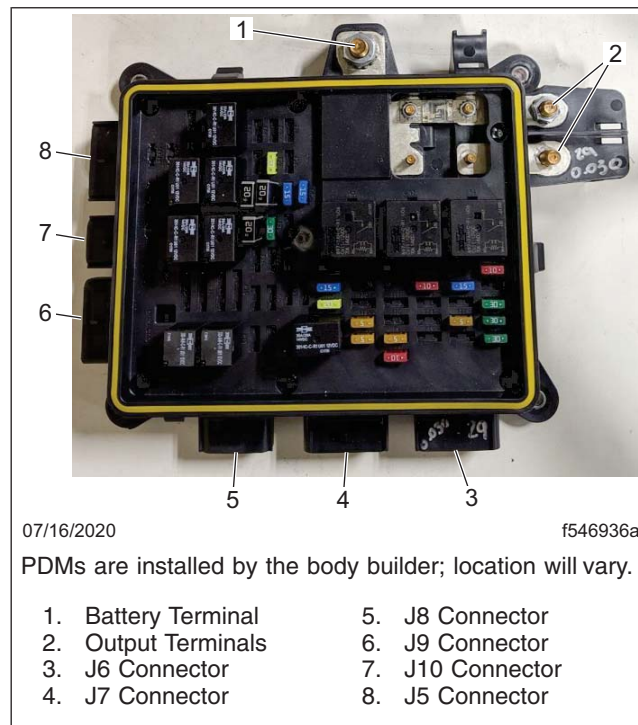
Fig. 1, PDM Components

5. Disconnect all electrical connections to the PDM. See [Fig. 1](#).

3. Locate the serial number on the side of the PDM. If the serial number is equal to, or less than, 18106398, go to the next step. If serial number is greater than 18106398, go to step 10.
4. Disconnect the chassis battery ground cable from the battery.

6. Remove the mounting fasteners attaching the PDM to the chassis and remove the PDM.

IMPORTANT: When replacing the PDM, remove the cover from the new PDM and compare the fuse and relay configurations with the PDM being replaced. Body builders may have added optional fuses and relays after the chassis was built. If this is the case, make certain to remove and reinstall the additional fuses and relays in the same location on the new PDM and replace the cover.

7. Using the mounting fasteners removed earlier, attach the PDM to the chassis.

8. Connect all electrical connections to the PDM.
