**SUBJECT: NEW VEHICLE DEMONSTRATION / DELIVERY HOLD -
Safety Recall 20S36**

Certain 2021 Model Year Medium Duty Trucks equipped with 7.3L Engine
Cabin Floor and Seat Mount Thermal Management Repairs

CERTAIN 2021 MODEL YEAR MEDIUM DUTY TRUCKS EQUIPPED WITH 7.3L ENGINE — CABIN FLOOR AND SEAT MOUNT THERMAL MANAGEMENT REPAIRS

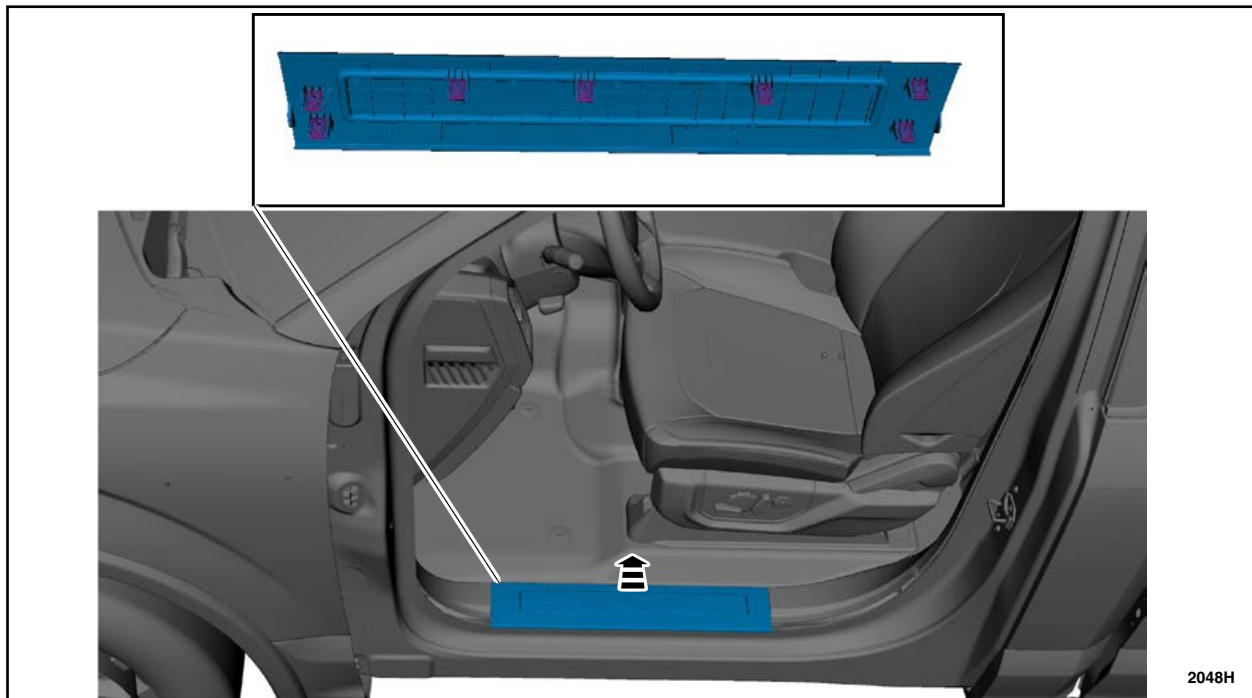
FIGURE 1

1. Release the clips and remove the front Left Hand (LH) side scuffplate trim panel. See Figure 1.

5. Position the carpet down and install the front LH cowl side trim panel. See Figure 2.
6. Install the front LH side scuffplate trim panel. See Figure 1.
7. Proceed to the 'Seat Mount Thermal Covers Inspection Procedure' on Page 4.

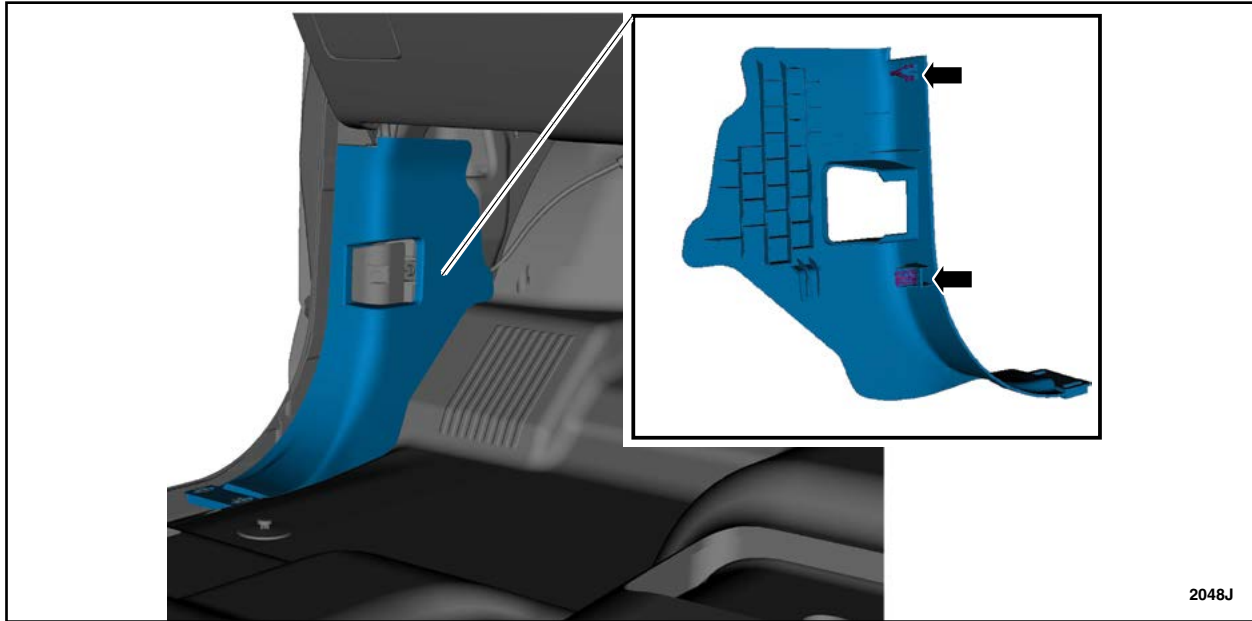
FIGURE 2

2. Remove the front LH cowl side trim panel. See Figure 2.

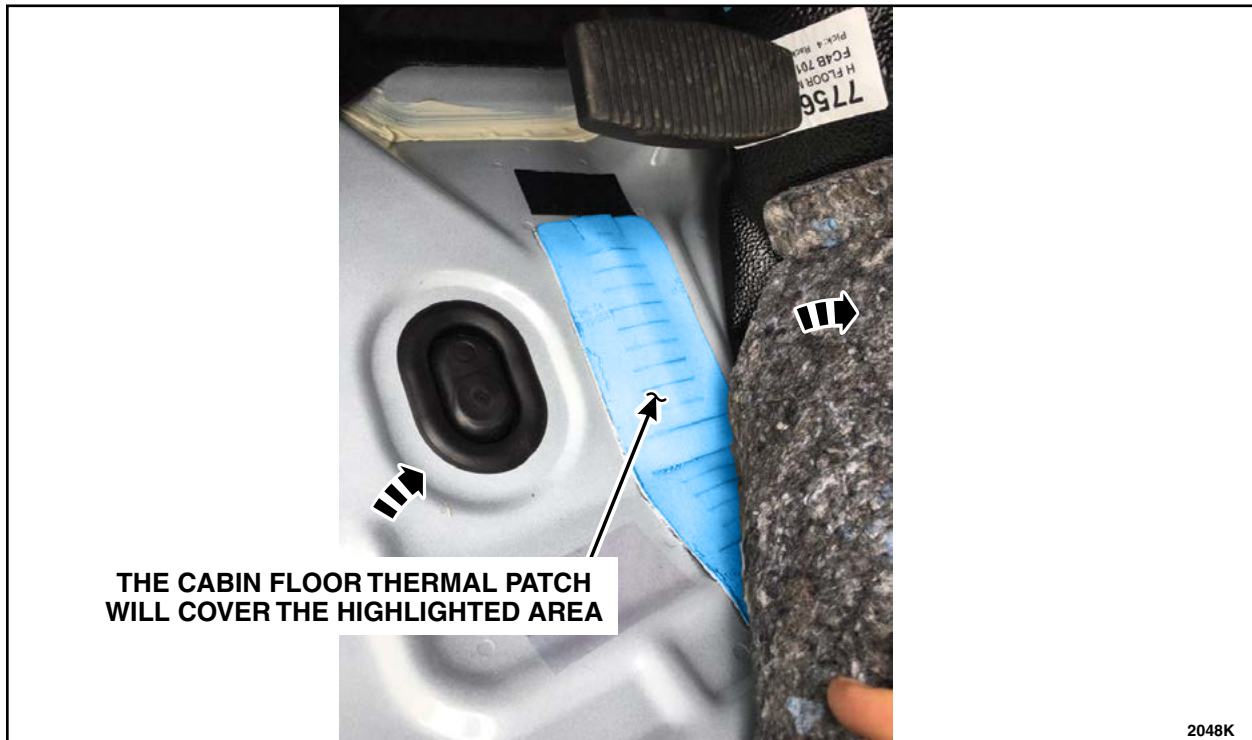
FIGURE 3

3. Lift up the carpet until the highlighted area, just below the brake pedal, is visible. See Figure 3.

4. Peel the protective backing cover from the *new* cabin floor thermal patch and install it over the highlighted area in Figure 3. Start at the bottom, sticky side down, and align the lower outboard heel of the thermal patch so that it sets between the areas indicated in Figure 4.

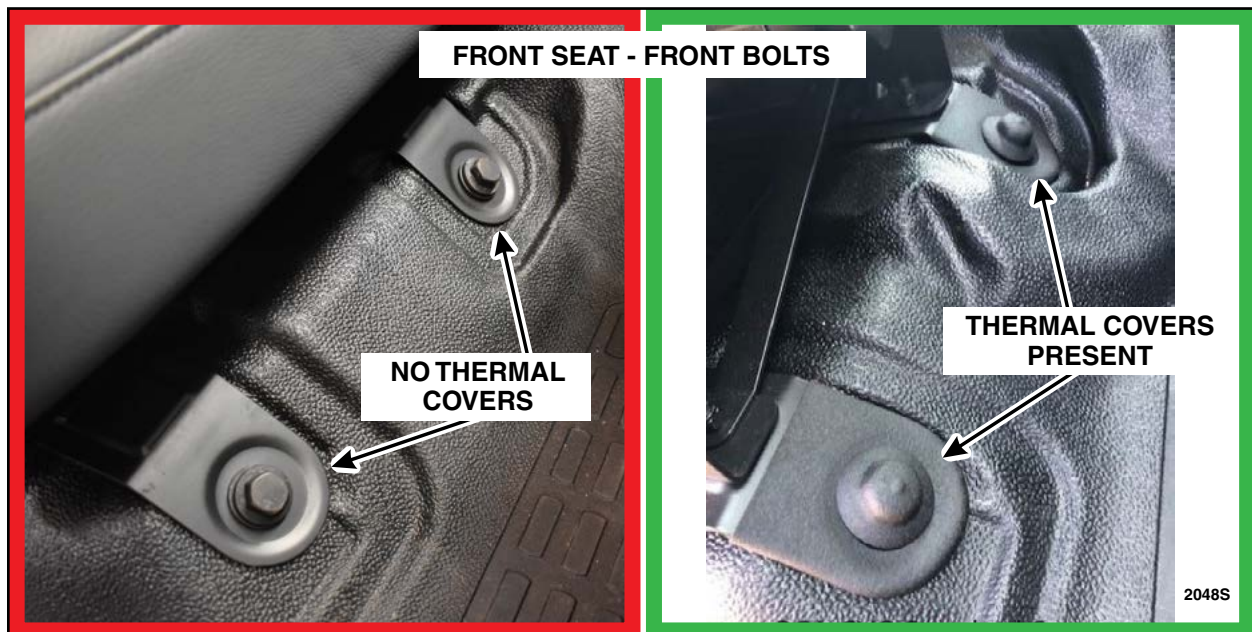
FIGURE 5

Regular Cabs - a. Covers and sleeve on both front seat, front bolts (4). See Figure 5.

Super Cabs and Crew Cabs - a. Covers and sleeve on both front seat, front bolts (4). See Figure 5.
b. Covers on both front seatbelt buckle anchor bolts (2). See Figure 6.
c. Covers on all bolts, on the front seat, rear bolts (4). See Figure 7.
d. Covers on the rear seat, front bolts (3). See Figure 8.

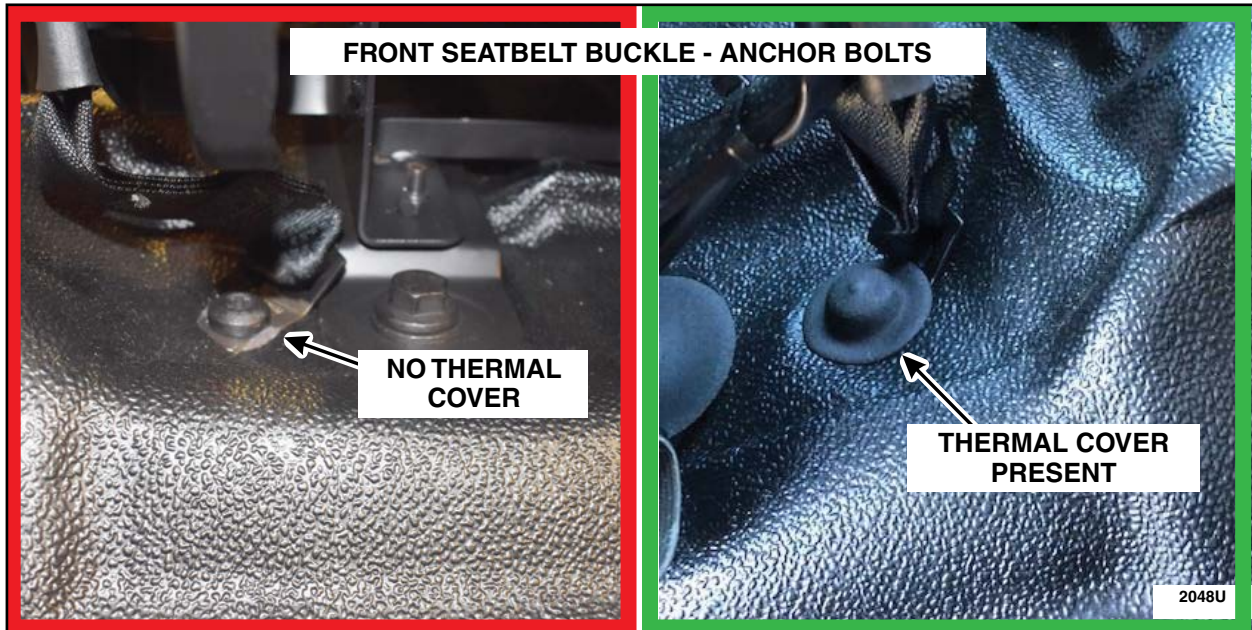
FIGURE 6

Super Cabs and Crew Cabs - a. Covers and sleeve on front seat, front bolts (4). See Figure 9
b. Covers on both front seatbelt buckle anchor bolts (2). See Figure 6.
c. Covers on all bolts, on the front seat, rear bolts (4). See Figure 7.
d. Covers on the rear seat, front bolts (3). See Figure 8.

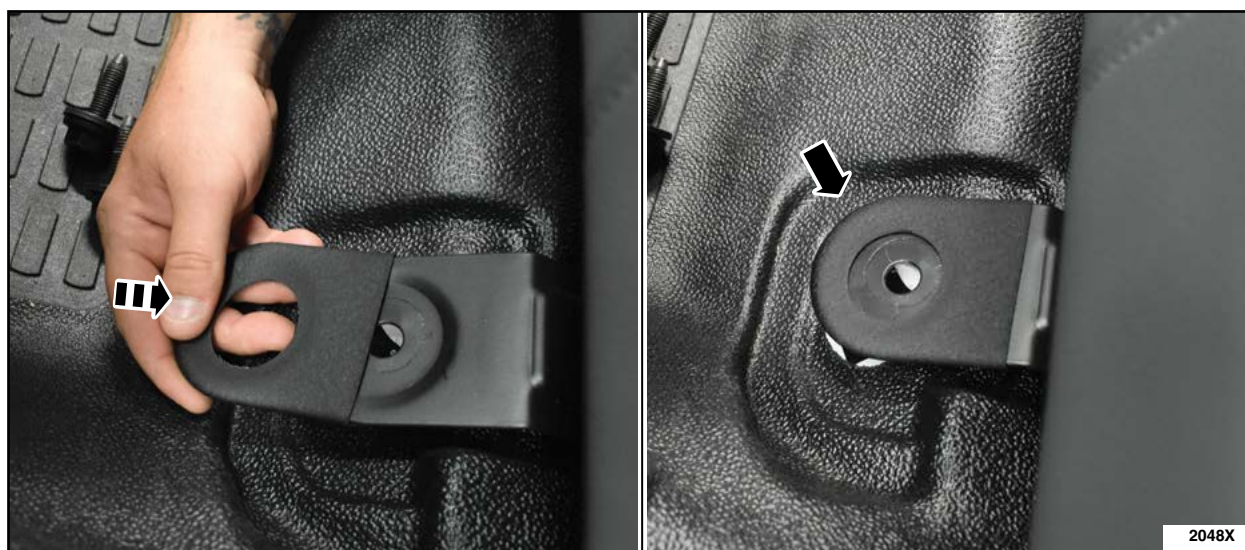
FIGURE 10

1. Remove both of the front bolts from the front seat.
2. Install a thermal protective sleeve over both front seat track legs as shown in Figure 10.

NOTE: Use Part Number MC4Z-99611D02-D, 2 required per seat.

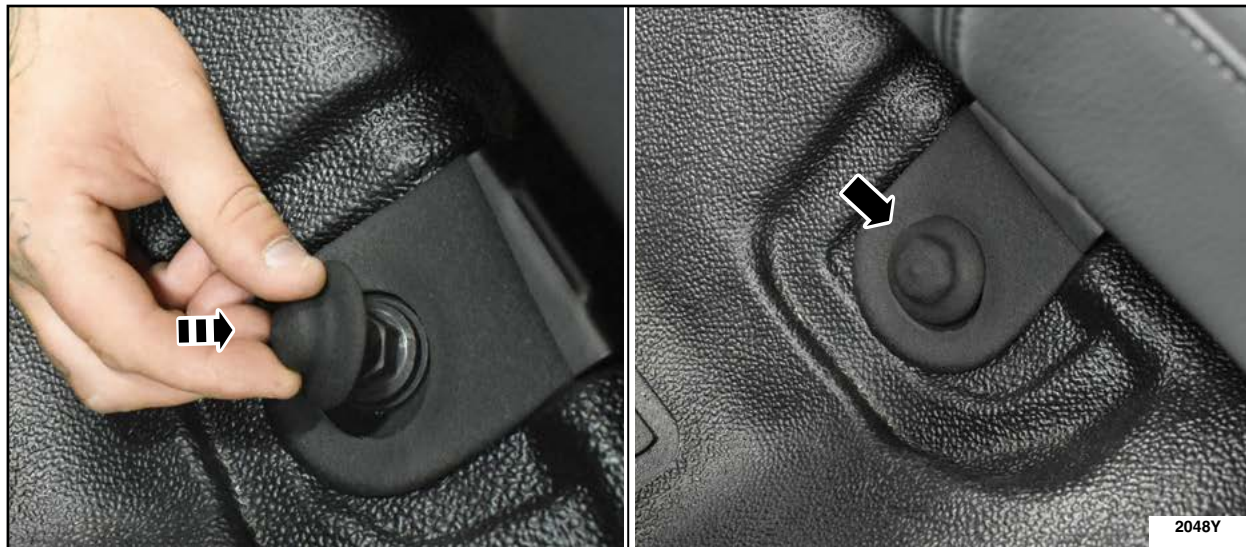
FIGURE 11

4. Install a seat bolt thermal protective cover as shown in Figure 11.

NOTE: Use Part Number MC3Z-16611D02-A, 2 required per seat.

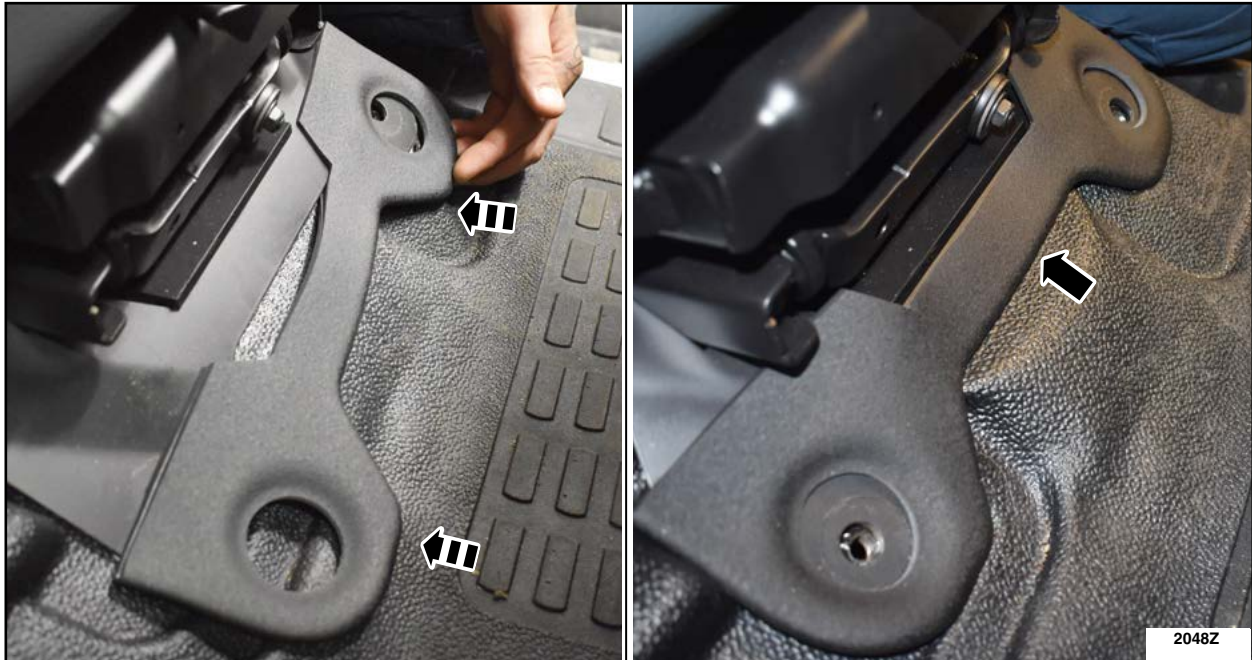
FIGURE 12

1. Remove the two (2) front bolts from the drivers front seat.
2. Install the thermal protective sleeve over the front seat track leg as shown in Figure 12.

NOTE: Use Part Number MC4Z-99611D02-B, 1 per seat.

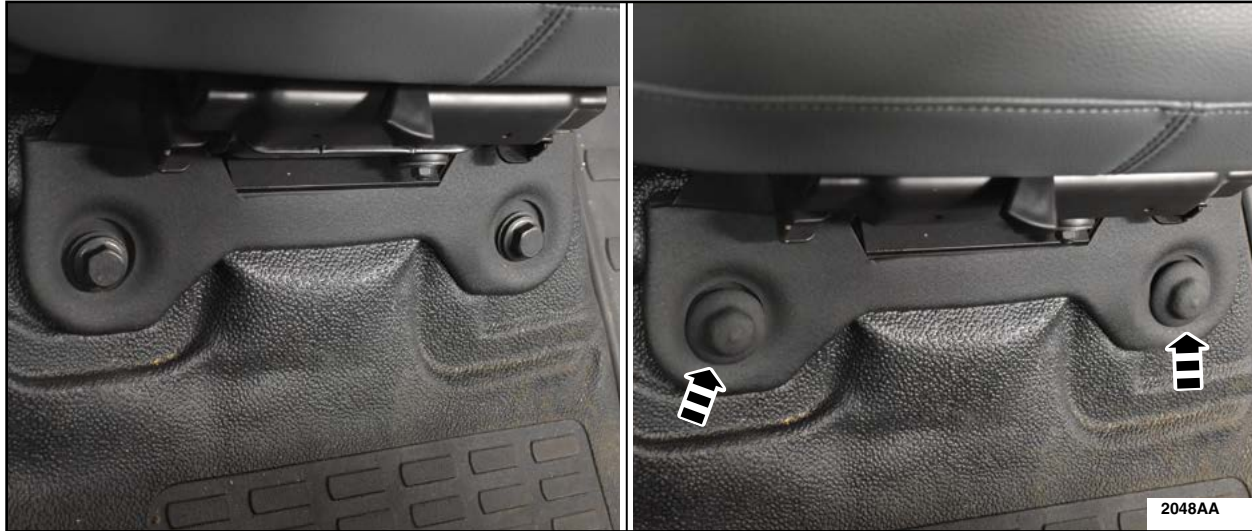
FIGURE 13

4. Install a seat bolt thermal protective covers as shown in Figure 13.

NOTE: Use Part Number MC4Z-16611D02-A, 2 per seat.

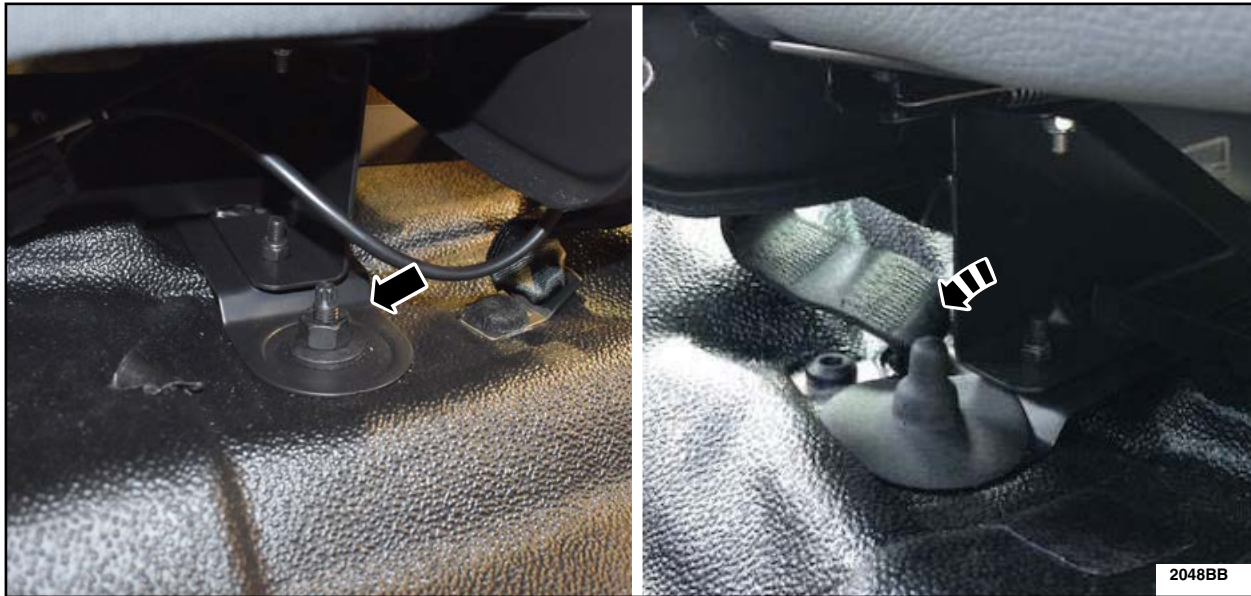
FIGURE 14

1. Install 2 front seat, rear bolt thermal covers per seat as shown in Figure 14.

NOTE: Use Part Number MC4Z-16611D02-B, 2 per seat.

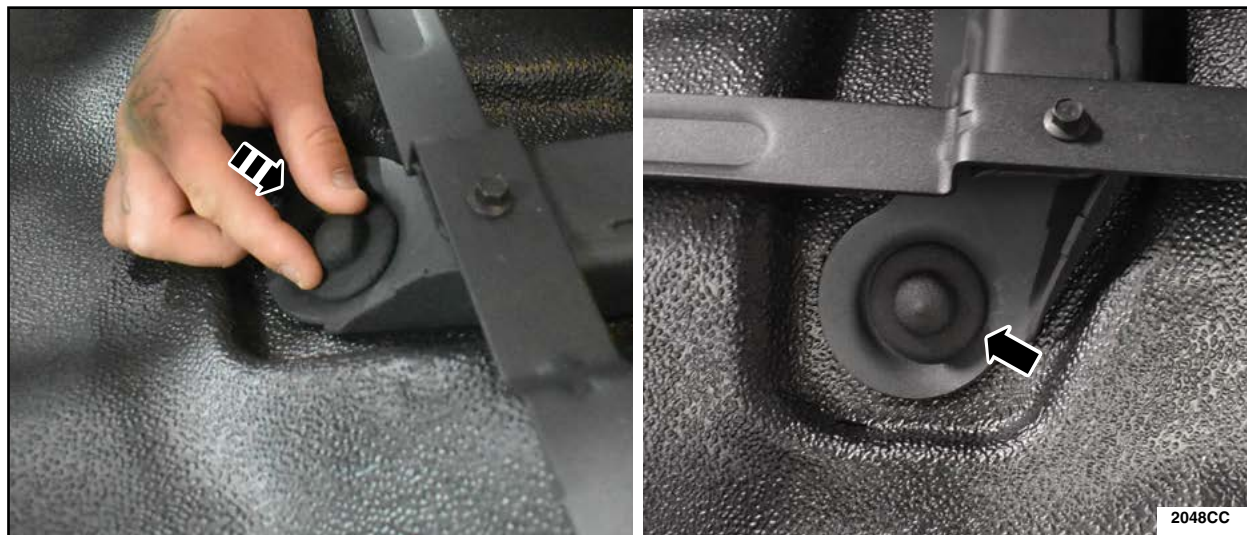
FIGURE 15

1. Install the rear seat front bolt covers as shown in Figure 15.

NOTE: Use Part Number MC4Z-16611D02-C, 3 required.

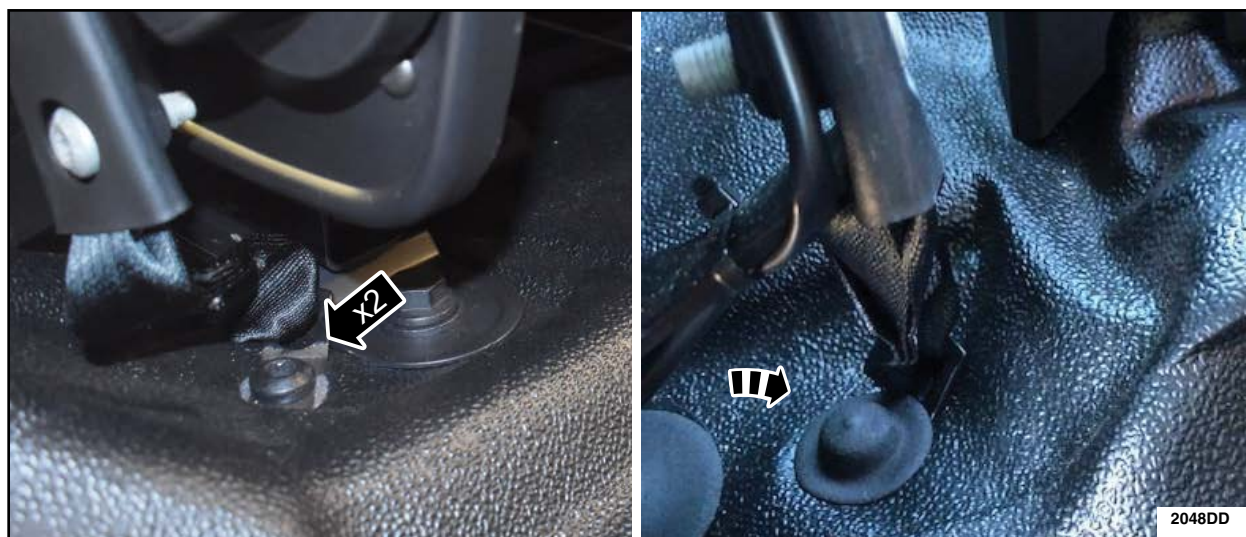
FIGURE 16

1. Install a thermal protective cover over both front seatbelt buckle anchor bolts as shown in Figure 16.

NOTE: Use Part Number MC4Z-16611D02-A, 1 per seatbelt anchor bolt.

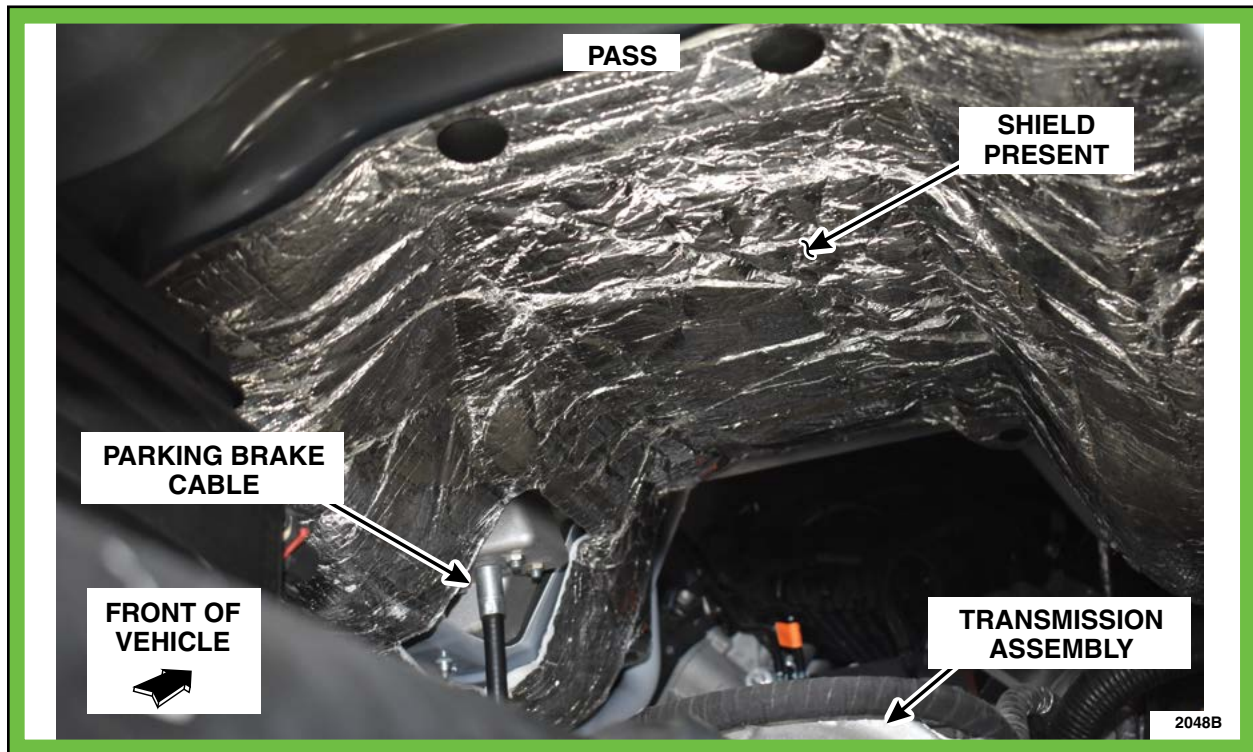
FIGURE 17

1. Inspect for the presence of an underbody tunnel heat shield over the transmission assembly. Is there a tunnel heat shield present? See Figures 17 and 18.

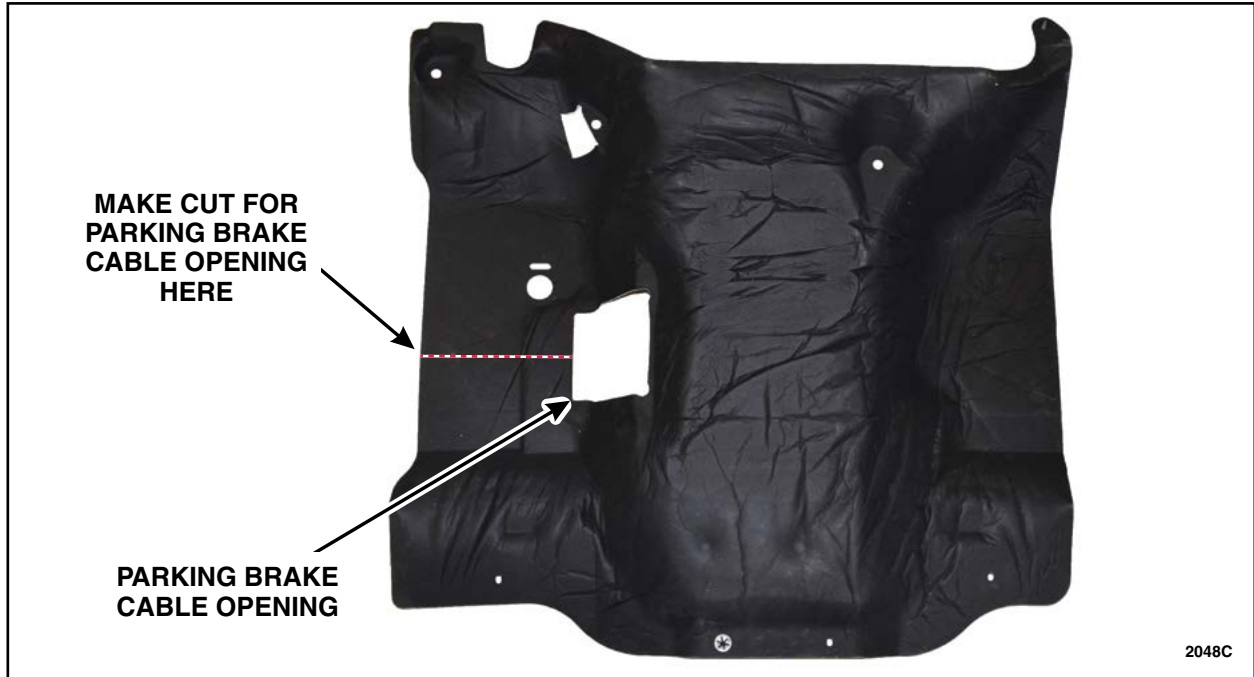
FIGURE 19

1. Before the heat shield is installed a cut must be made on the heat shield so that the shield can be positioned around the parking brake cable. Lay the heat shield down and locate the parking brake cable opening and the area in which to be cut, shown in Figure 19. Split the distance of the opening in half and using a pair of scissors, cut a straight line as indicated in Figure 19. Figure 20 shows a completed cut shield.

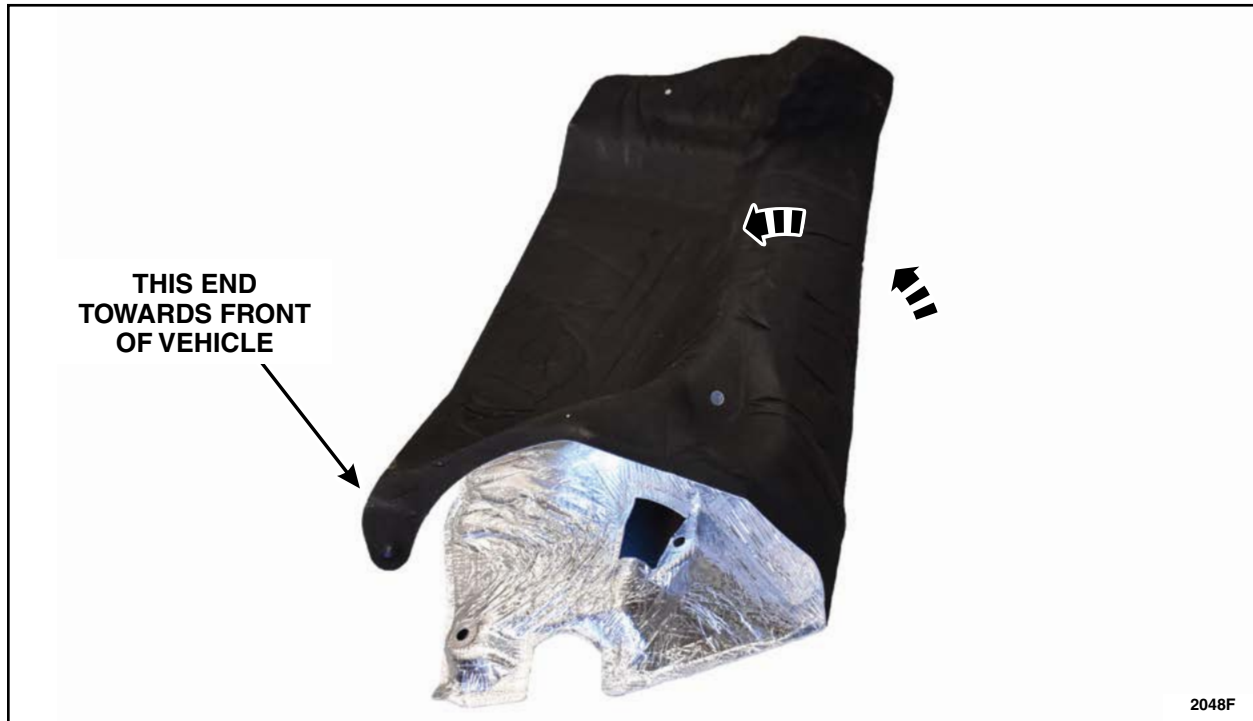
FIGURE 21

2. Fold the shield in half with the reflective sides touching. The end with the ears goes towards the front of the vehicle. See Figures 20 and 21.

NOTE: The heat shield is durable and can handle bending the sides to meet. However, care should still be taken not to deform or damage the heat shield. Heat tape can be used to fix any damage to the heat shield during installation.

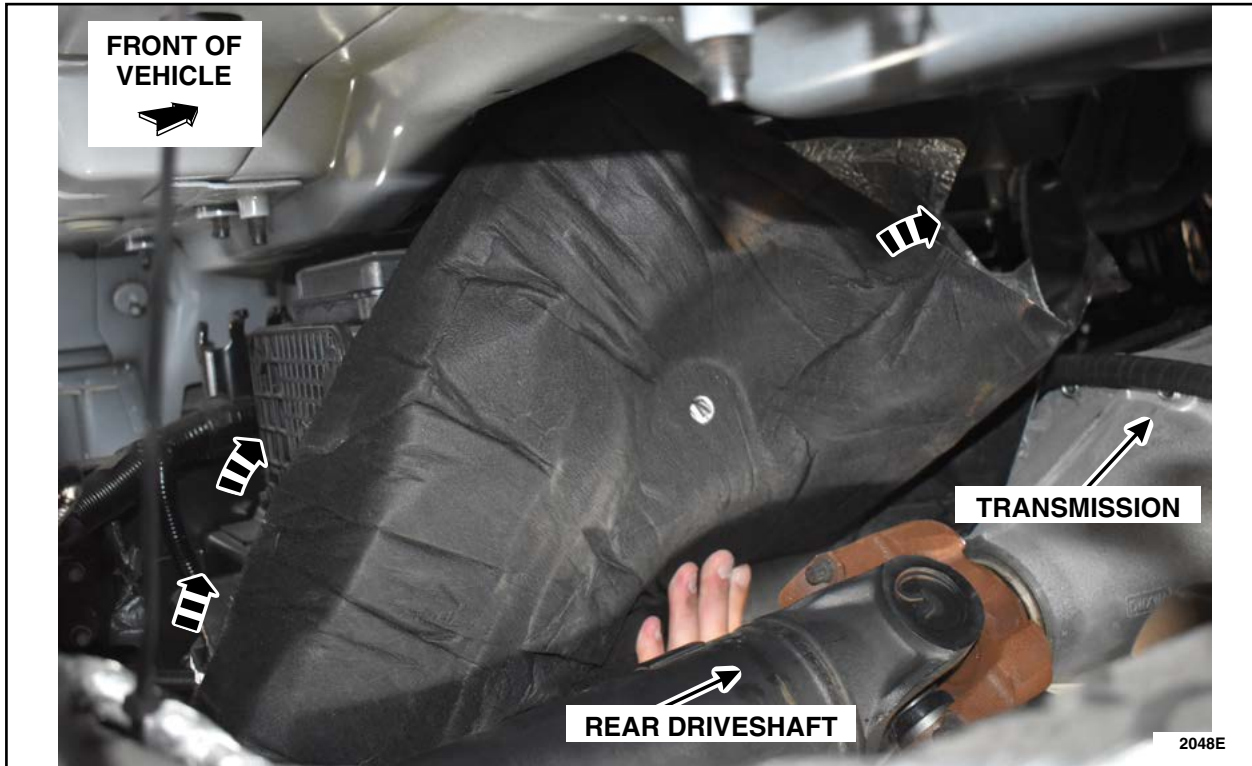
FIGURE 22

3. With the open portion of the folded shield facing down and parking brake cable opening on the drivers side of the vehicle, slide the folded shield along the left hand side of the drive shaft towards the front of the vehicle and up an over the transmission. See Figure 22.

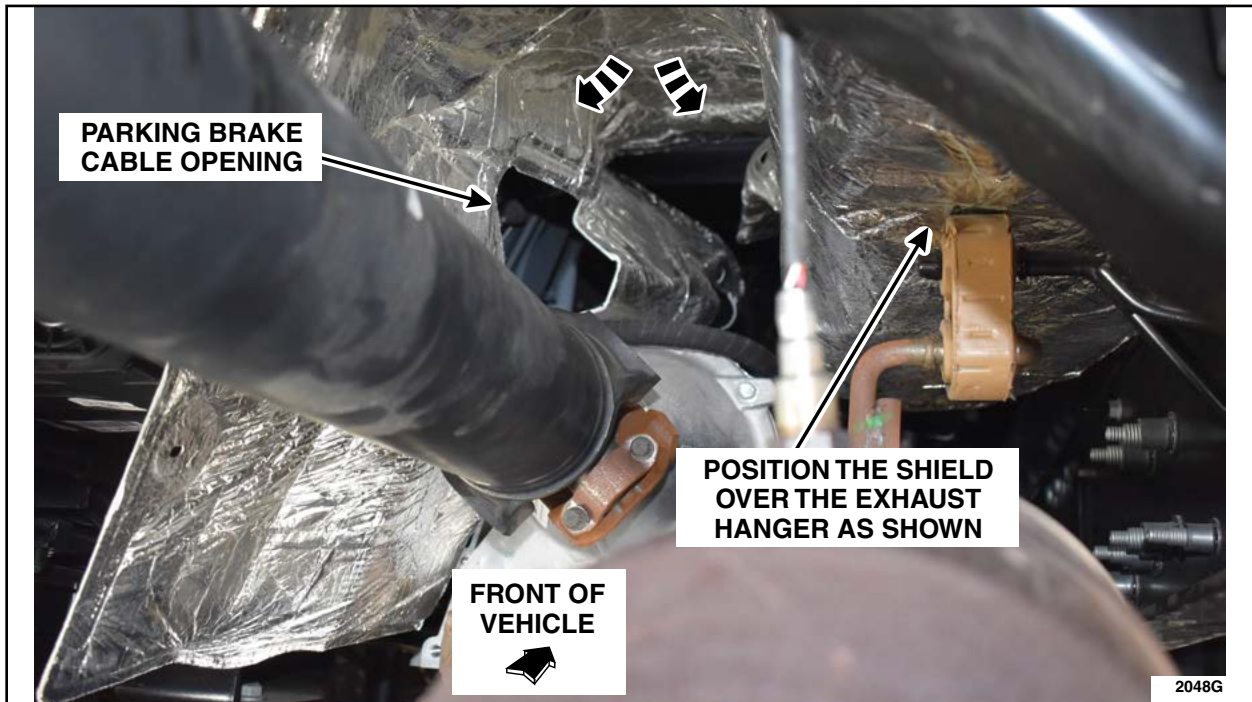
FIGURE 23

4. Continue to work the shield forward until its over the transmission. Once over the transmission, begin to open the shield up and position it loosely in place. See Figure 23.

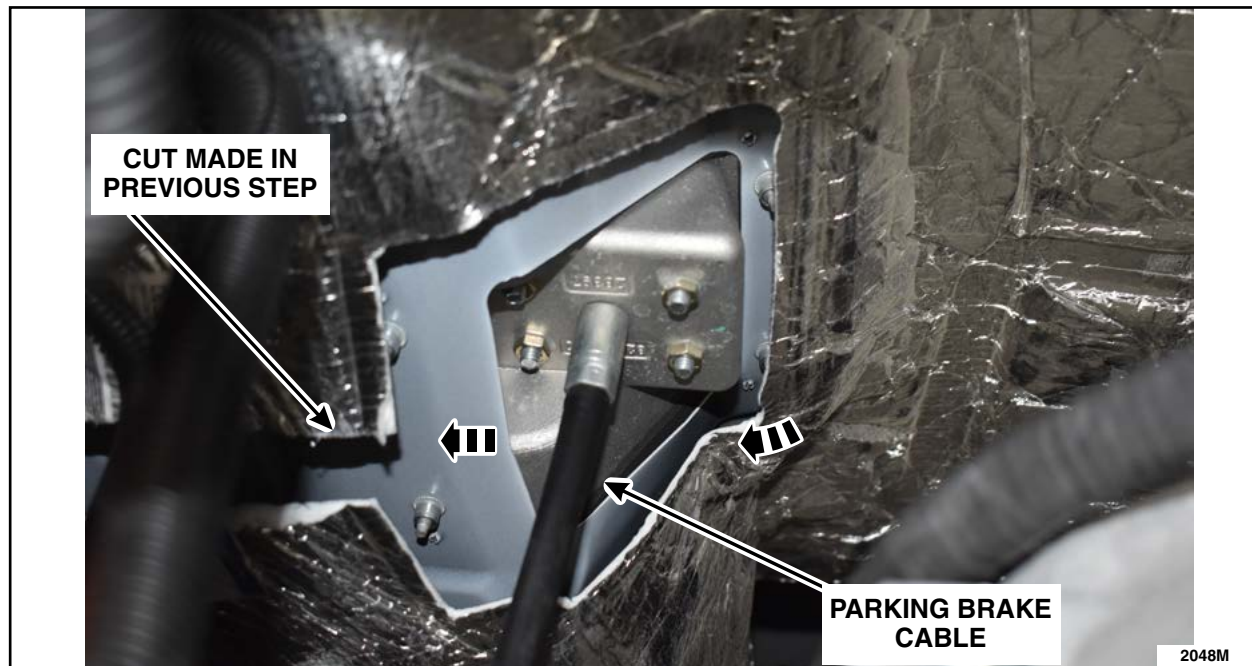
FIGURE 24

5. On the driver's side, position the shield around the parking brake cable and position the shield in place. See Figure 24.

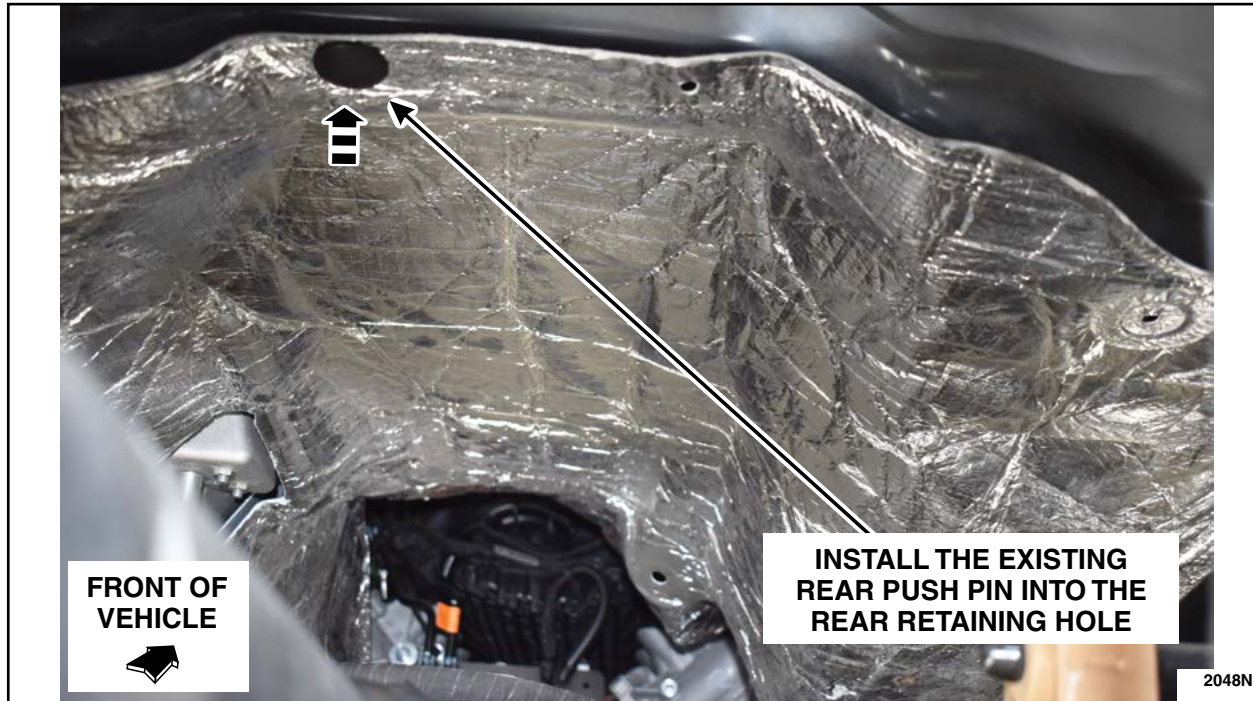
FIGURE 25

6. Slide all 4 corners in their respective positions and install the one (1) rear alignment fastener that came installed on the heat shield as shown in Figure 25.

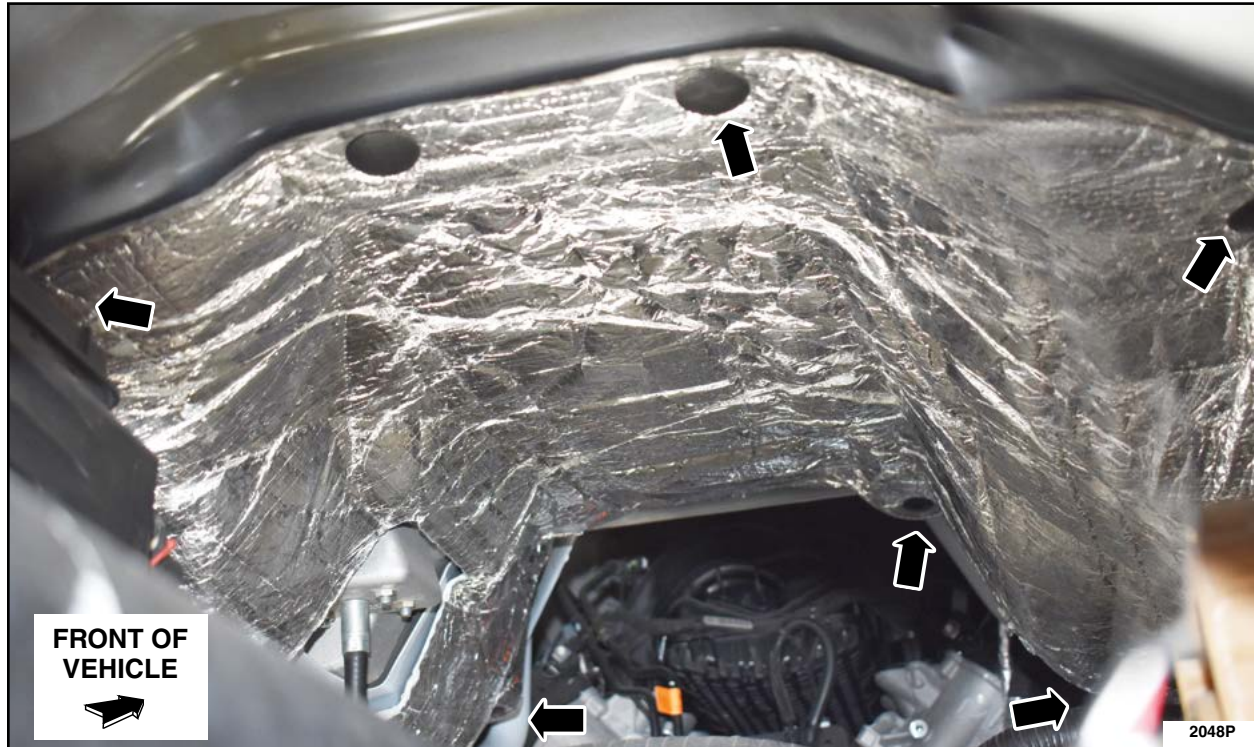
FIGURE 26

- Using the provided smaller shank push pins, install the three (3) remaining rear heat shield fasteners and using the provided larger shank push pins, install the three (3) remaining front heat shield fasteners. See Figure 26.

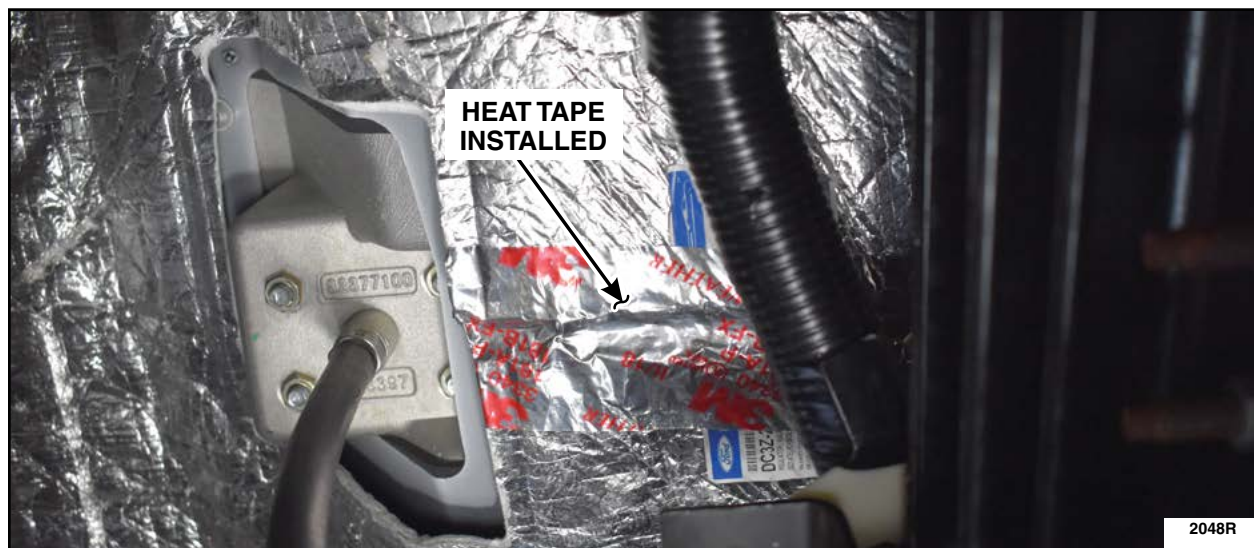
FIGURE 27

- Using a pair of scissors, cut a 9 in. strip of heat tape. Remove the protective backing from the heat tape and center it over the cut line for the parking brake cable (made in Step 1.) then press the sticky side on the shield. Continue to press the heat tape into the heat shield to prevent the two halves from separating. See Figure 27. Repair Complete.
