**SUBJECT: NEW VEHICLE DEMONSTRATION / DELIVERY HOLD -
Safety Recall 20S36 – Supplement #2**

Certain 2021 Model Year Medium Duty Trucks equipped with 7.3L Engine
Cabin Floor and Seat Mount Thermal Management Repairs

CERTAIN 2021 MODEL YEAR MEDIUM DUTY TRUCKS EQUIPPED WITH 7.3L ENGINE — CABIN FLOOR AND SEAT MOUNT THERMAL MANAGEMENT REPAIRS

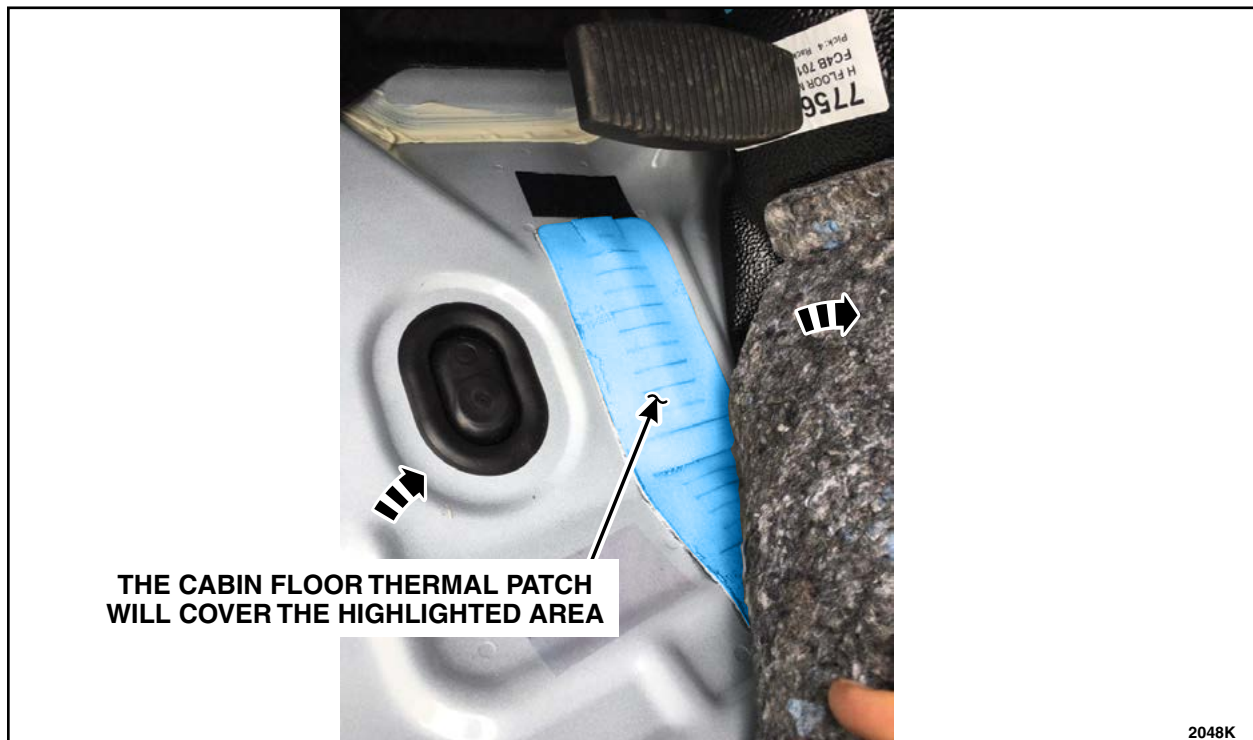
FIGURE 3

3. Lift up the carpet until the highlighted area, just below the brake pedal, is visible. See Figure 3.

5. Peel the protective backing cover from the *new* cabin floor thermal patch and install it over the highlighted area in Figure 3. Start at the bottom, sticky side down, and align the lower outboard heel of the thermal patch so that it sets between the areas indicated in Figure 4.

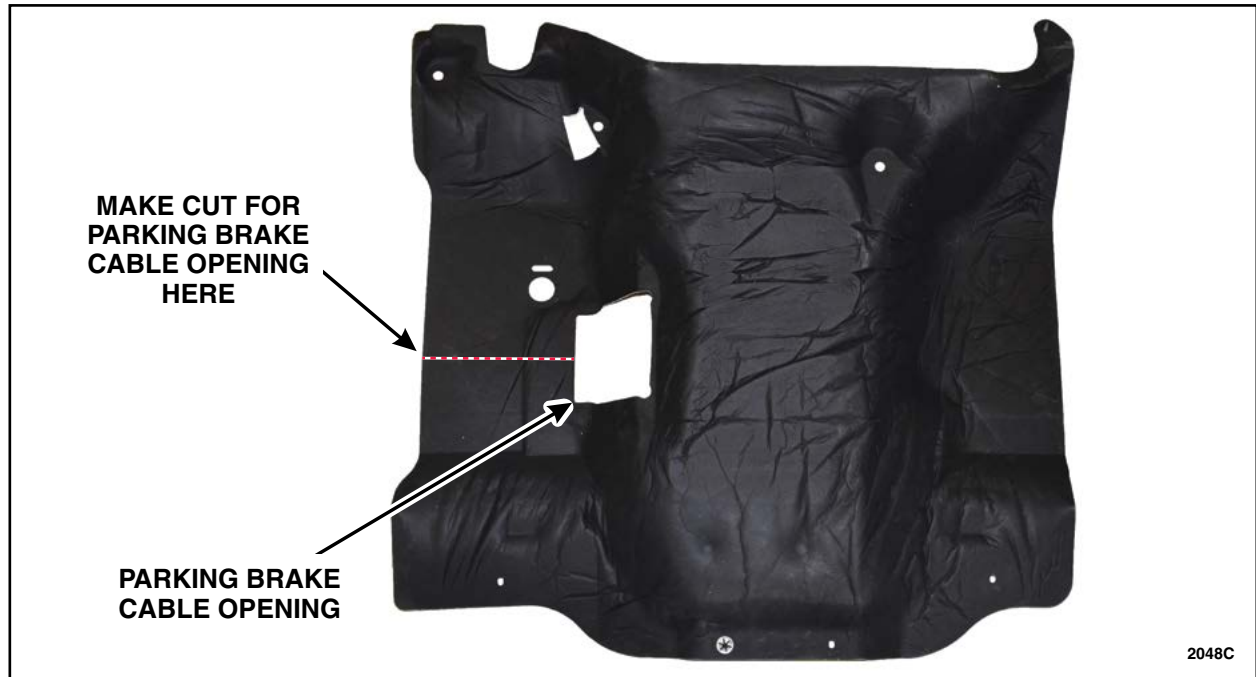
FIGURE 19

1. Before the heat shield is installed a cut must be made on the heat shield so that the shield can be positioned around the parking brake cable. Lay the heat shield down and locate the parking brake cable opening and the area in which to be cut, shown in Figure 19. Split the distance of the opening in half and using a pair of scissors, cut a straight line as indicated in Figure 19. Figure 20 shows a completed cut shield.

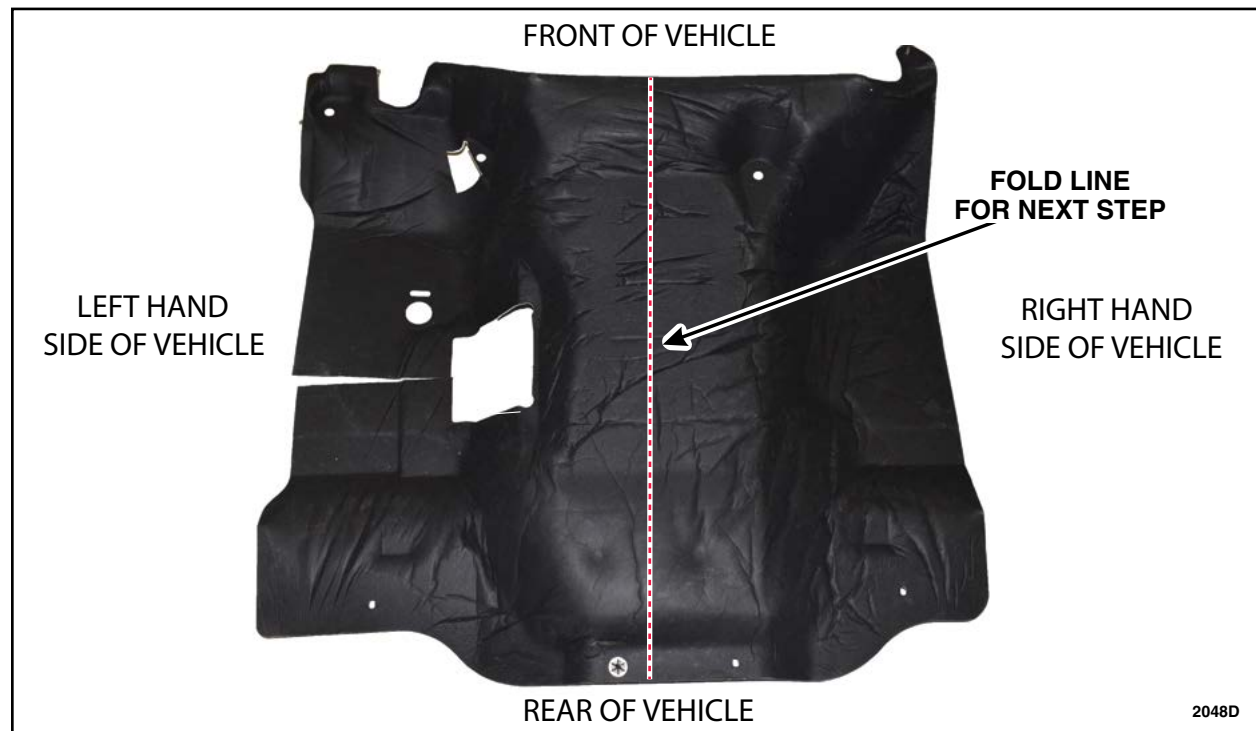
FIGURE 20

2. Fold the shield in half with the reflective sides touching. The end with the ears goes towards the front of the vehicle. See Figures 20 and 21.

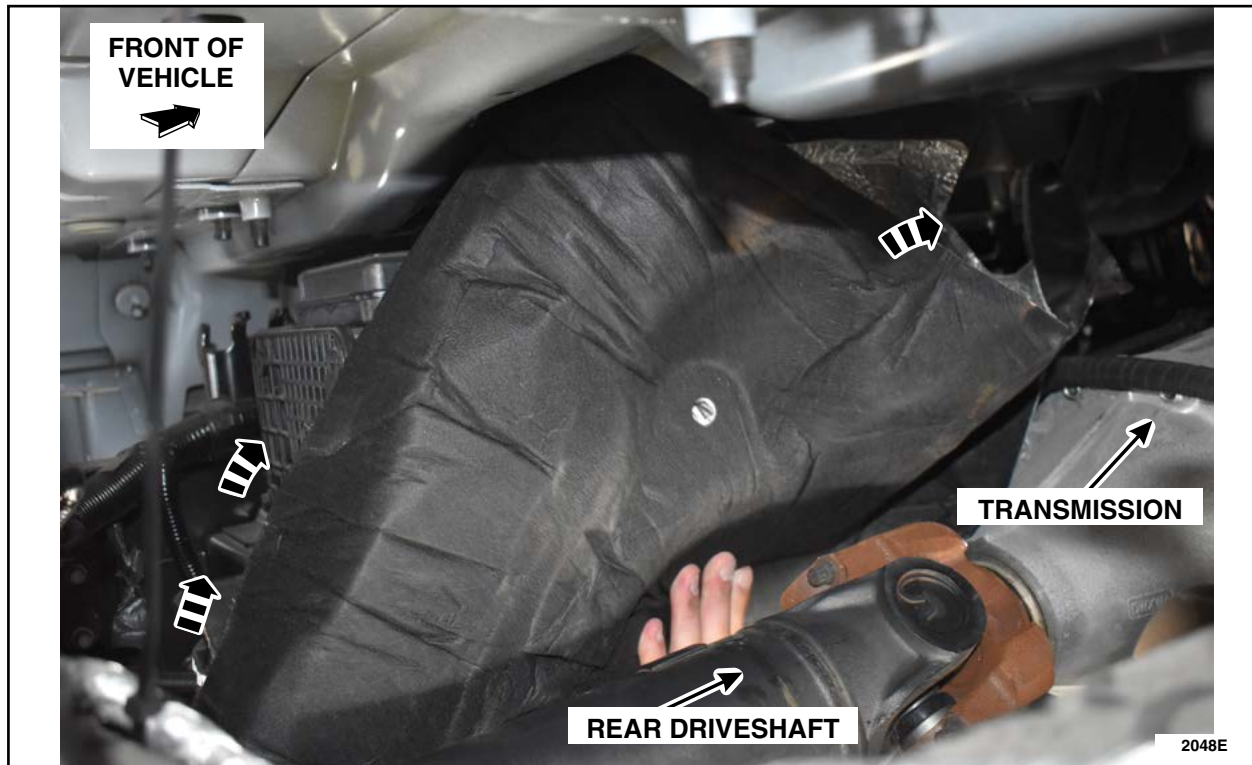
FIGURE 22

3. With the open portion of the folded shield facing down and parking brake cable opening on the drivers side of the vehicle, slide the folded shield along the left hand side of the drive shaft towards the front of the vehicle and up an over the transmission. See Figure 22.
