GS/GSX/GSX-R No. 252

March 22, 2021

## SAFETY RECALL CAMPAIGN 2A95 GSX250RL8 Headlamp Bulb

**Affected Models:** Certain 2018 GSX250R Models

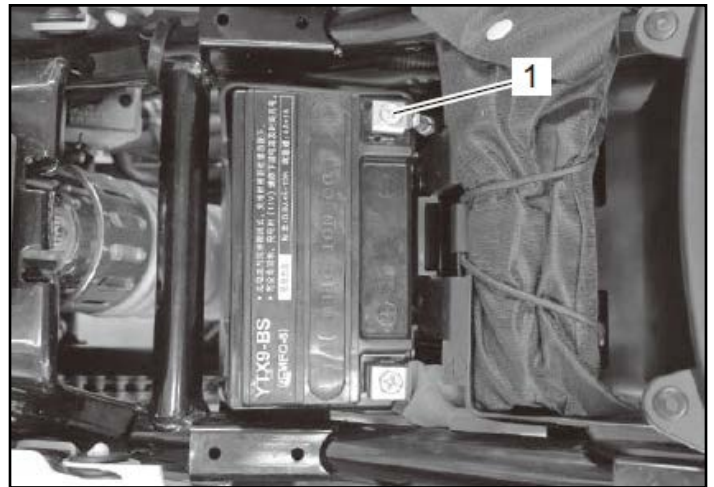
- 1) Remove the front seat (refer to Section 9D Seat Removal and Installation).
- 2) Remove the negative battery lead wire (1).
- 3) Remove the right and left rear view mirrors (refer to Section 9D Rear View Mirror Removal and Installation).

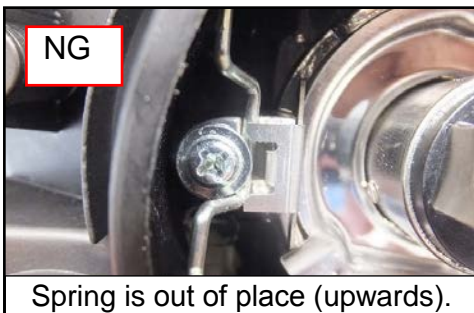
**Incorrect installation**

If the clip does not fit correctly, contact your Suzuki TSM.

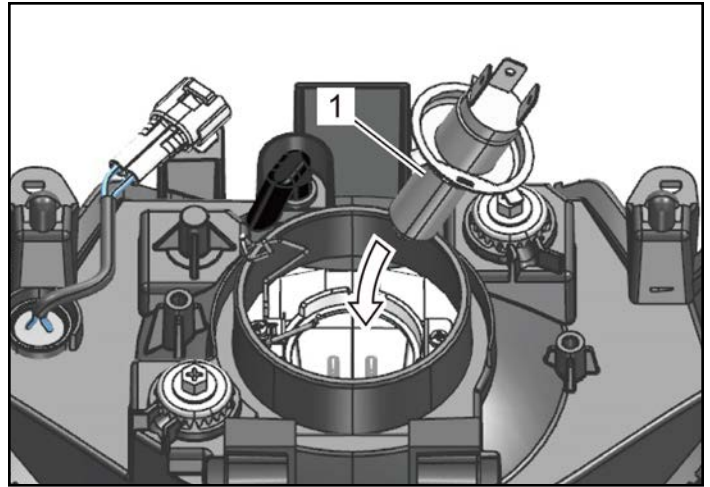
13) Replace with a countermeasure headlamp bulb (1).

Touching the glass portion of the countermeasure headlamp bulb with your fingers may deposit oils on the glass.

If you touch the bulb with your fingers, before installing the bulb, clean the glass of the bulb with a cloth moistened with alcohol or mild soapy water.
