**\*\*\* IMPORTANT SAFETY RECALL \*\*\***  
**NHTSA Recall No. 20E-018**  
**Cummins Campaign #C2302**

Cummins Inc. has decided that a defect which relates to motor vehicle safety exists in certain B6.7 diesel engines that were manufactured between December 16, 2015 and March 24, 2020 and equipped with fuel module option FS90301 or FS90453.

Cummins has released field Safety Campaign #C2302 "B6.7 Engine-Mounted Fuel Heater Safety Campaign" to correct this condition. This campaign is currently available at Cummins

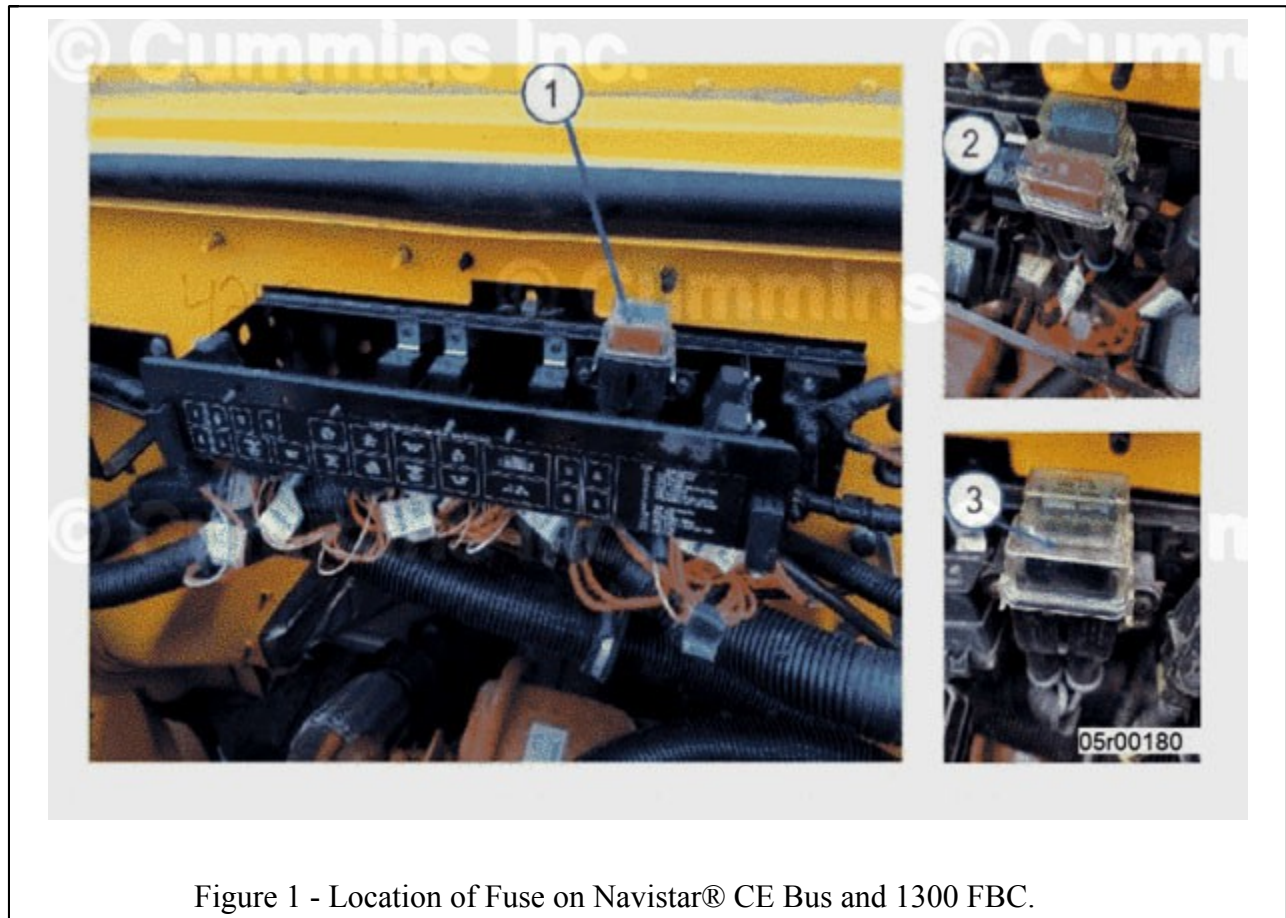
**Navistar® CE Bus and 1300 FBC Fuse Removal Instructions (Reference Figure 1 below)**

Figure 1 - Location of Fuse on Navistar® CE Bus and 1300 FBC.

1. Disconnect vehicle battery.
2. Locate red 50 Amp or green 30 Amp Maxi Fuse on under hood fuse panel.
3. Remove fuse cap and discard red or green Maxi Fuse.
4. Reinstall fuse cap. Do **not** replace fuse.
5. Reconnect vehicle battery.

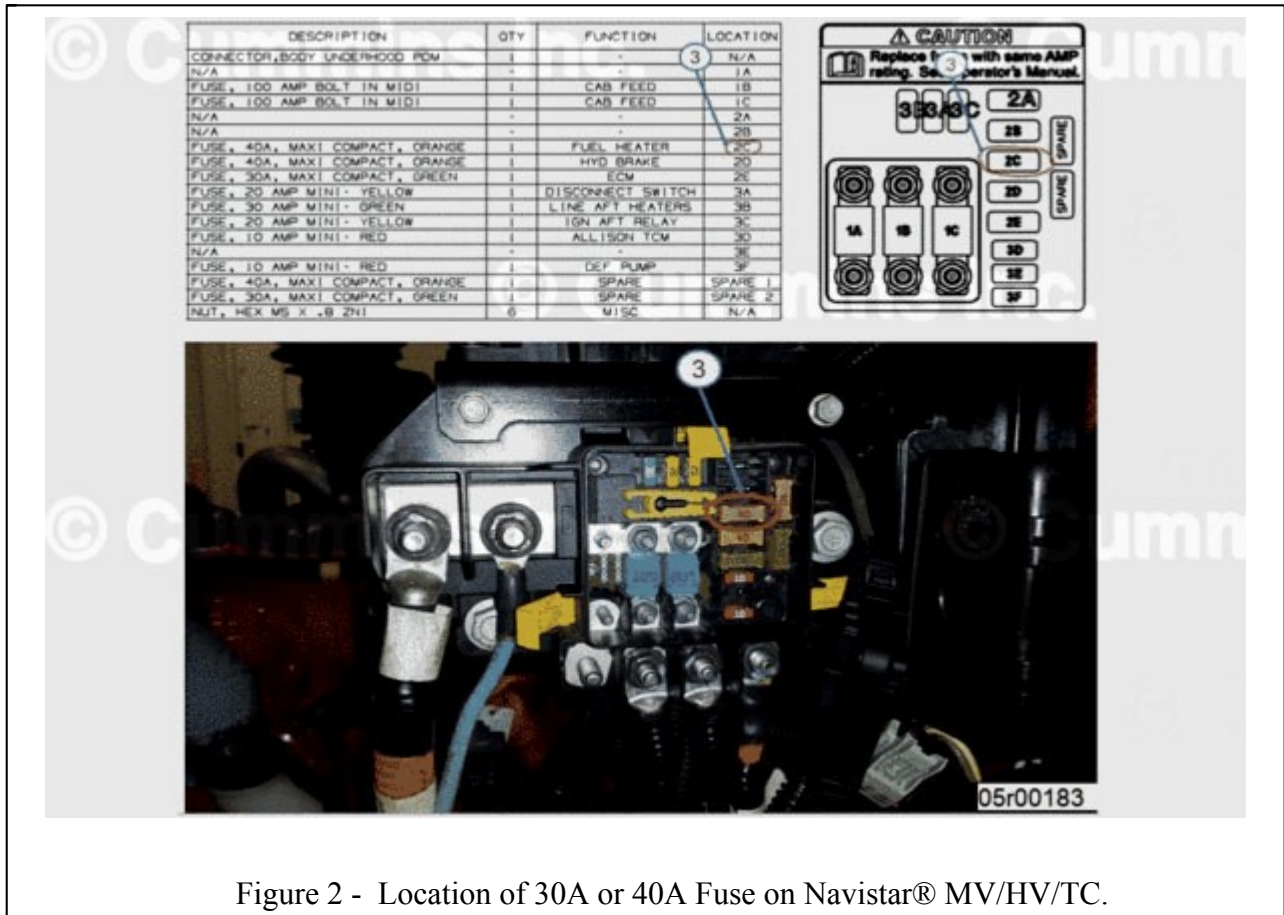
**Navistar® MV, HV and TC Commercial Bus (some DuraStar (4300)/WorkStar (7300)  
Fuse Removal Instructions (Reference Figure 2 below)**

Figure 2 - Location of 30A or 40A Fuse on Navistar® MV/HV/TC.

1. Disconnect vehicle battery.
2. Remove 30 or 40 amp fuse located at 2C cavity.
3. Reconnect vehicle battery.

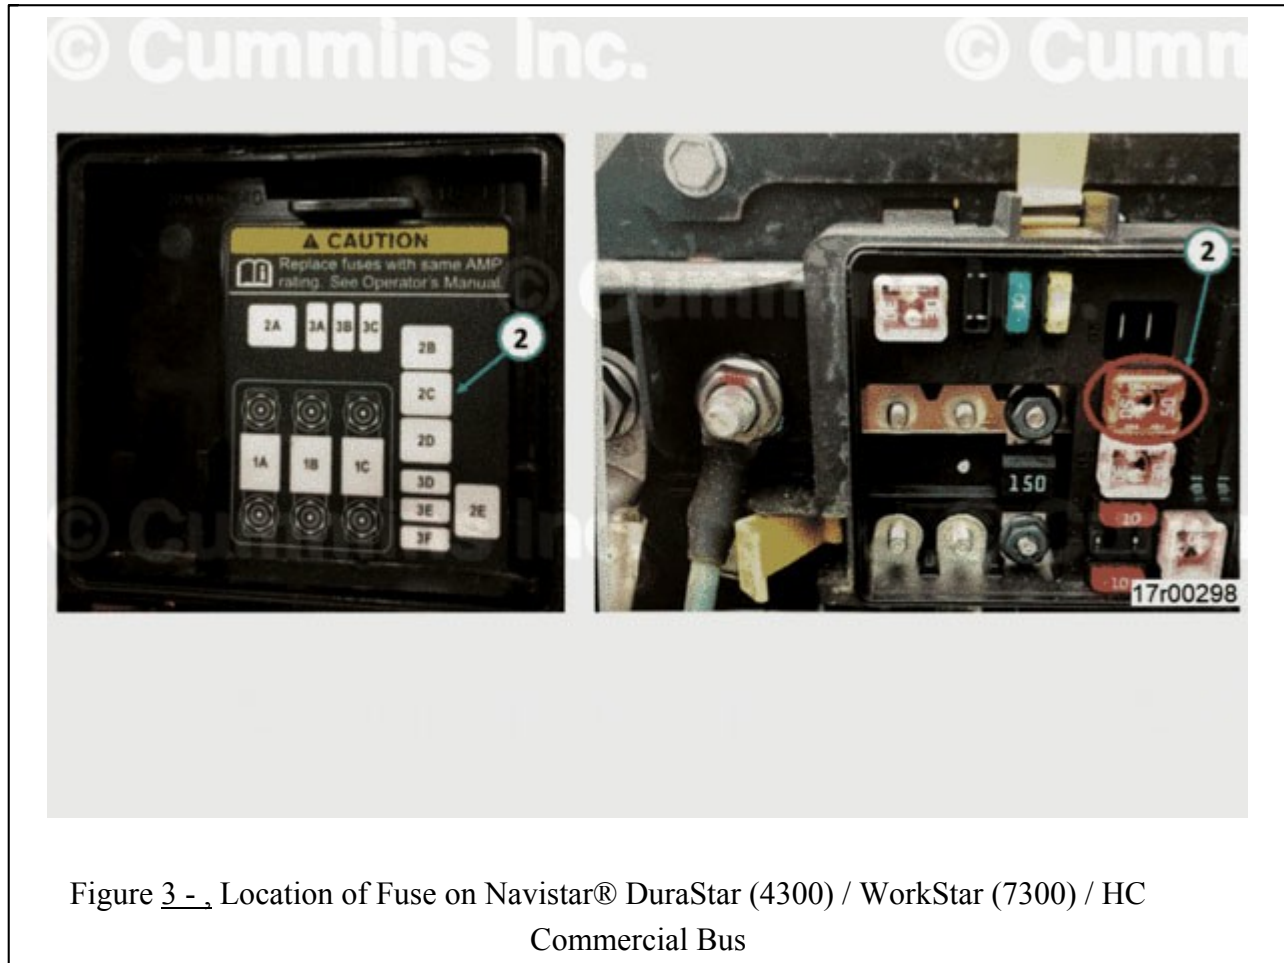
## Navistar® DuraStar (4300) / WorkStar (7300) / HC Commercial Bus Fuse Removal Instructions (Reference Figure 3 below)

Figure 3 - Location of Fuse on Navistar® DuraStar (4300) / WorkStar (7300) / HC Commercial Bus

1. Disconnect vehicle battery.
2. Remove Power Distribution Module (PDM) cover, located under the hood on the driver side of the vehicle.
3. Remove fuse located at cavity 2C.
4. Reconnect vehicle battery.
