SIB 65 03 20

**RECALL CAMPAIGN 20V-017: REPLACE DRIVER'S FRONT AIR BAG  
MODULE**

This Service Information Bulletin (Revision 4) replaces SI B65 03 20 **dated September 2024**.

## **Air Bag Generator Replacement E7x**

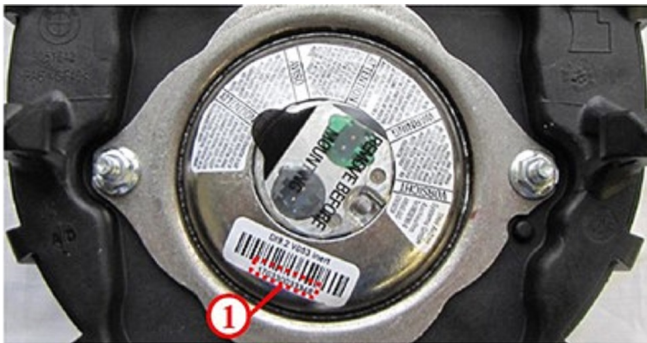
It is necessary to document which gas generator goes into which vehicle. Therefore, the technician is required to note on the repair order the serial number of the new gas generator. The serial number should also be entered into the warranty claims comment section. The serial number can be found on the gas generator below the barcode.

Serial Number location (1).

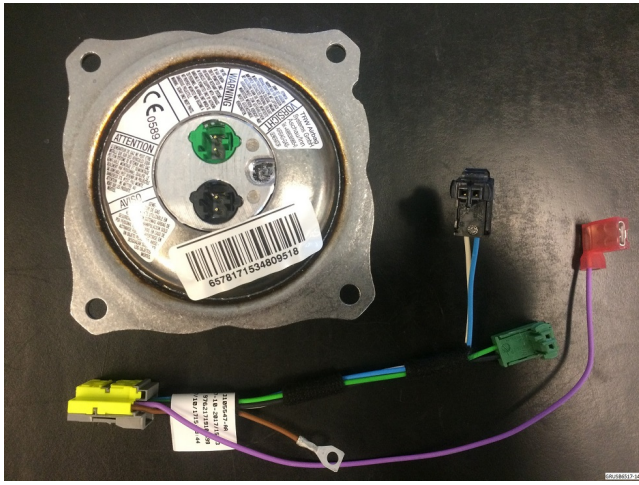
The new Repair Kit gas generator P/N 32 30 6 888 429 is installed utilizing a new jumper wiring harness that is installed between the generator and the steering wheel assembly.

Note: This harness **MUST BE USED** with this generator!

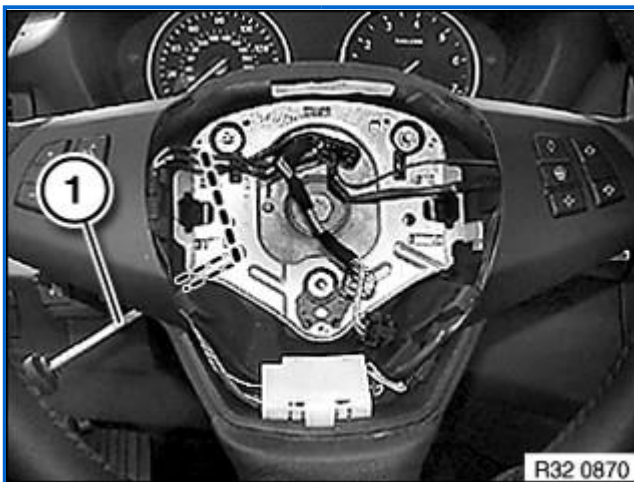
Insert Torx screwdriver T30 (1) at an angle into concealed opening on reverse side of steering wheel until a spring resistance is felt (approx. 2 cm).

Increase pressure with Torx screwdriver T30 (1) on spring leg until airbag unit is unlocked.

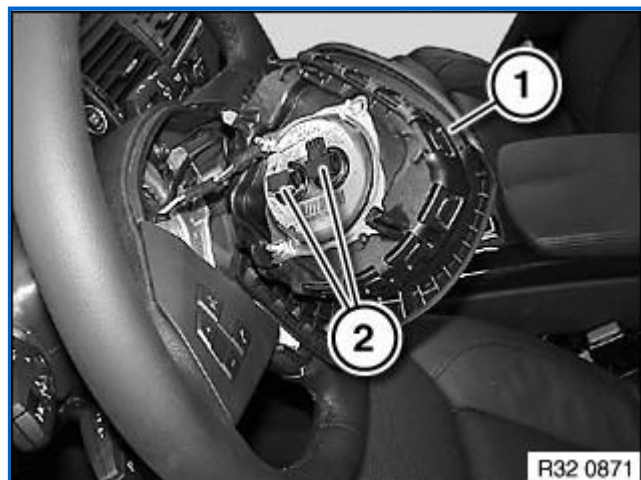
Tilt airbag unit (1) towards rear. Disconnect plug connections (2) and remove airbag unit (1).

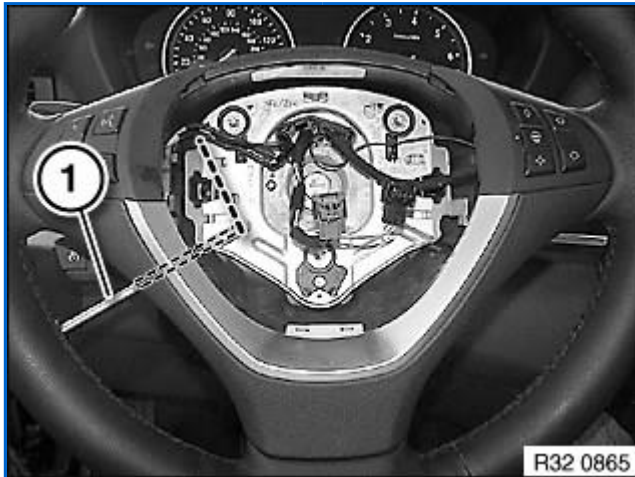
Insert Torx screwdriver T30 (1) at an angle into concealed opening on reverse side of steering wheel until a spring resistance is felt (approx. 2 cm).

Increase pressure with Torx screwdriver T30 (1) on spring leg until airbag unit is unlocked.

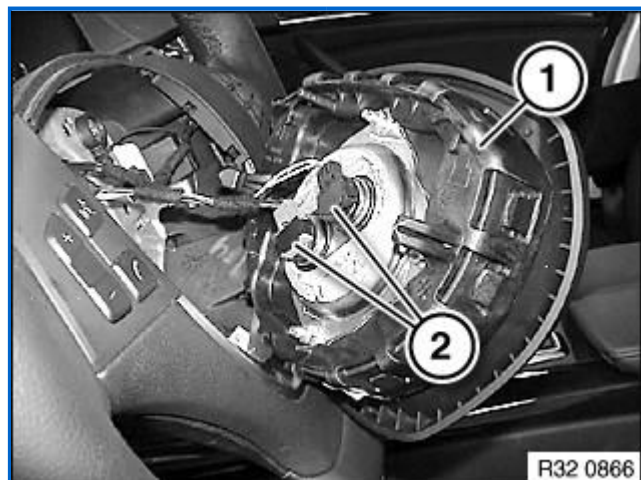
Tilt airbag unit (1) towards rear.

Disconnect plug connections (2) and remove

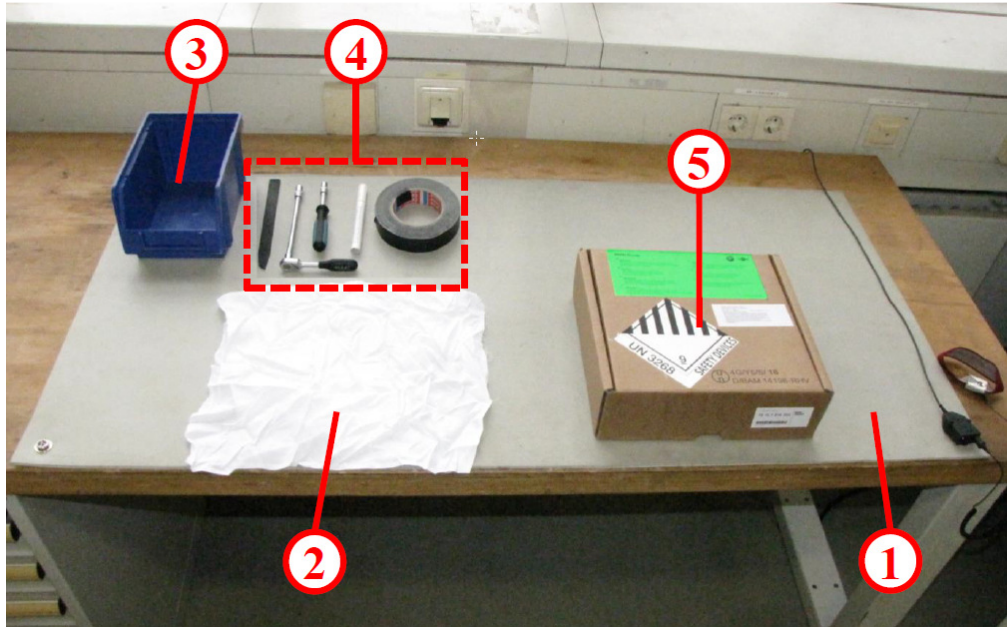
[1] The workbench should be prepared with the following items:

- Anti-Static mat (1) which must be grounded  
(See SWS 2 06 04 (128))
- A soft blanket or material (2) to prevent damaging the airbag cover
- A container (3) for disposal of the original Generator nuts
- A packaged new part (5)

Tools required (4) for the Generator exchange:

- Plastic bone tool (SWZ 0 490 539)
- Ratchet with extension and 8 mm socket
- Small torque wrench with 8 mm socket (5 NM)
- Felt tip marker (sharpie)
- Duct tape (.25 mm wide)

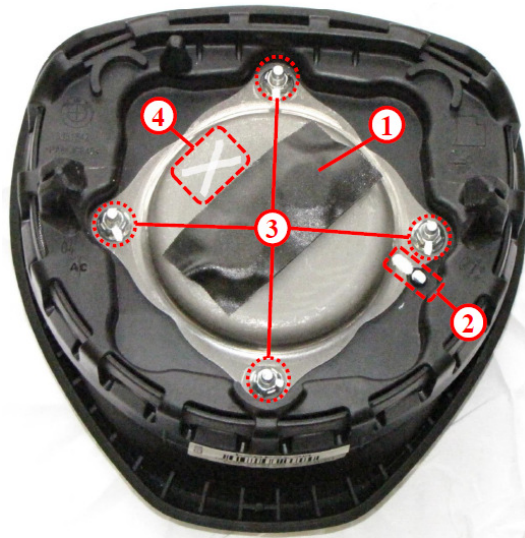
[6] Cover the connections on the old Generator with duct tape (1) so the contacts cannot be touched.

NOTE: – Picture above is an example and may not exactly match your Generator

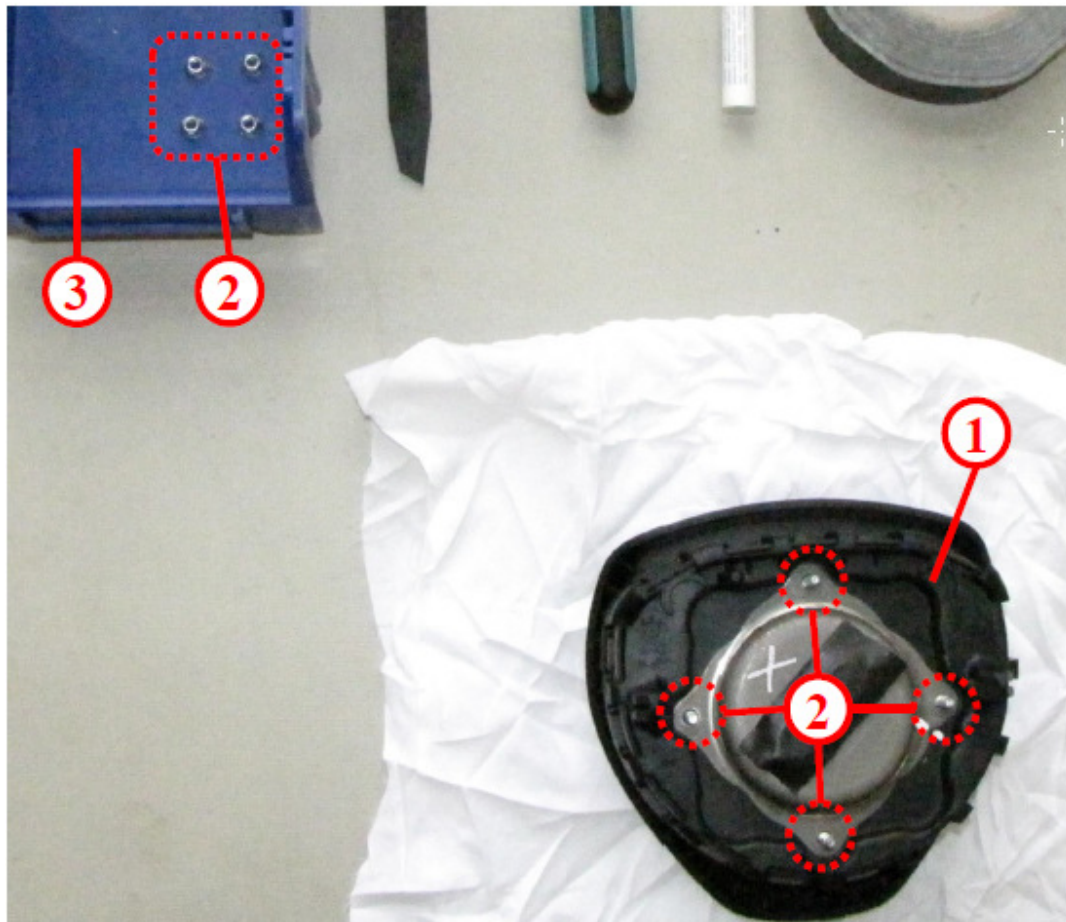
[8] 2<sup>nd</sup> Technician should hold airbag steady for 1<sup>st</sup> Technician

1<sup>st</sup> Technician should remove all four nuts (1) in any order and immediately place the used nuts into the provided container (2) for disposal. This is done to avoid mixing old parts and new parts.

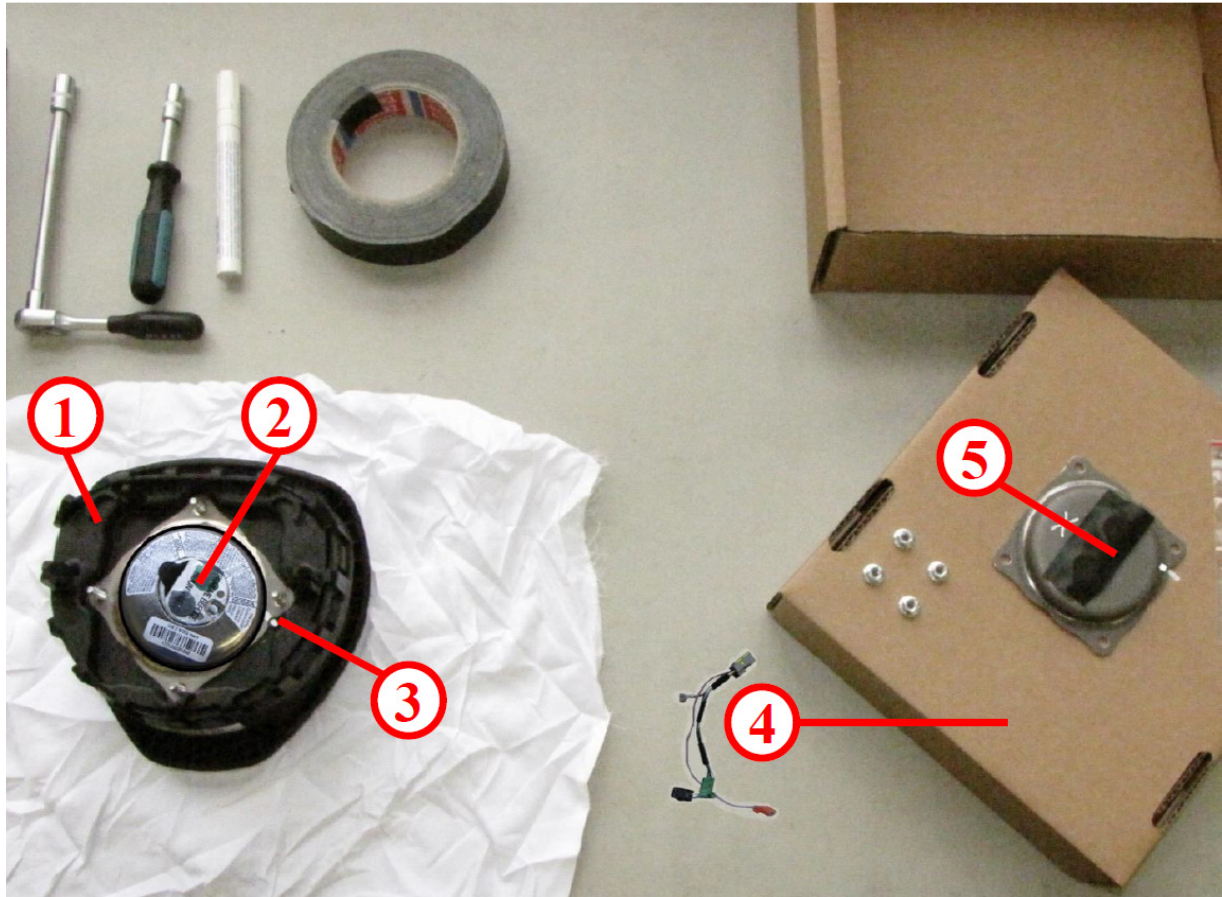
[14] Immediately after the visual inspection of the airbag cavity the new Generator (2) should be installed into the Air Bag (1).

**Check the orientation of the new Generator and the Air Bag and make sure the marks line up (3).**

[15] Insert the original Generator (5) into the packaging (4).

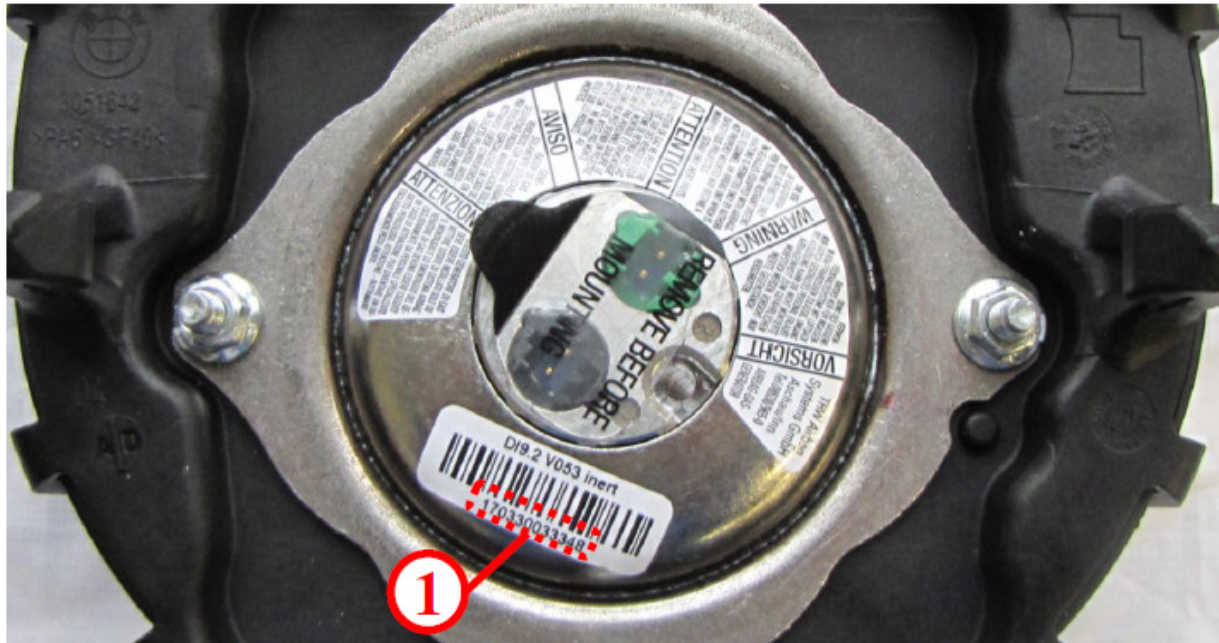
[18] Note serial number of the new Air Bag unit (1) on the Repair Order.

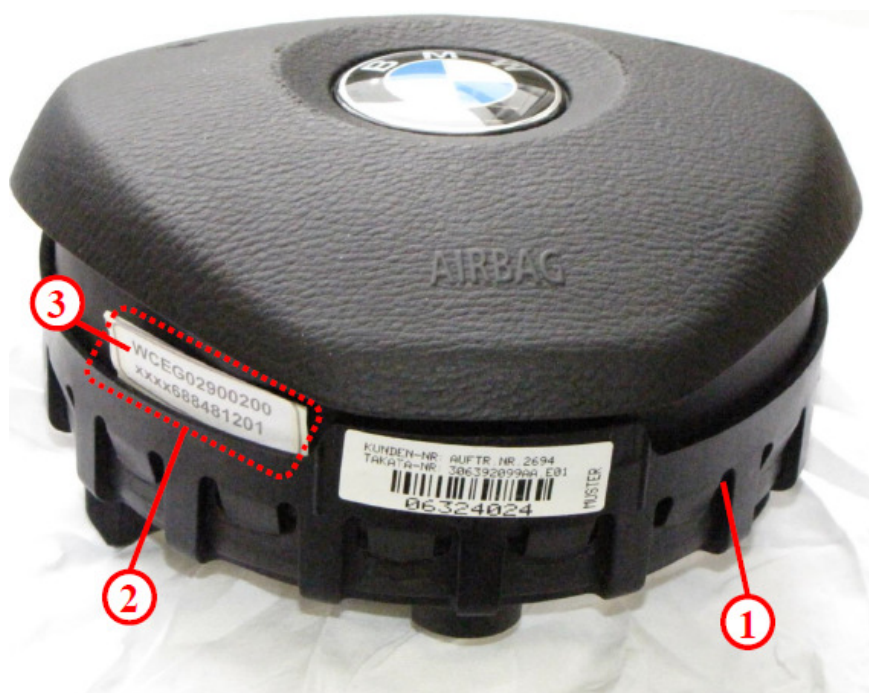
[18] Remove the 2 supplied stickers [18] Place the 1<sup>st</sup> airbag sticker onto the Air Bag in location (2) shown.

The 2<sup>nd</sup> serial number sticker of the new Generator must be placed on the Repair Order

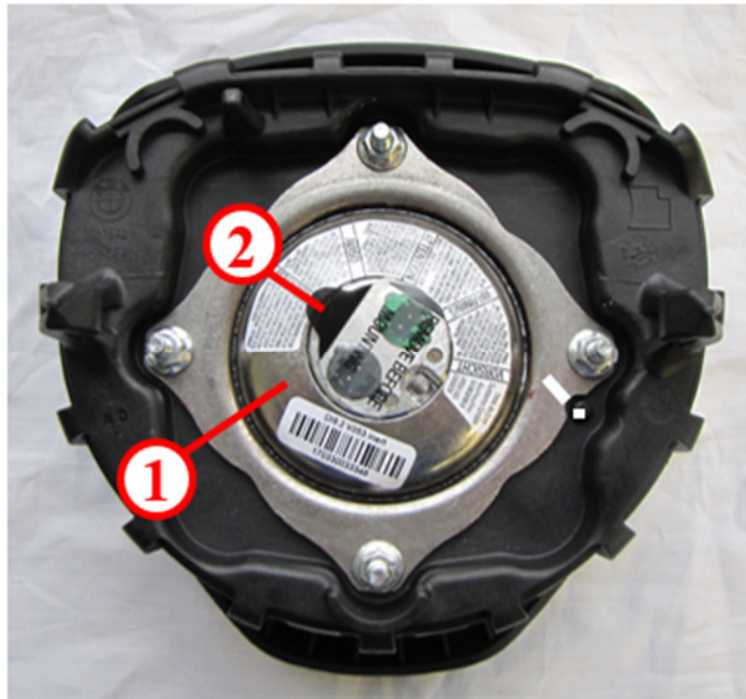
[19] Remove the tape (2) from the new generator (1).

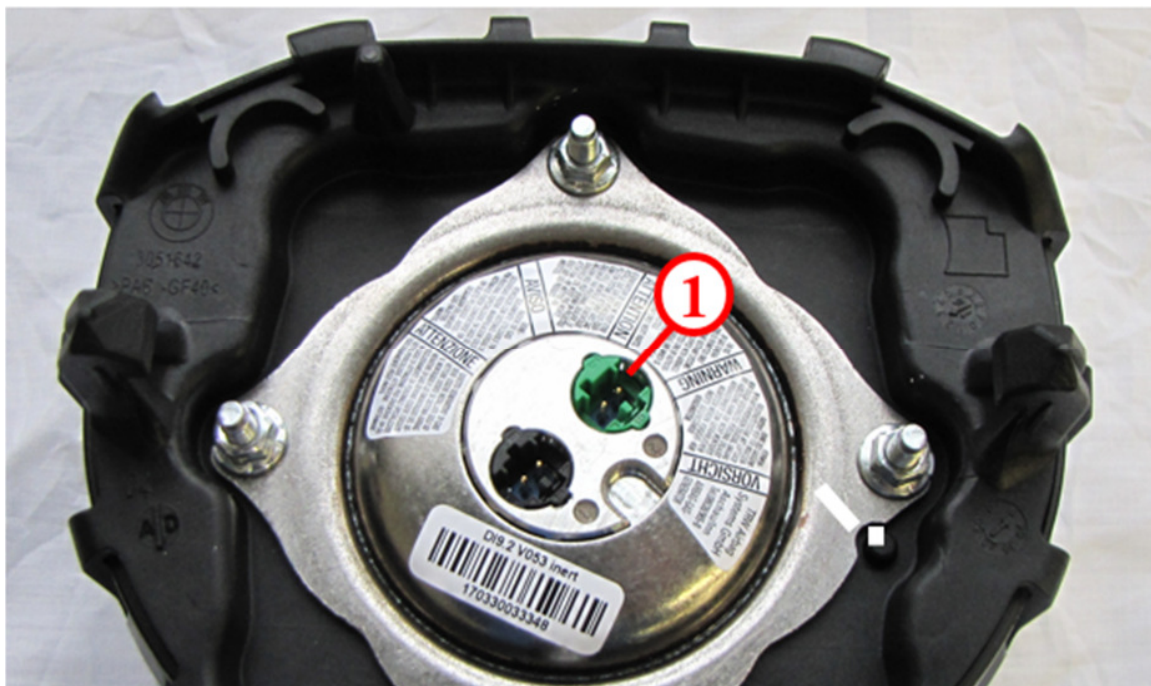
[20] 1<sup>st</sup> and 2<sup>nd</sup> Technician must ensure green connector is orientated as shown (1)

[21] Turn the Air Bag assembly over and perform a visual inspection of the Air Bag cover to ensure its condition matches what was noted on the Repair Order prior to this repair.

[22] Remove the wiring harness (5) from the steering wheel:

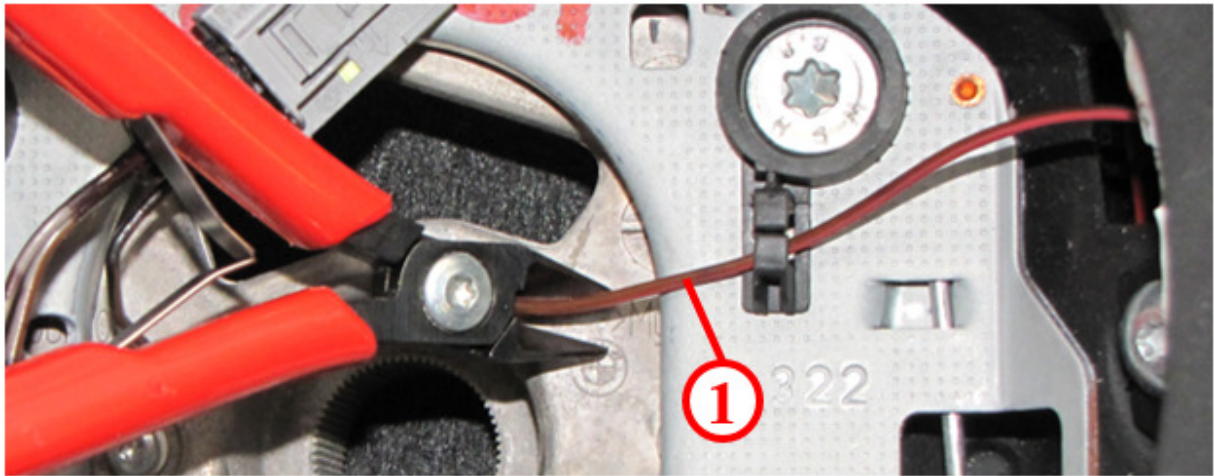
Cut the cable (1).

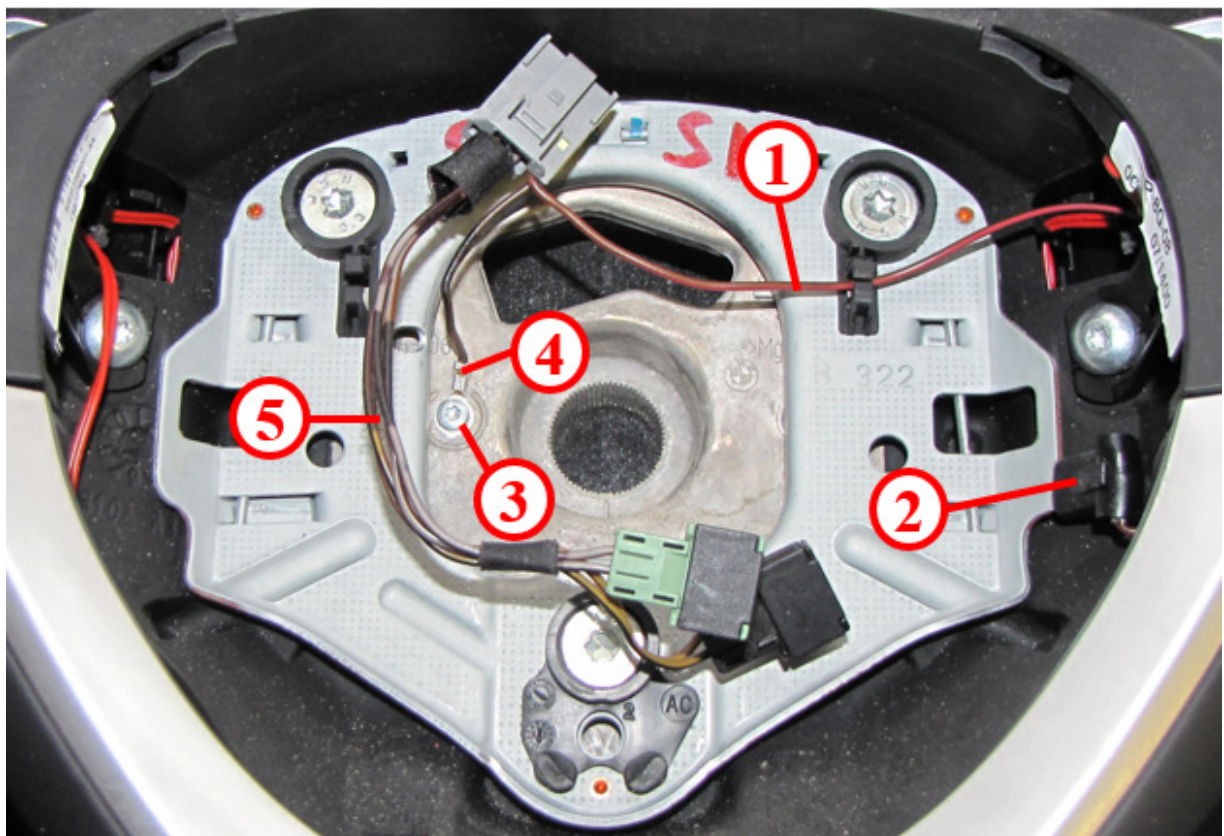
Disconnect the ground contact (2). Remove and dispose the ground cable (1).

Remove the bolt (3). Remove the ground contact (4).

Remove and dispose the wiring harness (5).

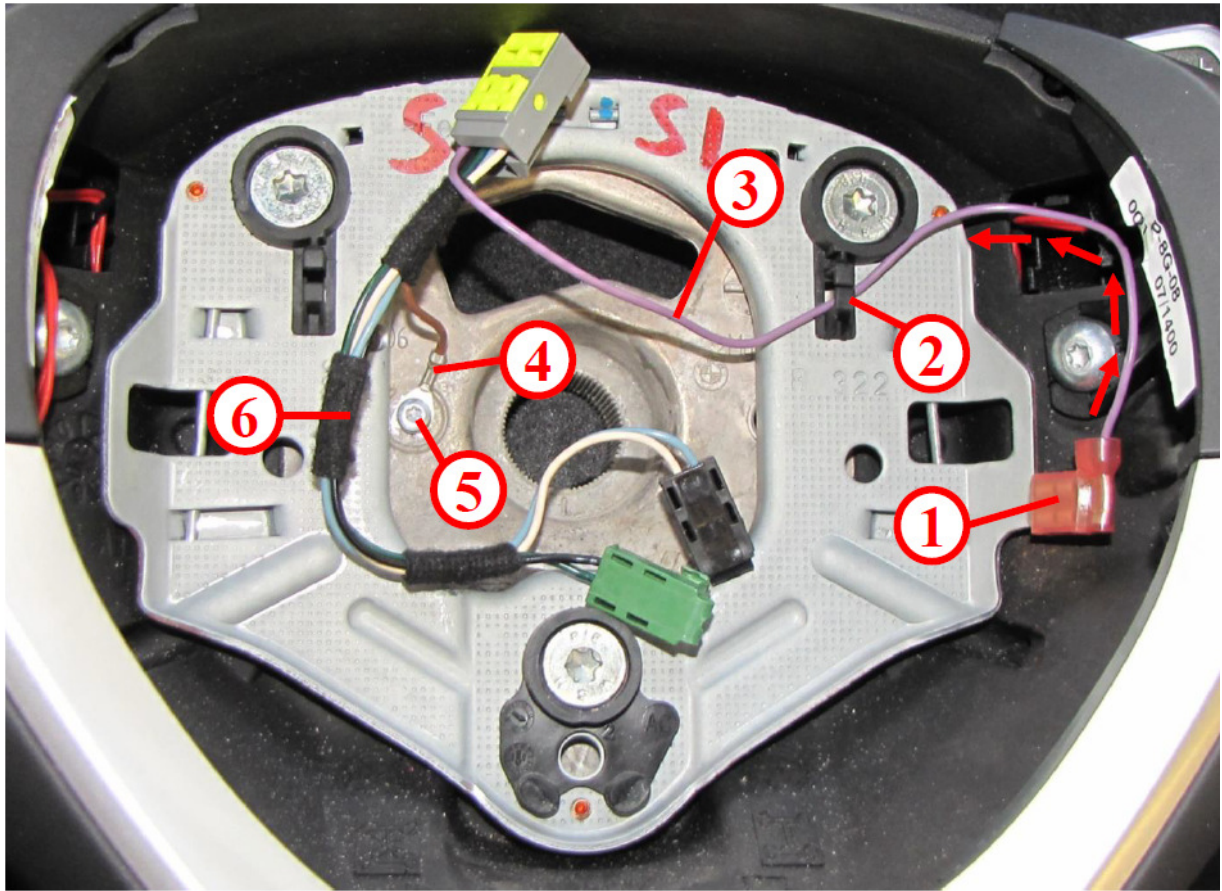
Place the wiring harness (6) as shown.

Connect the ground contact (1).
