# HYUNDAI

## Technical Service Bulletin

GROUP	NUMBER
<b>CAMPAIGN</b>	<b>20-01-010H</b>
DATE	MODEL(S)
<b>February, 2020</b>	<b>2020MY KONA</b>

**SUBJECT:** 2020MY KONA OS GROSS AXLE WEIGHT RATING (GAWR) CERTIFICATION LABEL REPLACEMENT (RECALL CAMPAIGN 187)

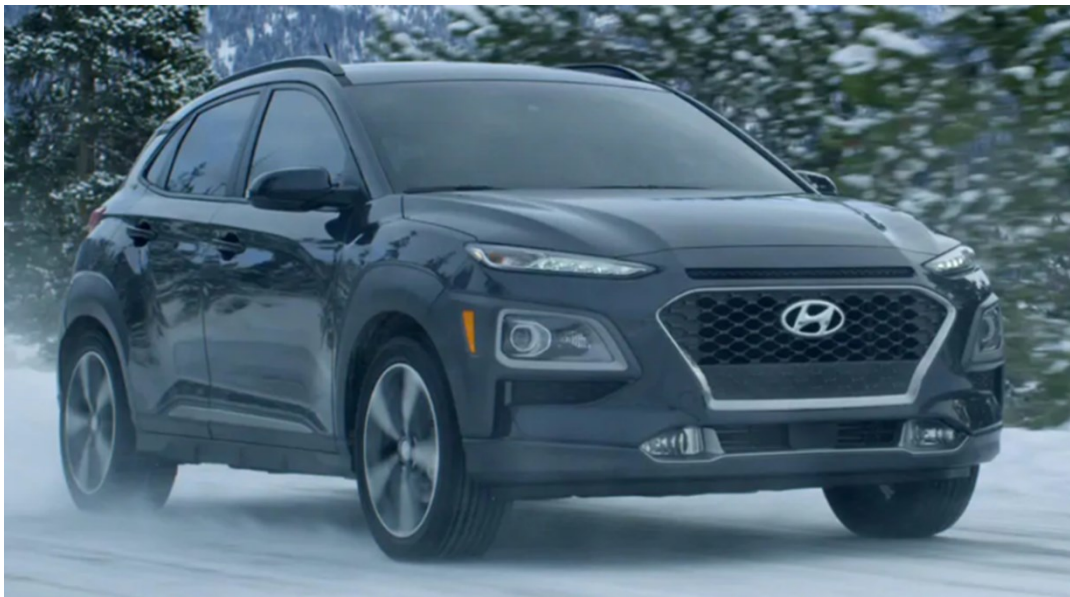
**Description:** Certain 2020 model year Kona vehicles indicate the incorrect Gross Axle Weight Rating (GAWR). As such, these vehicles do not comply with Federal Motor Vehicle Safety Standards. An incorrect GAWR could result in the vehicle being overloaded, increasing the risk of a crash. This bulletin describes the procedure to replace the affected area of the GAWR certification label.

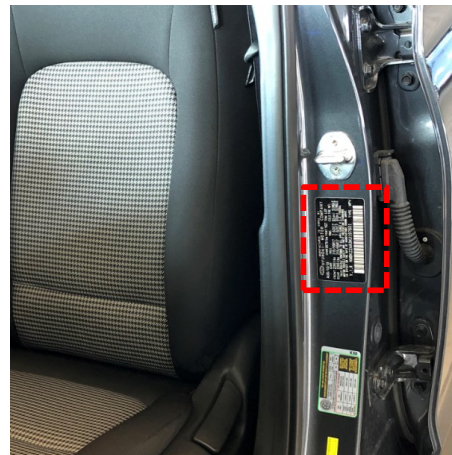
1. Open the driver's side door and locate the GAWR certification label located just below the B pillar door latch.

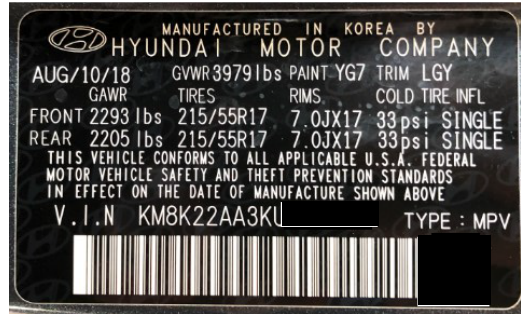
2. Ensure the existing GAWR certification label is clean and dry. If necessary wipe with a clean water dampened rag and dry the label off.

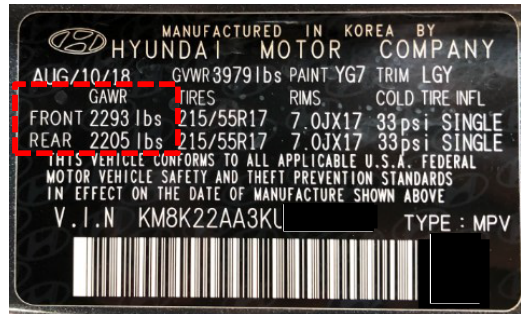
3. Put the updated GAWR label over the portion of the existing GAWR label.

Completely place the updated GAWR label straight so it does not cover any other information on the existing label.
