Campaign Service

BULLETIN NUMBER:
CB20-C-001B

IMPORTANT SAFETY RECALL

SEAT BELT INSPECTION AND REPLACEMENT – 20V-025 (Transport Canada 2020-012)

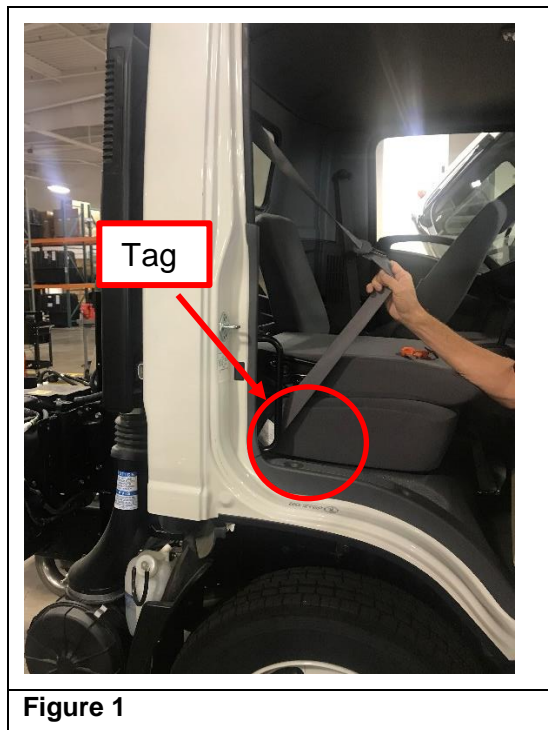
1. Place the vehicle in Park (P), apply the parking brake, and turn the engine off.
2. Inspect the driver and passenger side tongue seat belt assembly tags' product number and manufacturing date which are located near the seat belt's lower anchor point. (See Figures 1 and 2.) Record these numbers on the repair order for the vehicle.

- Using Table 1 below, compare the product number and the manufacturing date found on each tongue seat belt assembly tag. If both the product number and the manufacturing date on the tongue seat belt assembly tag match Table 1, proceed to Step 4. If either the product number or the manufacturing date on the tongue seat belt assembly tag DO NOT match Table 1, proceed to Step 15.

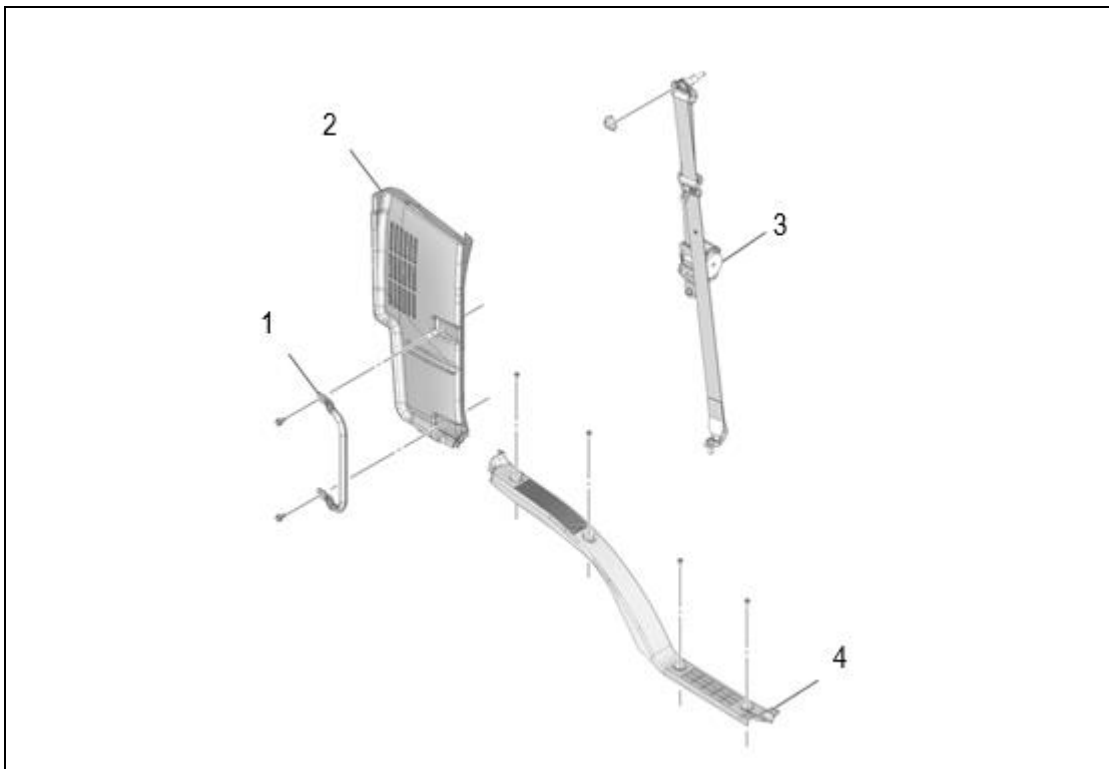
Figure 3

- Assist Handle
- Rear Pillar Lower Trim
- Tongue Side Seat Belt Assembly
- Door Side Floor Mat Trim Cover

- Remove the two (2) 12mm bolts from the assist handle. Remove and set aside for reuse. (See Figure 3.)
- Remove the four (4) T25 screws from the door side floor mat trim cover. Remove and set aside for reuse. (See Figure 3.)

6. Remove the rear pillar lower trim by pulling the rear of the cover inwards to the center of the cab to detach the mounting clips. Remove and set aside for reuse. (See Figure 3.)
7. Use a small flat head screwdriver to remove the cover from the seat belt upper anchor bolt. (See Figure 4.) Set aside for reuse.

11. Re-install the lower panel trim and firmly push the panel to engage the retaining clips. (See Figure 3.)

12. Re-install the door side floor mat trim cover using the four (4) T25 screws. (See Figure 3.)
13. Re-install the assist handle using the two (2) 12mm bolts. Tighten both bolts to the specified torque. (See Figure 3.)

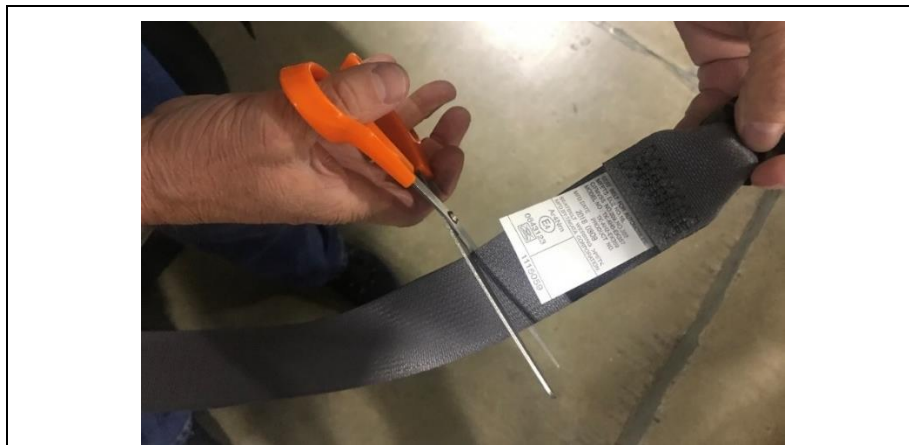
Figure 5

8. Remove the three (3) 14mm bolts from the tongue side seat belt assembly: the retractor fixing bolt; the upper anchor bolt; and the lower anchor bolt. Remove the tongue side seat belt assembly. The mounting bolts will not be reused.
9. Use a pair of scissors or shears to cut off the webbed belt portion of the ***old*** tongue seat belt that has both the tag and the lower anchor. (See Figure 5.) Return this portion of the seat belt to your parts department for warranty retention. Discard the remaining portion of the old tongue seat belt assembly.
