October 26, 2020

Version 2

Safety Recall: Isuzu Oasis Driver's Frontal Airbag Inflator (NADI-Factory Installed)

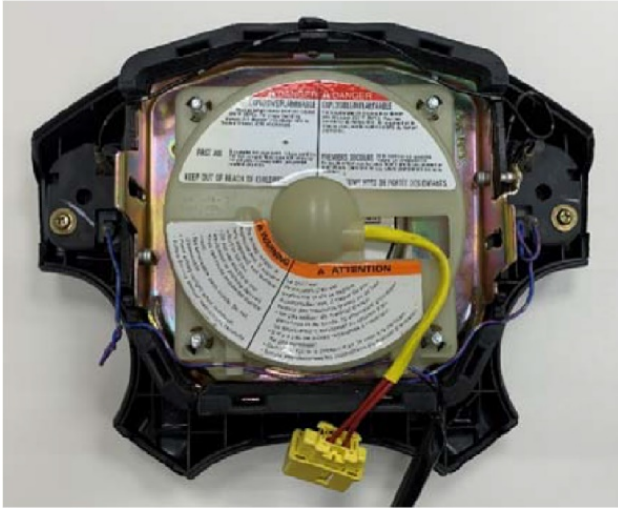
With Cover

- To successfully complete this inspection and verification procedure, be sure to use the V-SMART tool along with the following steps in this bulletin.
 - Before using the tool, review the job aid *Using V-SMART for NADI Recalls*. Keep in mind there is another job aid called *Using V-SMART*, but be sure not to use it. It does not include NADI Recall information.
6. Check if the airbag module has a plastic inflator cover.

- If it does, go to step 7.
- If it does not, go to step 10.

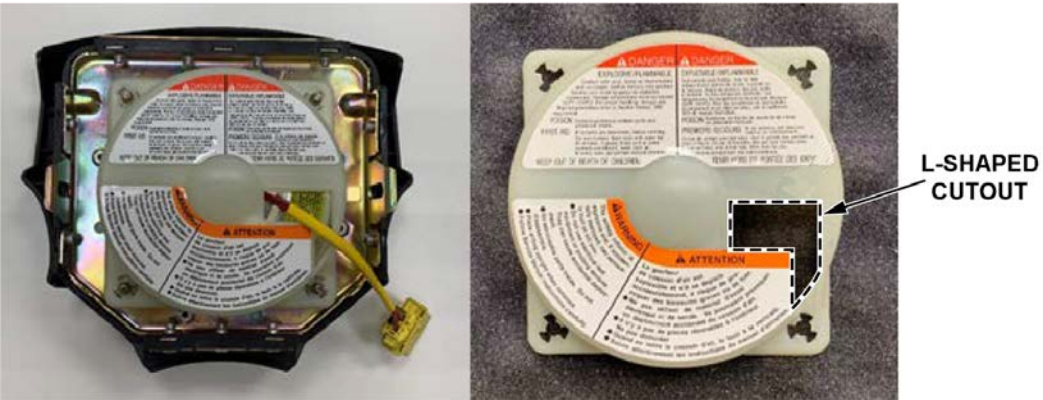
- **Inflator cover Type 2** has an L-shaped cutout at the right side of the cover.

- If the inflator cover is **Type 1** or **2**, go to step 8.
- If the inflator cover is **Type 3**, this campaign does not apply. Go to step 23 to complete the V-SMART procedure and install the airbag module.

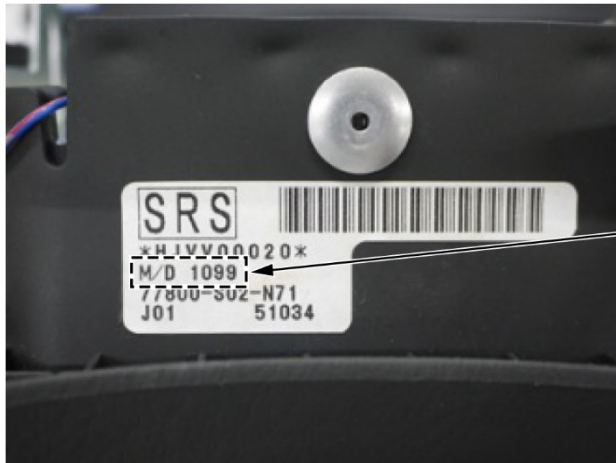
Check the last two M/D numbers.

11. Check the **M/D** number on the airbag module serial number label.

- If the last two numbers are **95, 96, 97, 98, or 99**, go to step 12.
- If the label is missing, or is unreadable, go to step 12.

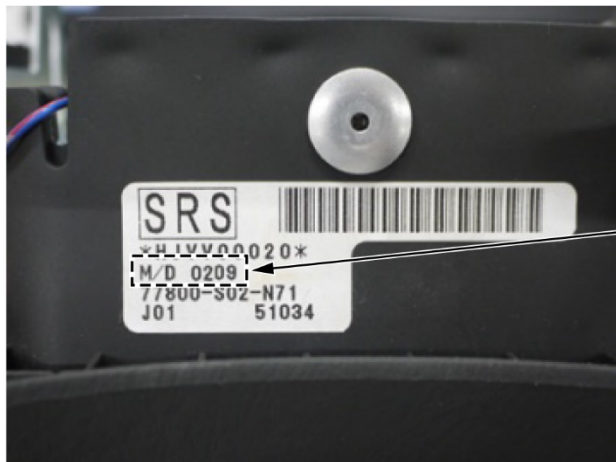
Check the last two M/D numbers.

- If the last two numbers are **not 95, 96, 97, 98, or 99**, this campaign does not apply. Go to step 23 to complete the V-SMART procedure and install the airbag module.

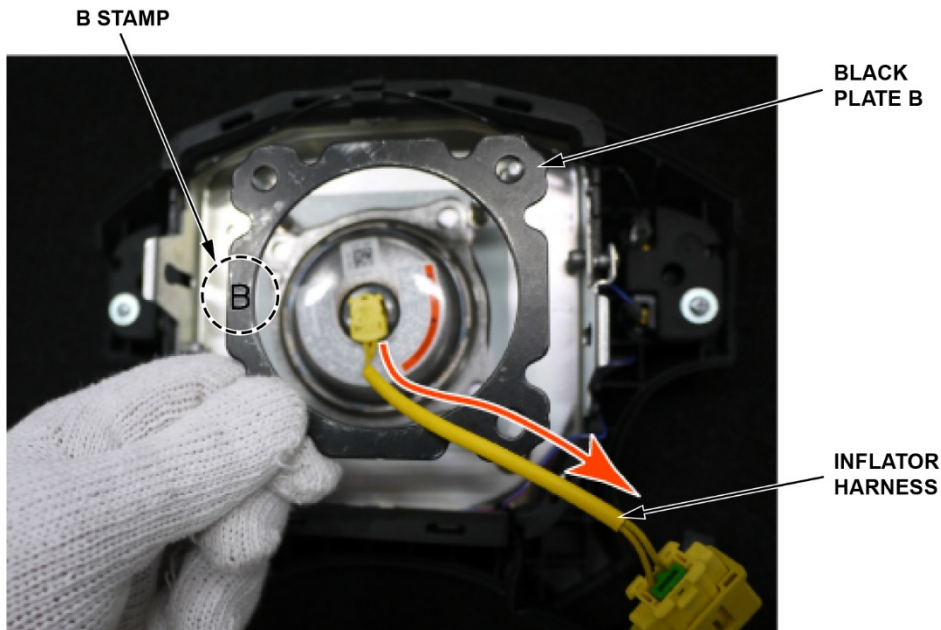
Black plate B may have scuffs and paint peeling that occurred during packaging. There is nothing wrong with it.

17. Make sure the **B** stamp on black plate B is positioned on the left side. Then, pass the inflator harness through the opening.

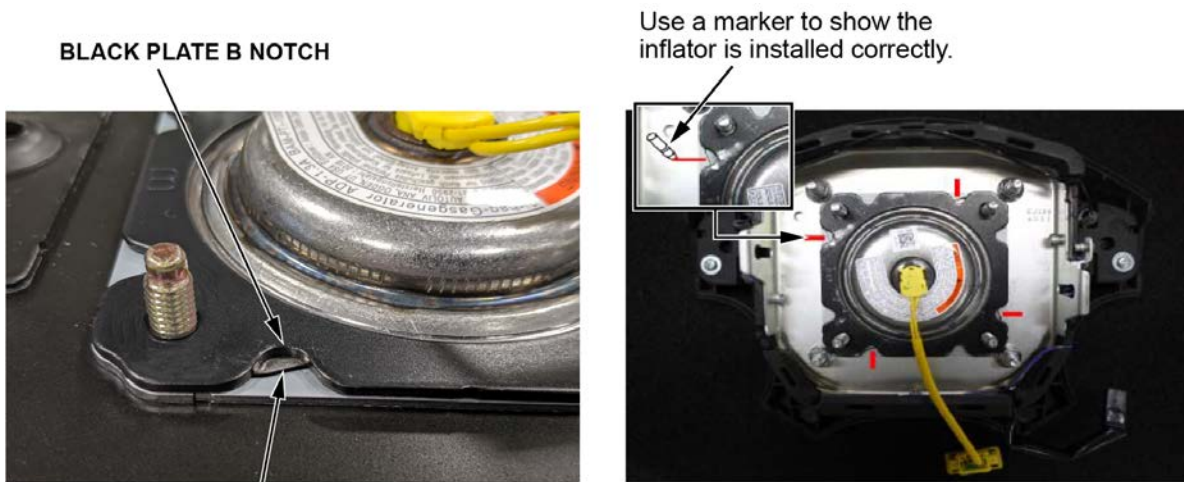
NOTE: Make sure the inflator is within the opening of silver plate A and they are not overlapping. Check all four notches on black plate B carefully.

19. Make sure the inflator is installed correctly by checking the four notches on black plate B. The inflator should be within the opening of silver plate A, and not overlapping. Using a marker, mark each of the four notches after you made sure it is installed correctly. If the inflator is not installed correctly, go back to step 16.
