TECHNICAL INSTRUCTIONS

SAFETY RECALL 20TA01

FRONT DRIVER AIRBAG **INFLATOR** REPLACEMENT

Certain 1997-1998 Model Year Supra
Certain 1998-1999 Model Year Celica
Certain 1998-2000 Model Year RAV4
Certain 1998-1999 Model Year RAV4 EV

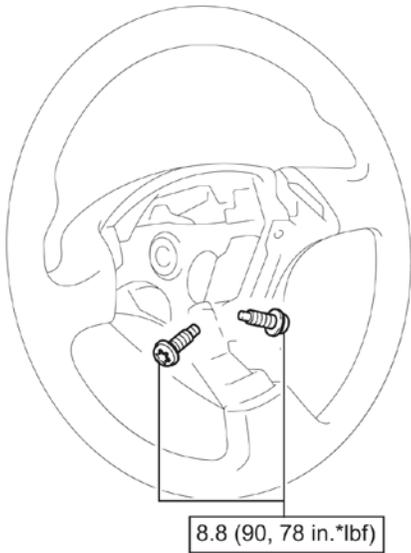
R2003090003E

●SELF-LOCKING NUT (Serial number check result was NG)

3.9 N·m (40, 35 in.*lbf)
Be careful not to overtighten.

●INFLATOR
(Serial number
check result was NG)

HORN BUTTON ASSEMBLY
(Design will vary depending
on the vehicle model and
specification)

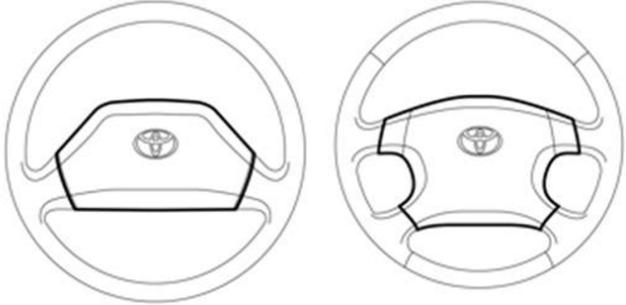
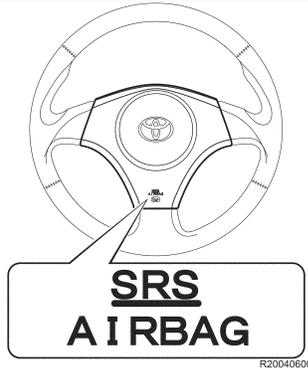
<p>2 Spoke</p> <p>4 spoke</p>

<p>3 spoke</p>
<p>a. How many spokes does the steering wheel have?</p> <ul style="list-style-type: none">• 2 or 4 spokes: Vehicle IS NOT affected. Campaign complete.• 3 spokes: Vehicle is potentially affected, proceed to next inspection step.	<p>b. Does the 3 spoke steering wheel have SRS AIRBAG sign as shown?</p> <ul style="list-style-type: none">• NO SRS AIRBAG sign: Vehicle IS NOT affected. Campaign complete.• YES: Vehicle is potentially affected, proceed to next step.

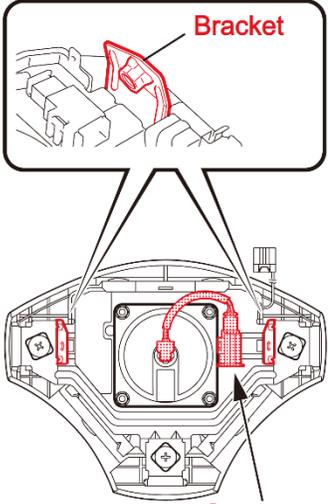
<p>Bracket</p> <p>Connector on RH side</p> <p>R2004240001</p>

Airbag assembly design	Serial number location
<p><u>With bracket for steering wheel connection</u></p>

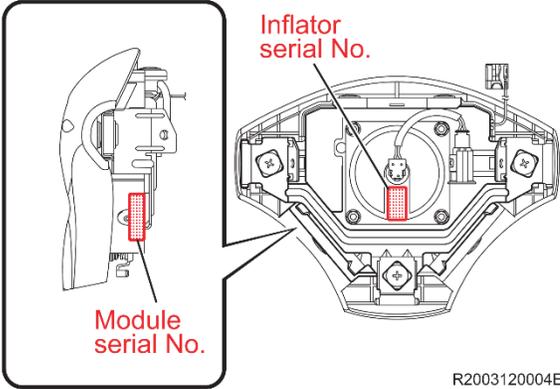
<p>Inflator serial No.</p> <p>Module serial No.</p> <p>R2003120004E</p>
<p><u>Without bracket for steering wheel connection</u></p>

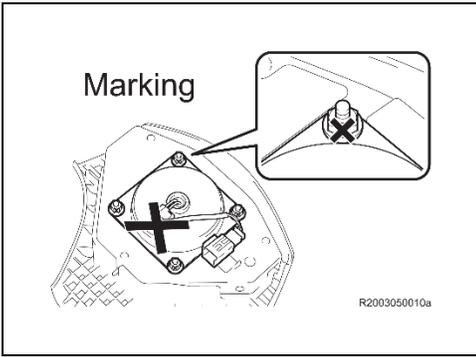
2. APPLYING MARKING ONTO THE PARTS TO BE REPLACED

- a. In order to avoid reusing the parts to be replaced mistakenly, apply marking on the inflator and the 4 nuts to be removed.

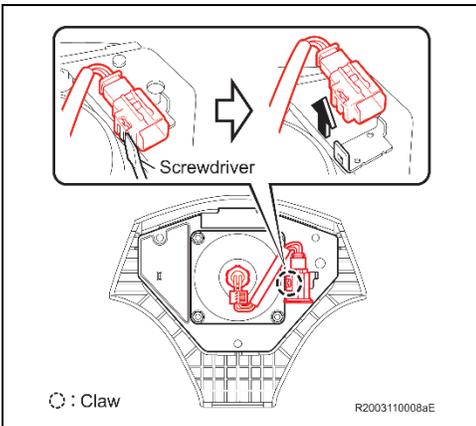
3. REMOVE THE INFLATOR

- a) Using a screwdriver, disconnect the airbag connector from the inflator side of the airbag assembly.

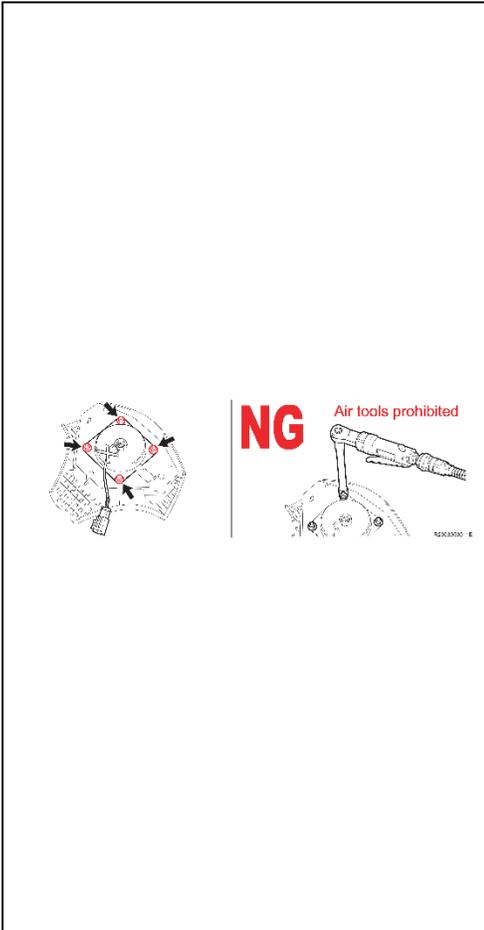
b) Remove the 4 nuts.

*NOTE: There are 2 different types of nuts installed, one is a self-locking nut and the other is nuts coated with seal lock adhesive. **NEVER** use air tools to remove the nut, otherwise the stud bolt may break*

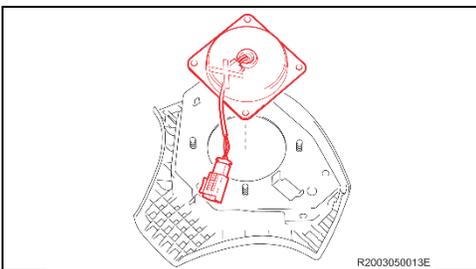
d) Remove the inflator.

e) Store the removed inflator in the replacement inflator box.

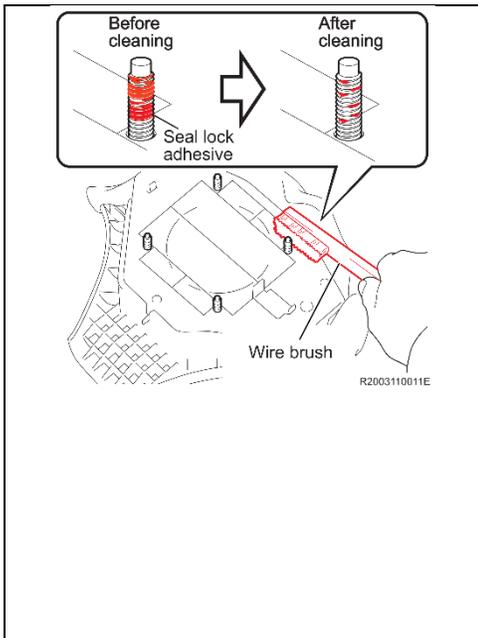
4. CLEAN THE STUD BOLTS ON THE AIRBAG ASSEMBLY (ONLY NEEDED FOR AIRBAG ASSEMBLY THAT DOES NOT HAVE THE BRACKET FOR STEERING WHEEL CONNECTION)

NOTE: Only for the airbag assembly that does NOT have the bracket for the steering wheel connection. Also, if there is seal lock adhesive applied to the stud bolts. Remove the adhesive before installing the **NEW** nuts.

- a) Perform the following work before cleaning the stud bolts.
 - (1) Apply tape to protect the airbag assembly from removed adhesive.
- b) Protect the design surface of the airbag assembly with clean shop cloths to prevent damage.

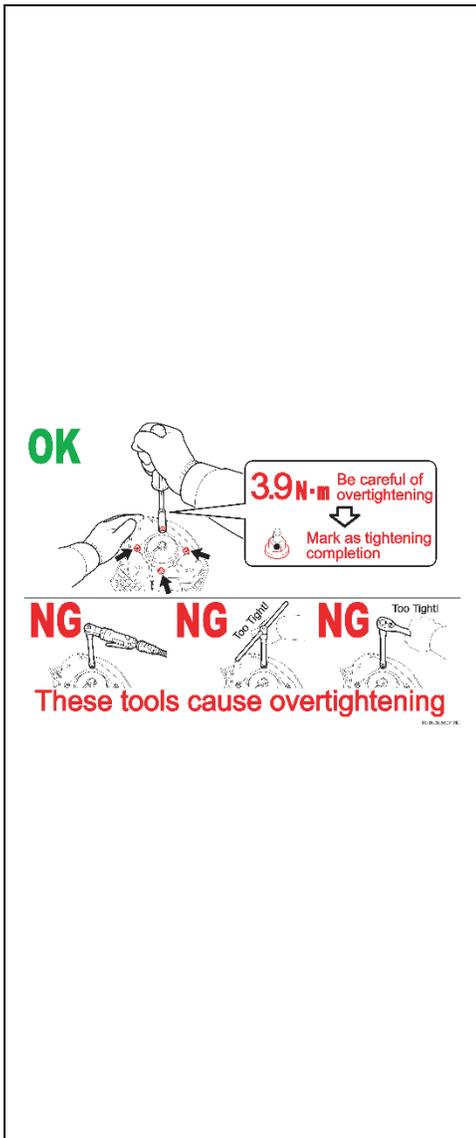
5. INSTALL THE NEW INFLATOR

- a) Using a socket driver, tighten **NEW** 4 self-lock nuts (you may feel some resistance while tightening because they are a self-locking nuts). Ensure you tighten the nuts evenly.

Torque nuts to 3.9 N*m (40 kgf*cm, 35 in.*lbf)

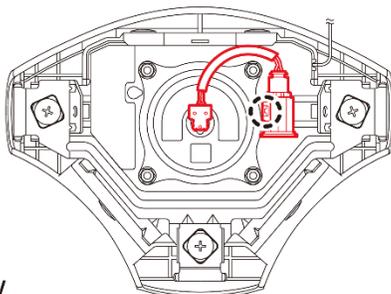
[With bracket for steering wheel connection]

- a) Attach the connector to the bracket and ensure the harness is routed correctly.

○ : Claw

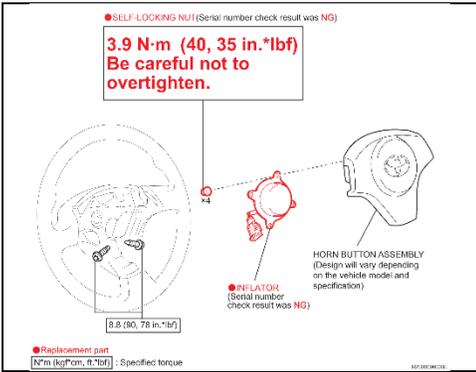
7. INSTALL THE AIRBAG ASSEMBLY

- a) Connect each connector.
- b) Using a "TORX" socket wrench, tighten the 2 "TORX" bolts to install the airbag assembly.
- c) Torque: 8.8 N*m (90 kgf*cm, 78 in.*lbf)

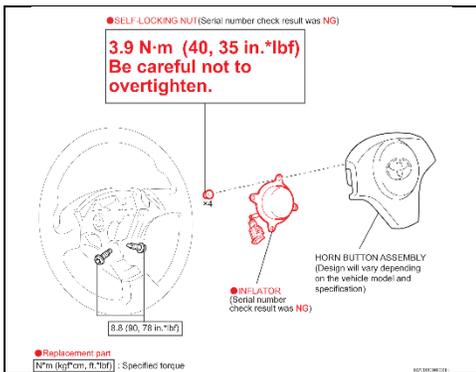
2. INSTALL THE AIRBAG ASSEMBLY

- a) Connect each connector.
- b) Using a "TORX" socket wrench, tighten the 2 "TORX" bolts to install the Airbag.
- c) Torque: 8.8 N*m (90 kgf*cm, 78 in.*lbf)
