TECHNICAL INSTRUCTIONS

SAFETY RECALL 20LA02

CERTAIN ENGINE BLOCKS CAN CAUSE ENGINE FAILURE LEADING TO FIRE RISK

CERTAIN 2020 ES 300h

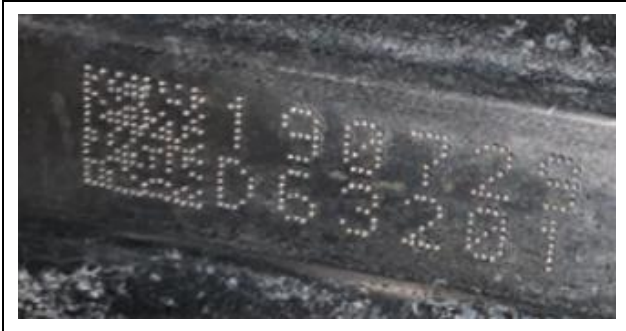
4. TAKE A PHOTO OF THE BLOCK ID No.

- a. Use a camera to take a photo of the Block ID No. Be sure to place the camera as straight and level as possible to the surface of the stamping.

- a. Zoom in on the Block ID No. in the photo to be sure all 12 characters can be clearly read. If all 12 digits are not legible, retake the photo.

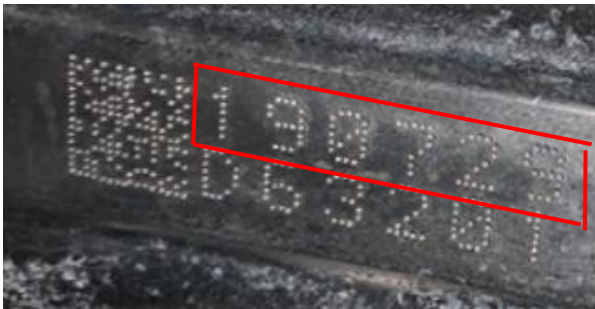
- a. Enter the top row of the Block ID No. (6 digits) when prompted.

NOTE: All 6 digits are NUMBERS.

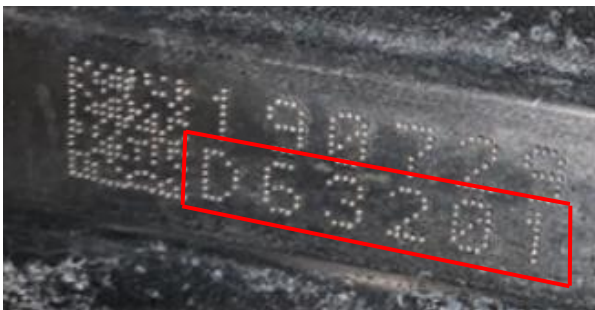
- b. Enter the bottom row of the Block ID No. (6 digits) when prompted.

NOTE: The first digit is a LETTER, the remaining digits are NUMBERS.
