ALA2 Delivery Stop/Recall Campaign - Reworking/replacing service cover of fuel pump

Vehicle type: **Macan/Macan S/Macan GTS/Macan Turbo**

Subject: **Service cover of fuel pump**

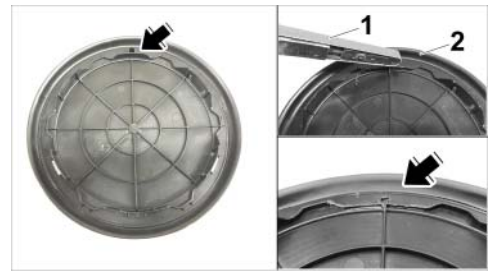
Underside of service cover

- 3 On the underside of the service cover, use a commercially available grinder ⇒ *Underside of service cover -1-* to take the rib with the positioning lug ⇒ *Underside of service cover -arrow-* down to **approx. 1 mm in height**. Make sure not to take down the rib completely and do not damage the sealing lip ⇒ *Underside of service cover -2-*.

- **Damage to service cover and sealing lip**
- ⇒ **Do not remove rib with positioning lug completely**
- ⇒ **Do not damage sealing lip during grinding**

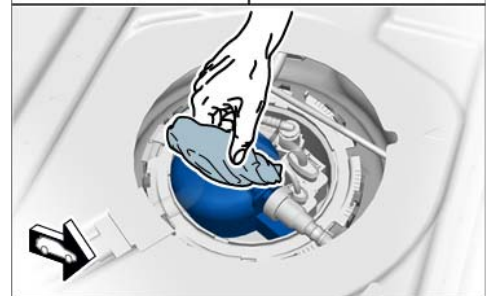
Cleaning top of filter flange of fuel pump

- 2 Clean the top of the filter flange of the fuel pump using a cleaning cloth and a suitable plastic cleaner ⇒ *Cleaning top of filter flange of fuel pump.*

Do **not** spray plastic cleaner directly on the filter flange, but only on the cleaning cloth you are using.

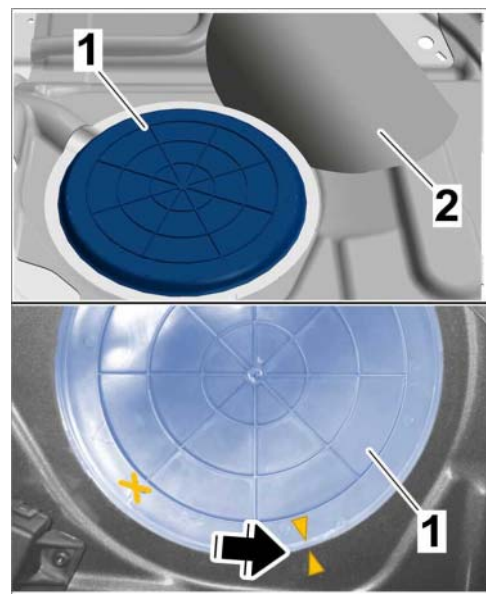
Installing service cover of fuel pump

- Procedure:
- 1 Install the service cover ⇒ *Installing service cover of fuel pump -1-*.
When doing so, make sure that the position marking on the service cover is at the same position as the marking on the body panel of the vehicle. In the case of a reworked service cover, position the previously re-affixed marking at the correct position ⇒ *Installing service cover of fuel pump -arrow-*.
Then fold up the protective mat ⇒ *Installing service cover of fuel pump -2-*.
 - 2 Install rear seat ⇒ *Workshop Manual '724819 Removing and installing rear seat'*.
 - 3 Enter the campaign in the Warranty and Maintenance booklet.
