SIB 51 06 20

## DELIVERY STOP & RECALL 20V-095: REAR SPOILER

BMW AG is conducting a Voluntary Safety Recall (effective February 13, 2020) on a small number of Model Year 2020 BMW X6 SAC models that were produced between January 6, 2020 and January 24, 2020.

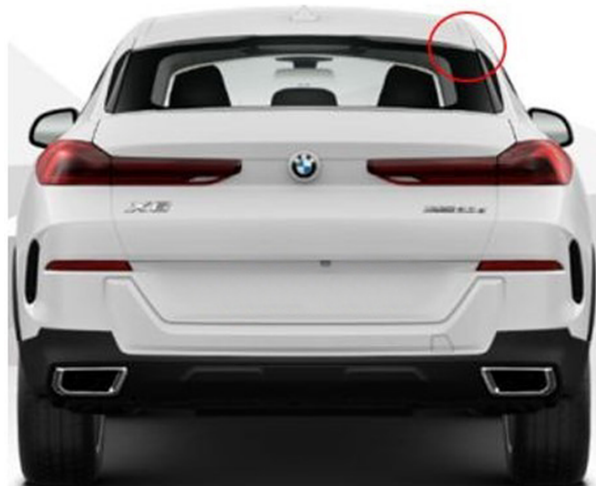
Shown above is the area (right side only) of the spoiler that will be inspected.

The upper right corner of the rear spoiler can delaminate due to a defective gluing of the material.

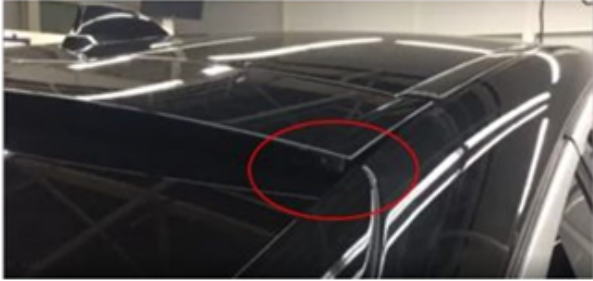
1. In the area shown above and to the left, visually compare the height of the rear spoiler from left to right.

Note: Use the left side for reference, because the left side will always be correct.

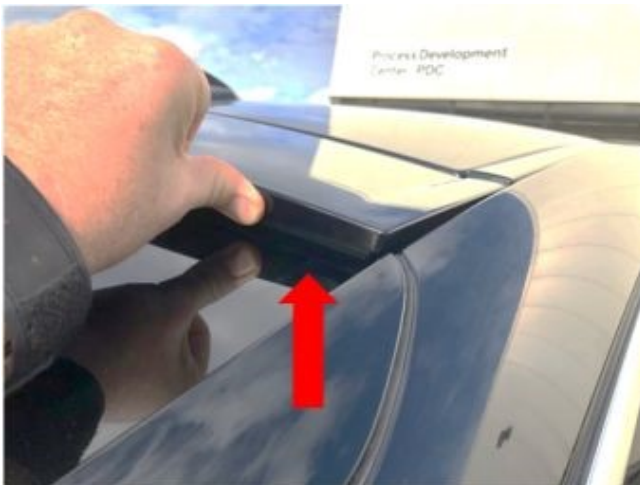
3. While pressing upwards using a thumb and moderate force, measure the gap between the glass and the bottom of the rear spoiler (arrow) again.

4. Taking into consideration the original distance between the spoiler and the rear window, were you able to lift the spoiler more than 6 mm **above the original value measured in step 2?**

5. Replace the rear spoiler following repair instructions REP 51 71 407 "**Replace rear spoiler**".
