SIB 51 06 20

## DELIVERY STOP & RECALL 20V-095: REAR SPOILER

BMW AG is conducting a Voluntary Safety Recall (effective February 13, 2020) on a small number of Model Year 2020 BMW X6 SAC models that were produced between January 6, 2020 and January 24, 2020.

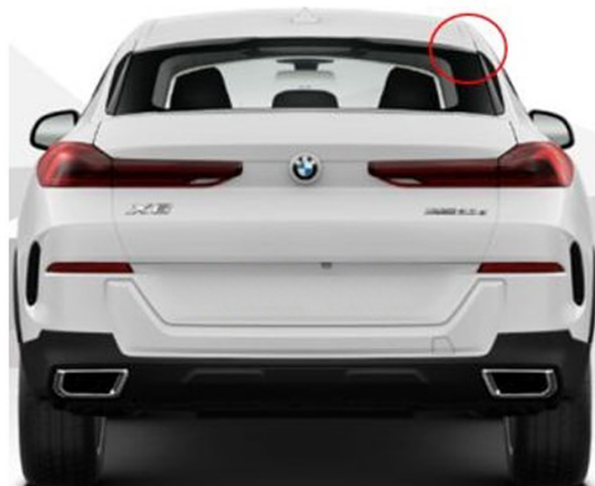
Shown above is the area (right side only) of the spoiler that will be inspected.

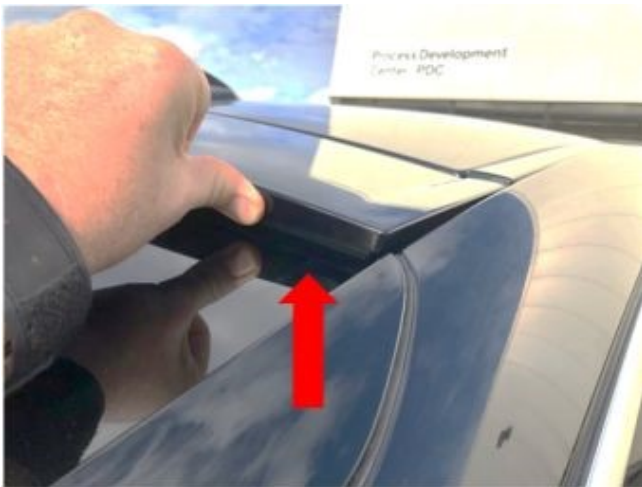
3. While pressing upwards using a thumb and moderate force, measure the gap between the glass and the bottom of the rear spoiler (arrow) again.

4. Taking into consideration the original distance between the spoiler and the rear window, were you able to lift the spoiler more than 6 mm **above the original value measured in step 2?**

Yes: Continue to step 5.

No: No further correction is needed.

5. Replace the rear spoiler following repair instructions REP 51 71 407 "**Replace rear spoiler**".
